Preliminary Report on the Performance of the New Orleans Levee Systems in Hurricane Katrina on August 29, 2005

Report No. UCB/CITRIS – 05/01
November 2, 2005

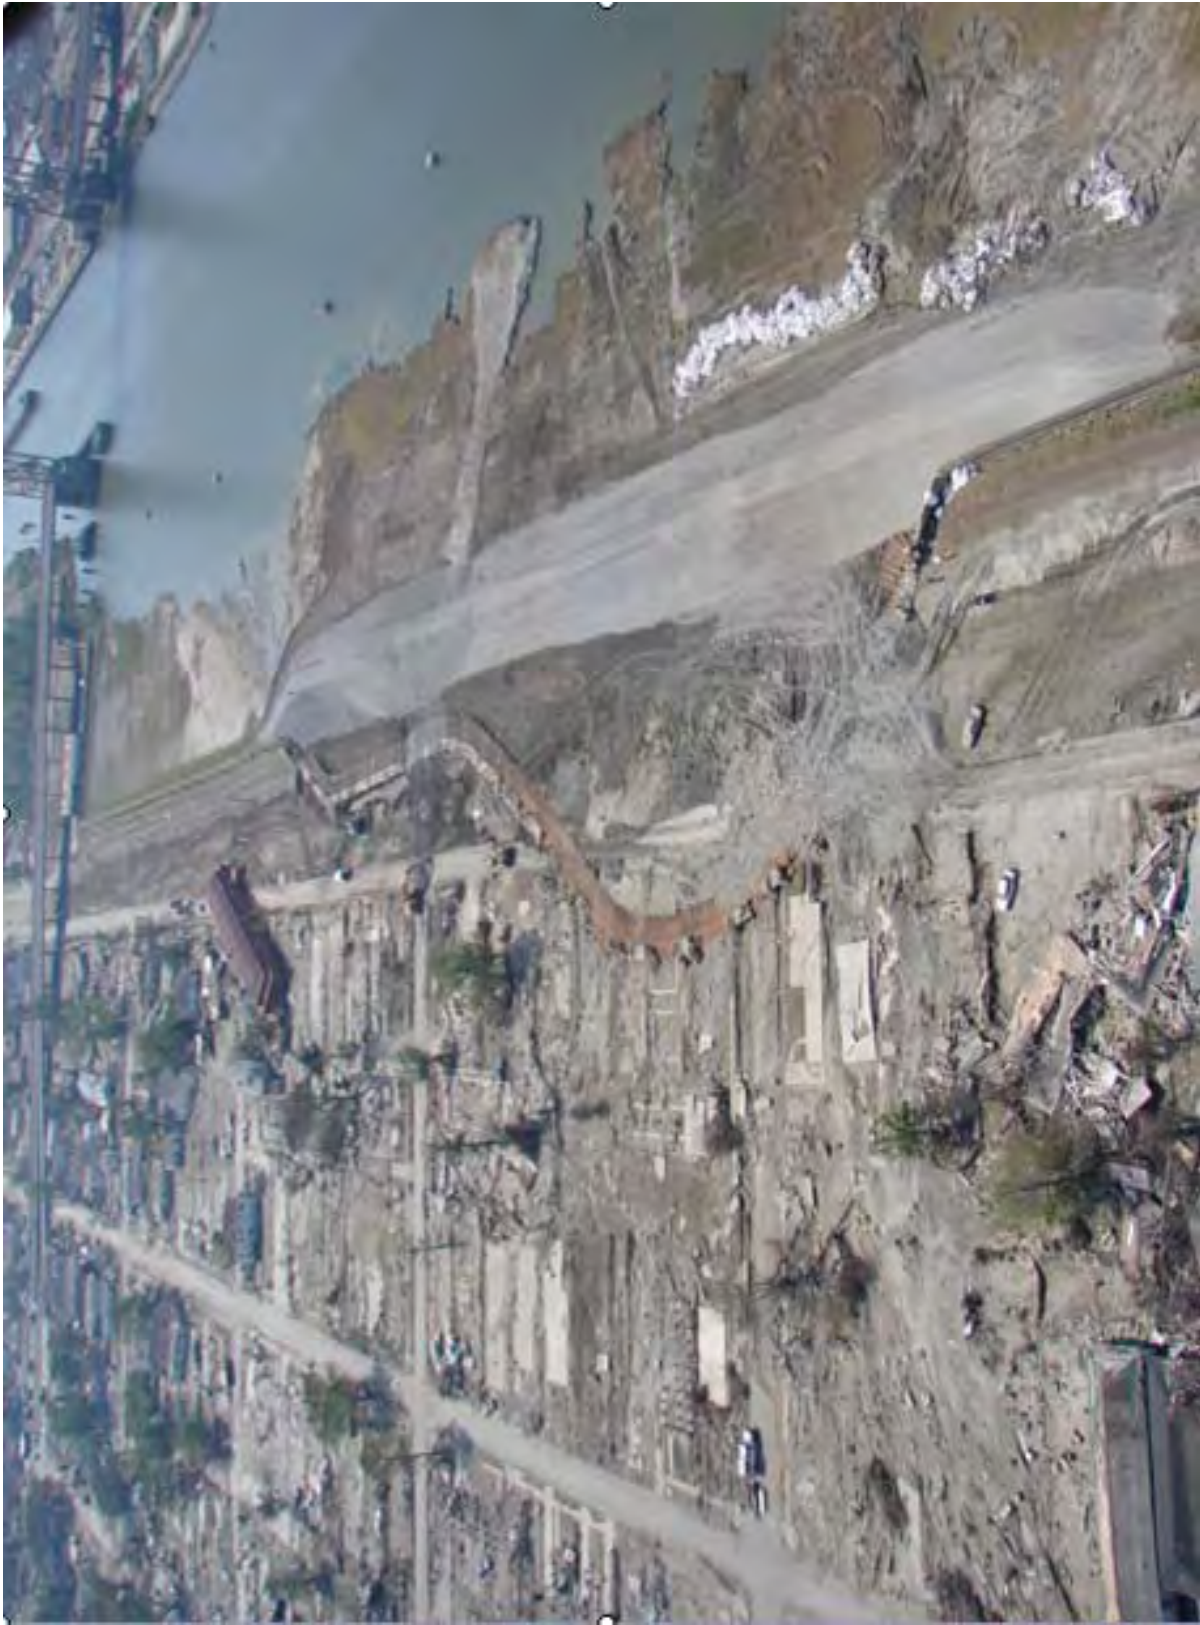
Figure 1.9: Oblique view of the (south) levee break at the Inner Harbor Navigation Canal into the lower Ninth Ward.

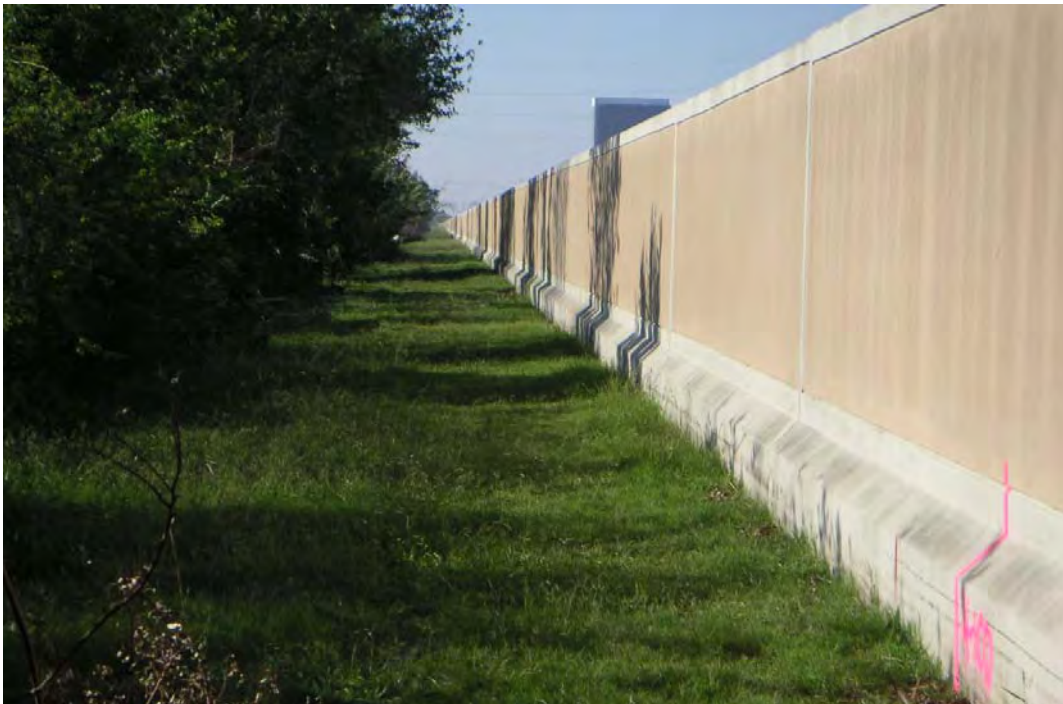
Figure 2.11: Typical conditions at the inboard side of floodwalls along the 17th Street Canal showing no scour of soil at the toe of the wall.

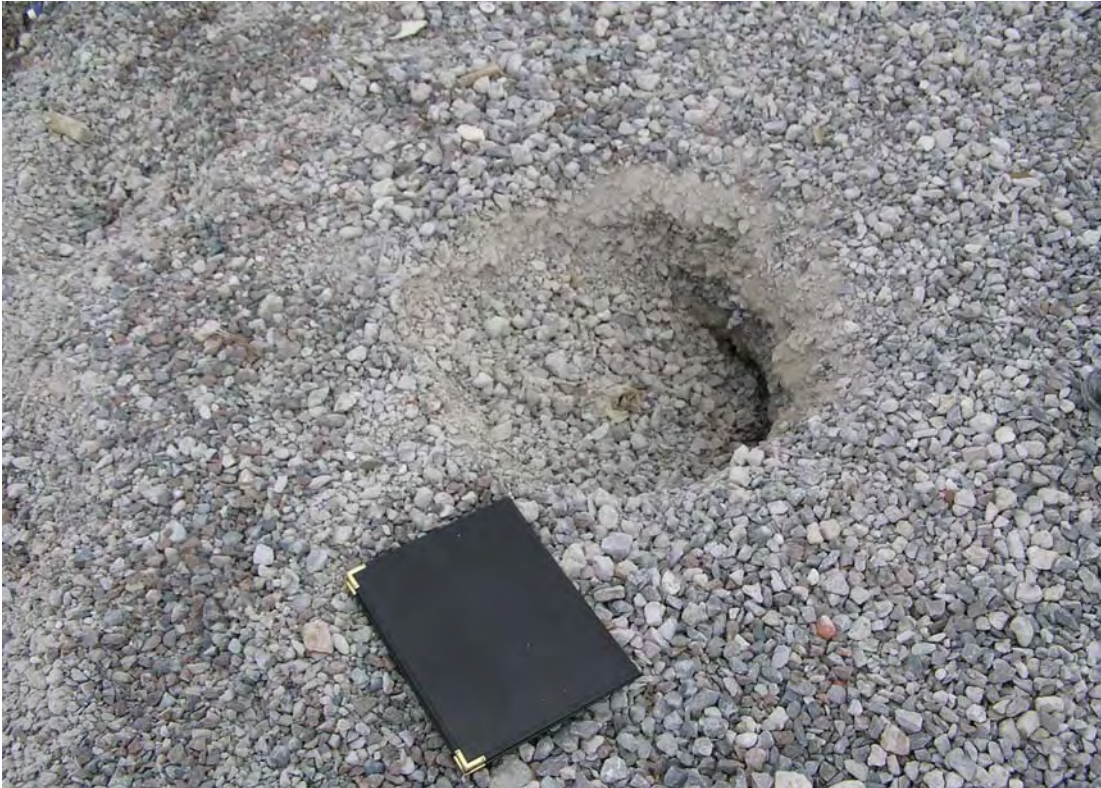
Figure 2.13: One of four sinkholes noted at the front lip of the crest of the temporary closure section embankment.

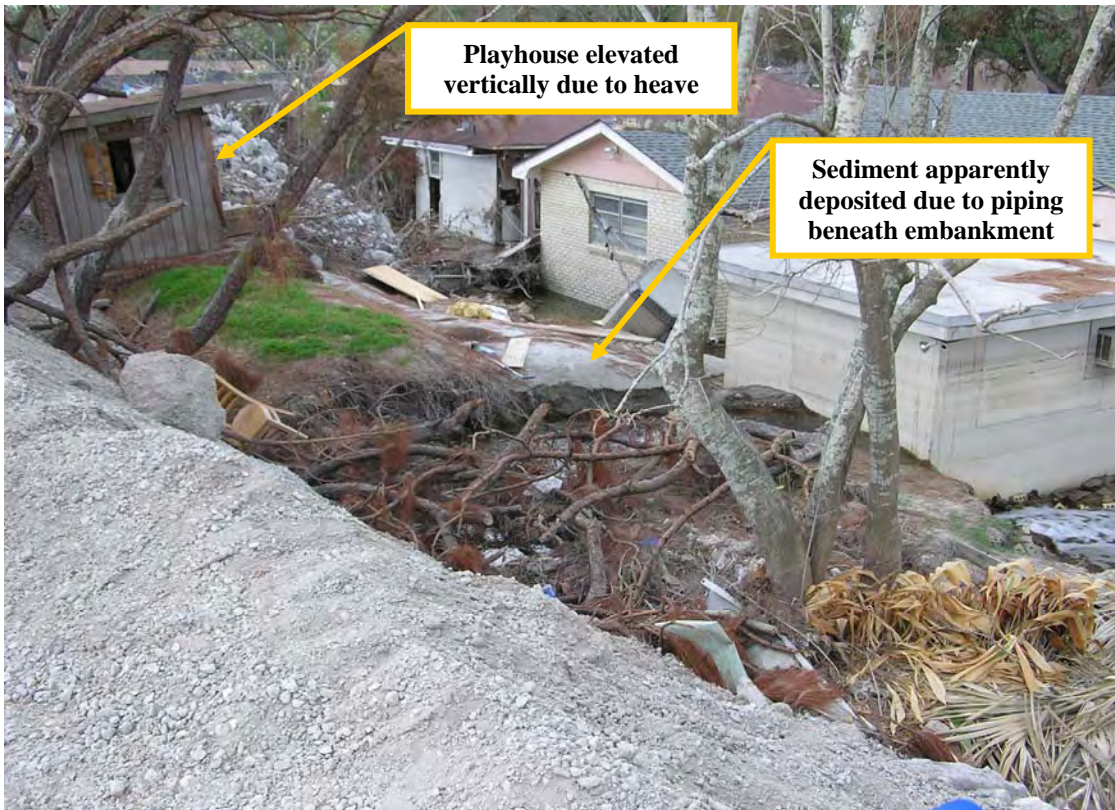
Figure 2.16: Conditions at the inboard toe of the London Avenue Canal (North) breach section.

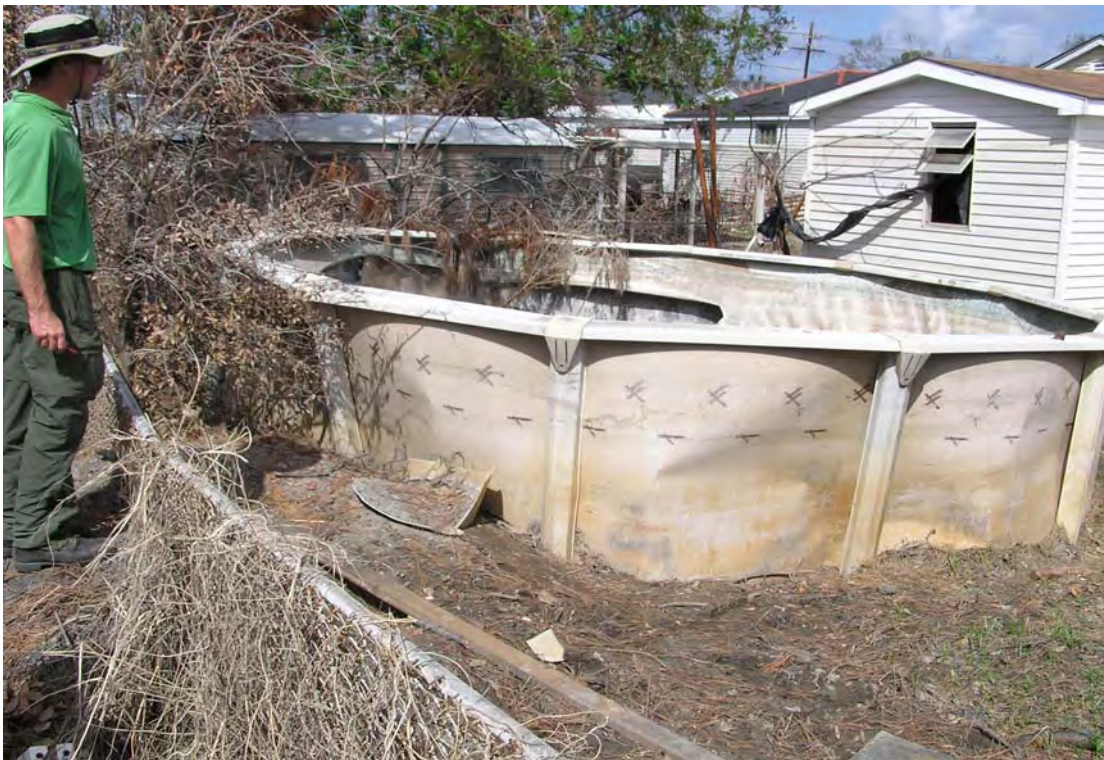
Figure 2.22: View of conditions at the inboard toe, immediately inboard of the locations shown previously in Figures 2.21 and 2.22. Note the bulged and hummocky ground, the laterally displaced chain link fence, and the piping boil ejecta.

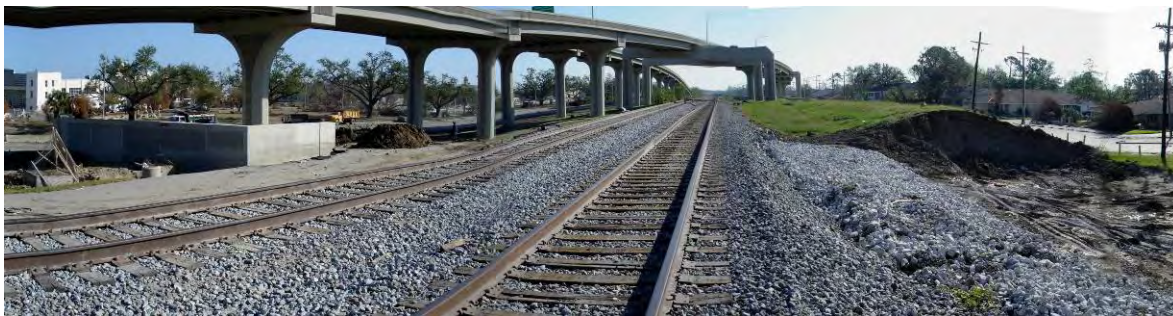
Figure 3.2: Complex transition near Lakefront Airport consisting of various flood protection heights, differing materials and junctures between various jurisdictional organizations. These types of complex transitions were found to be associated with several of the levee flood protection problems.

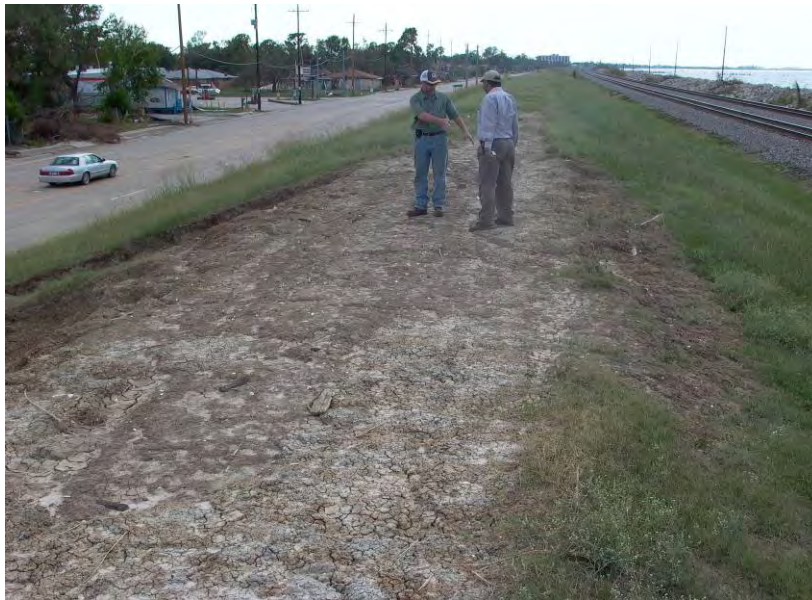
Figure 3.6: Wave overtopping of lakefront earthen levee at low spot in structure did not cause serious damage (Photo by F. Silva – N 30° 03' 47.8", W 89° 58' 13.1)

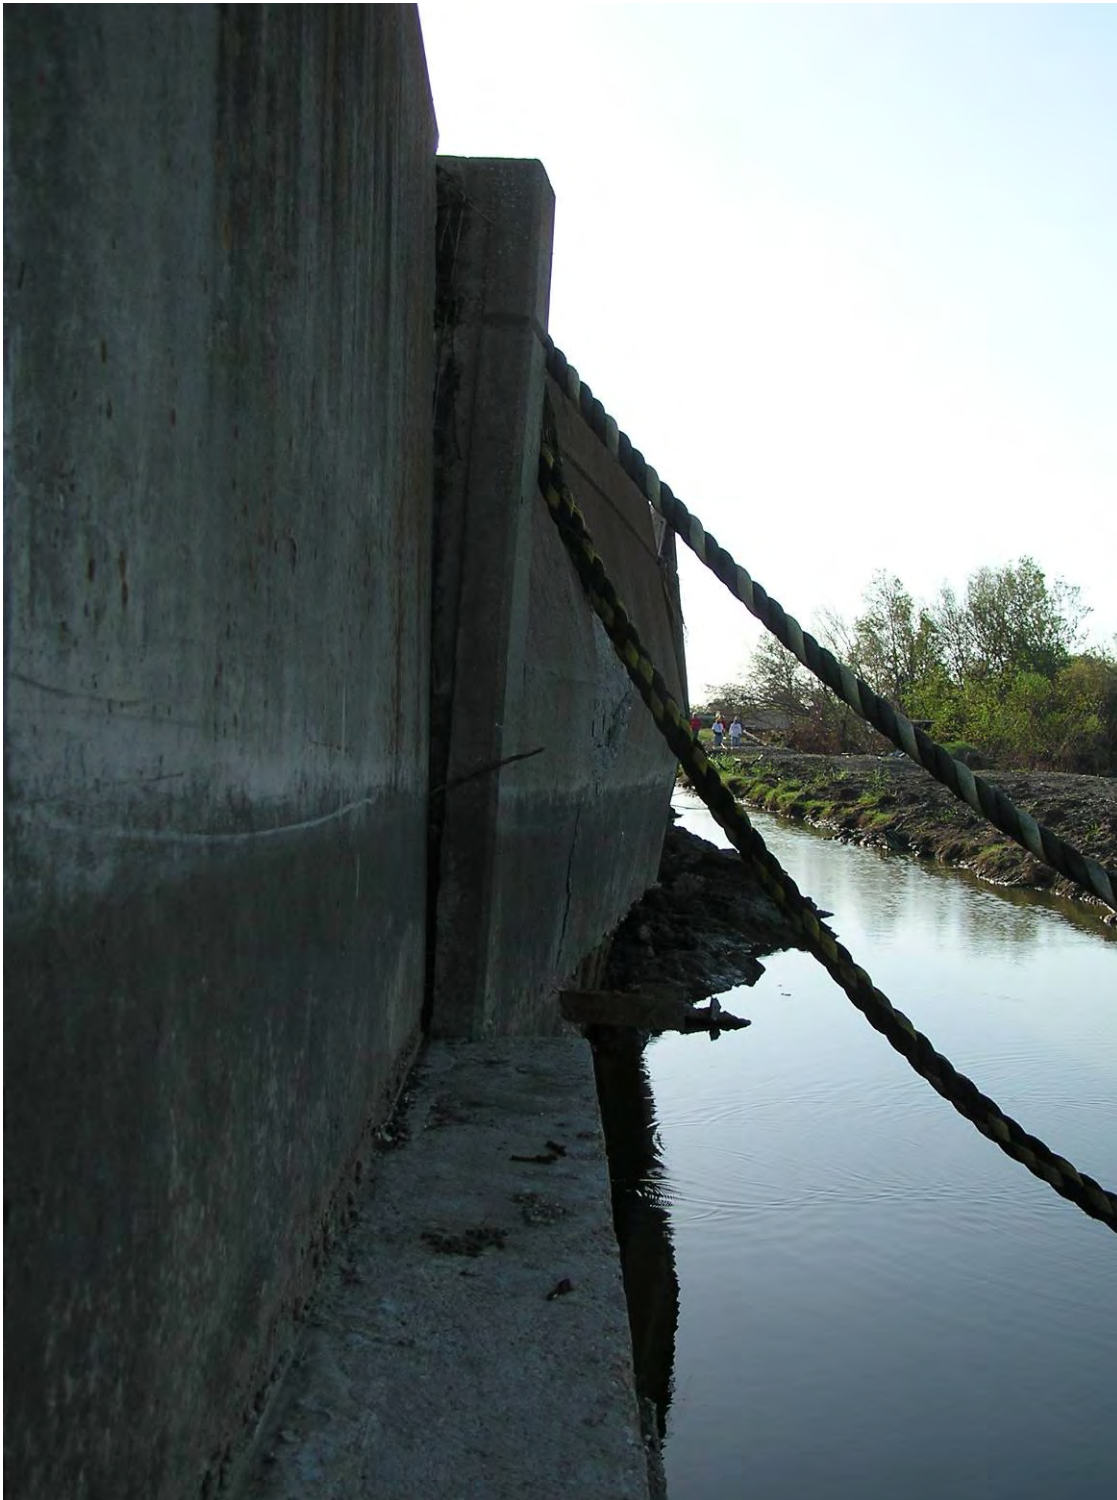
Figure 3.11: Undamaged T-wall in foreground and damaged I-wall in background along the Intracoastal Waterway. Severe scour on the landside and distress of the I-wall (N30.00030 W89.99459).

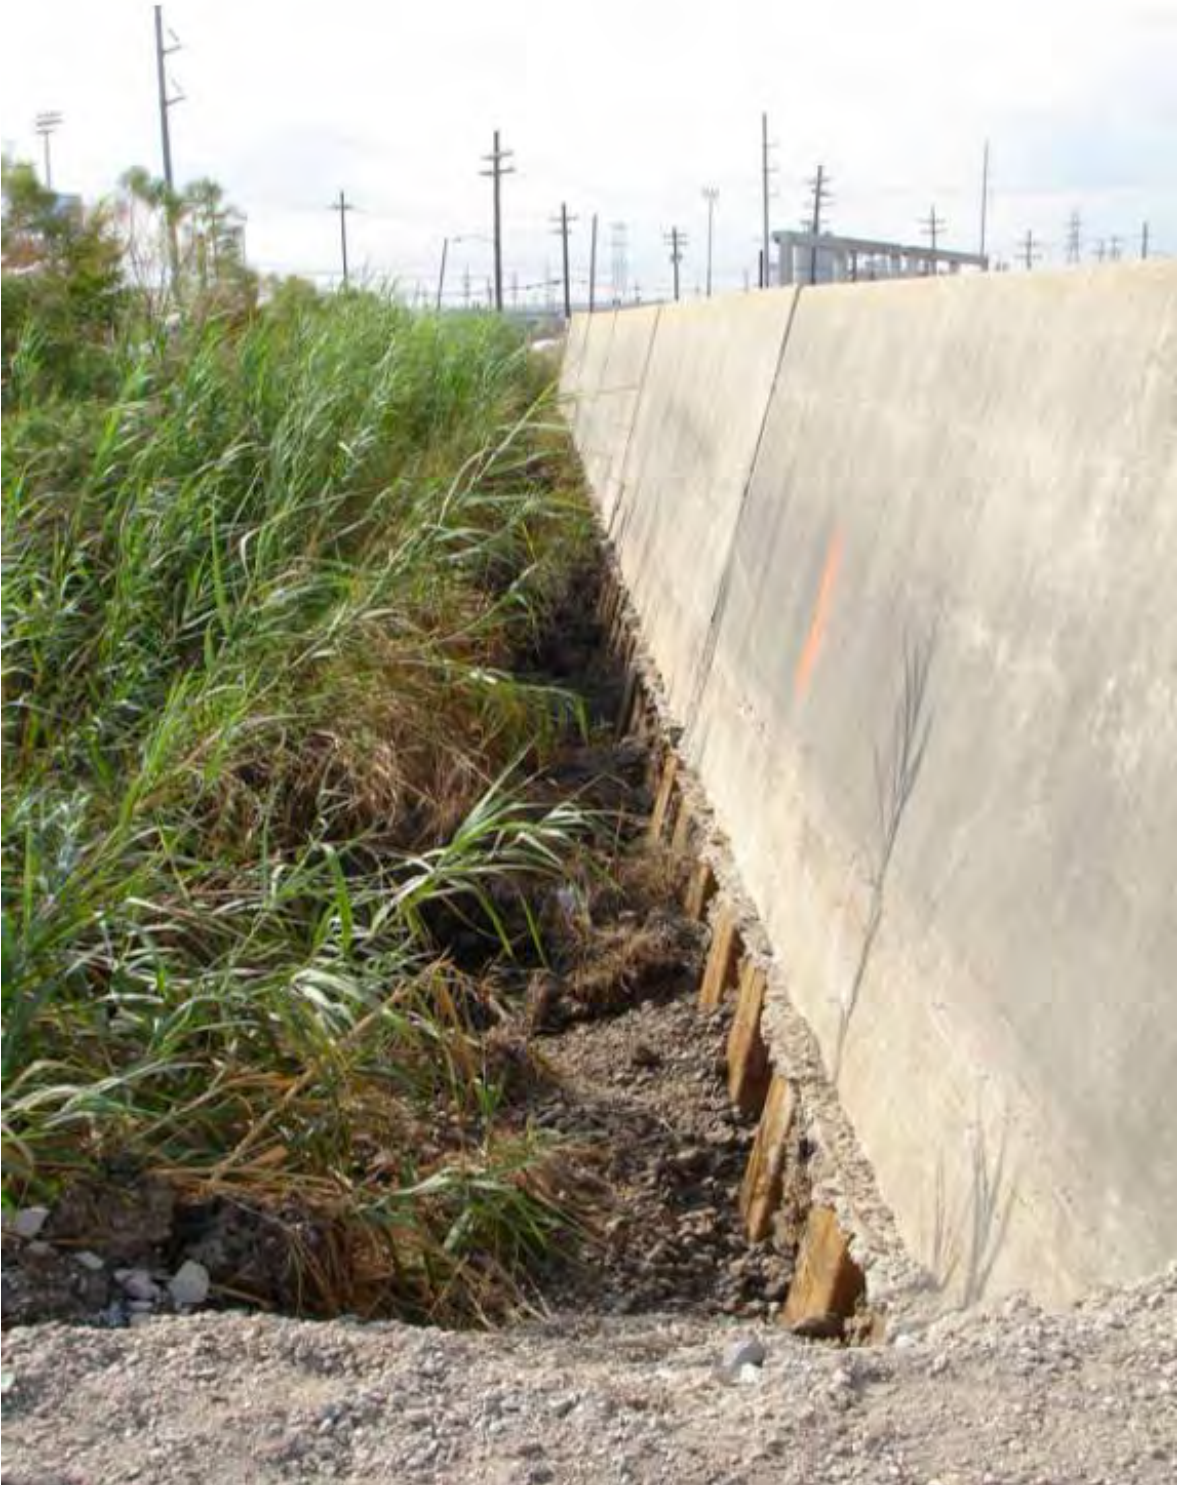
Figure 3.12: “Gapping” between soil and wall as distressed wall was displaced landward from the Intracoastal Waterway.

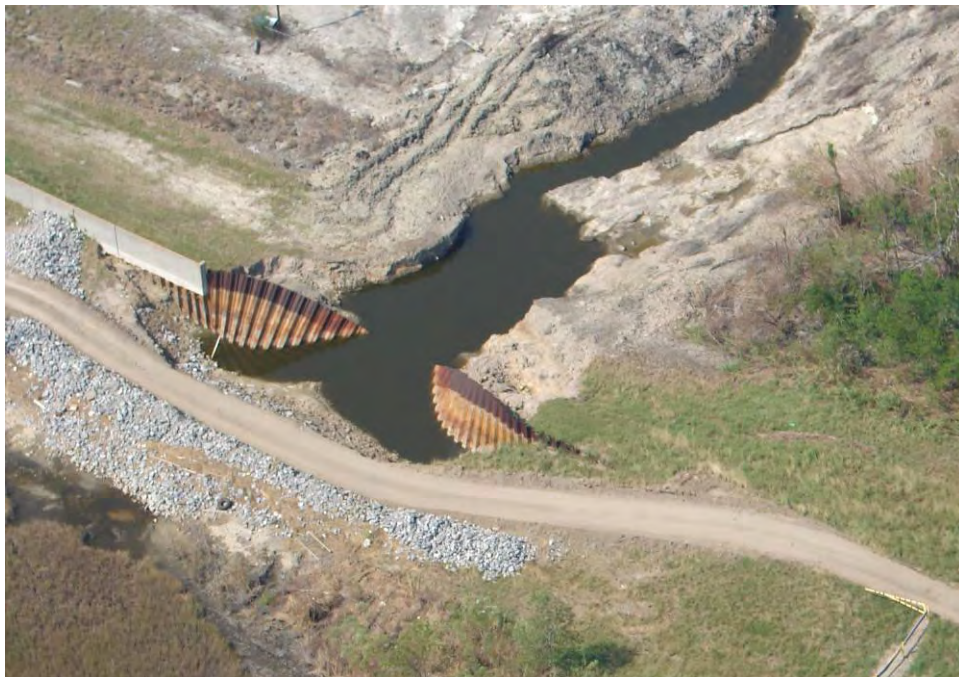
Figure 3.14: Aerial view of the failed wall section shown in Figure 3.13

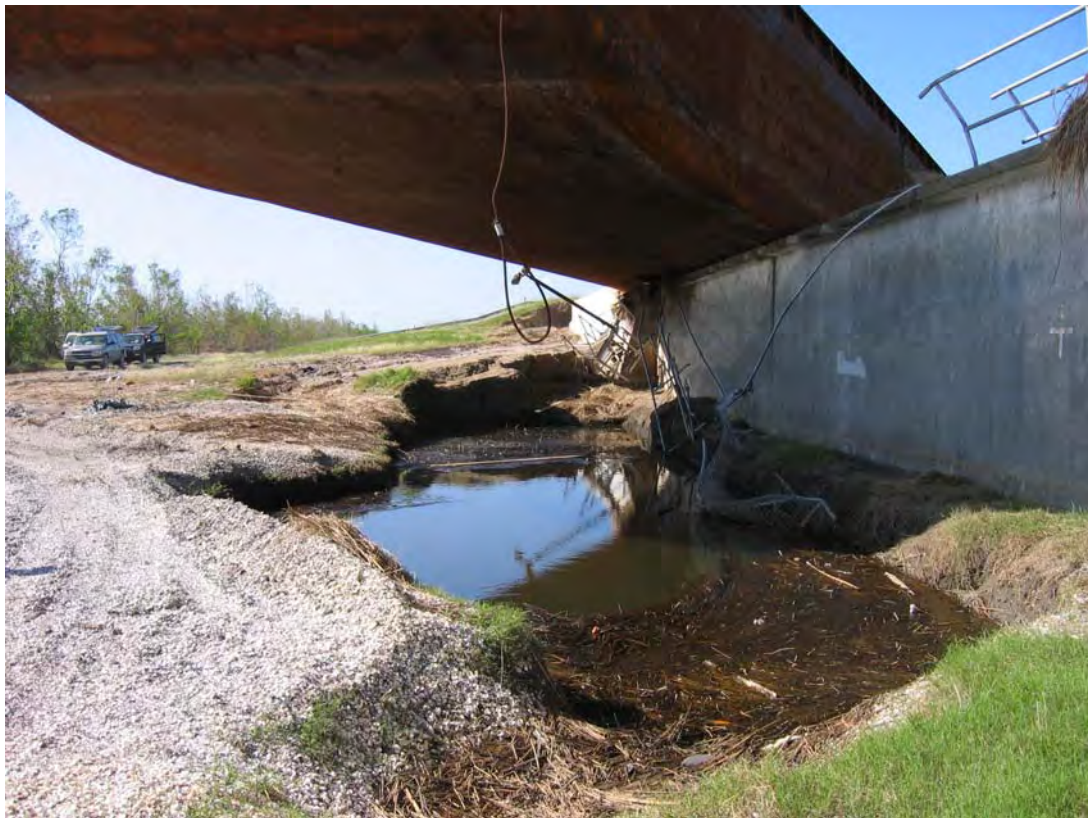
Fig. 4.14: Scour near barge damage at the Bienvenue Gate site (J. Wartman, October 5, 2005).

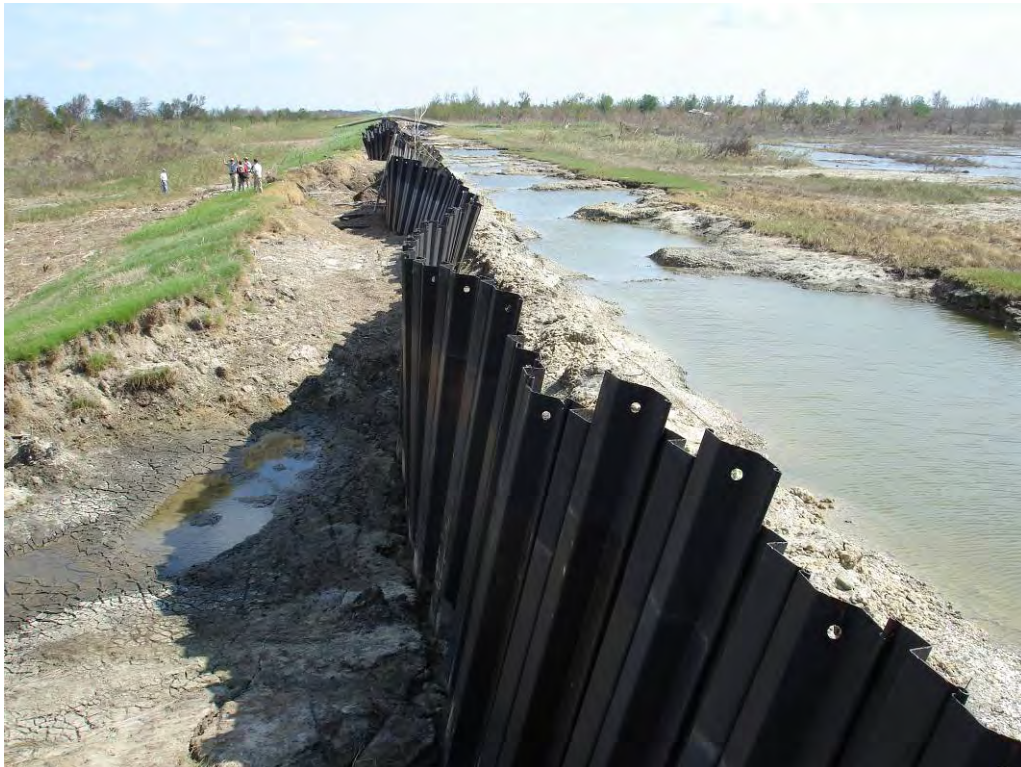
Fig. 20, Failure of earth levee with steel sheetpile barrier on the southeast bank of the MRGO. Note severe erosion and scour (L. Wooten, October 6, 2005).

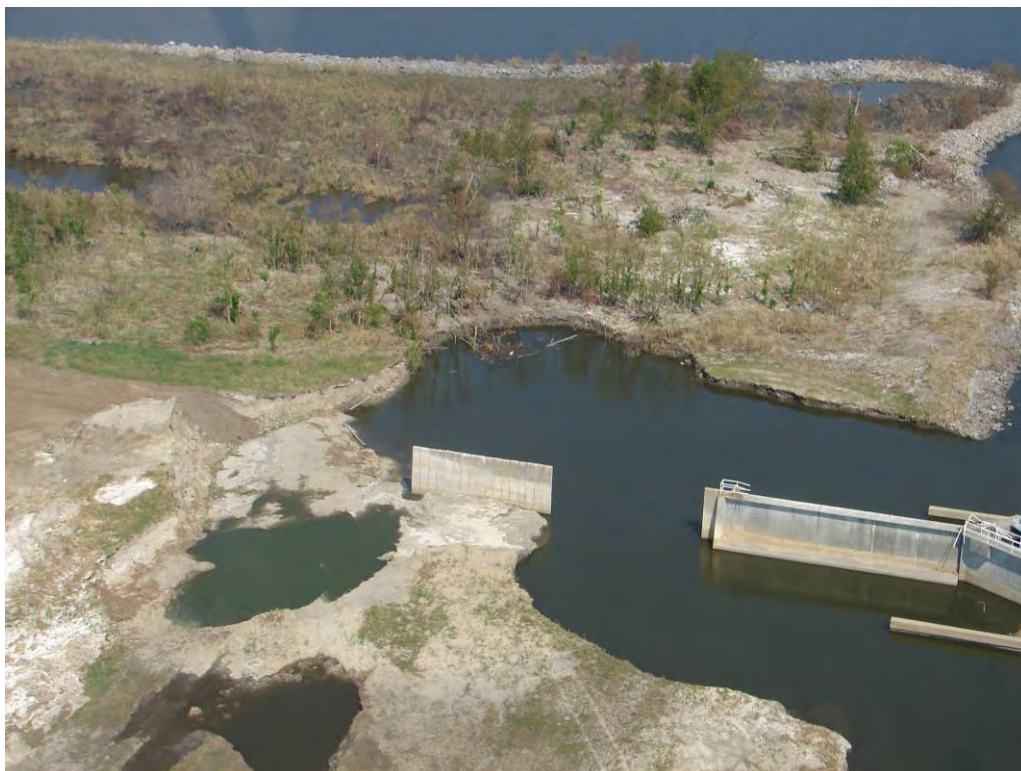
Fig. 22, Levee failure on southwestern bank of MRGO at Bayou Dupree. Note concrete sheetpile and levee transition washouts. (L. Harder, October 14, 2005).

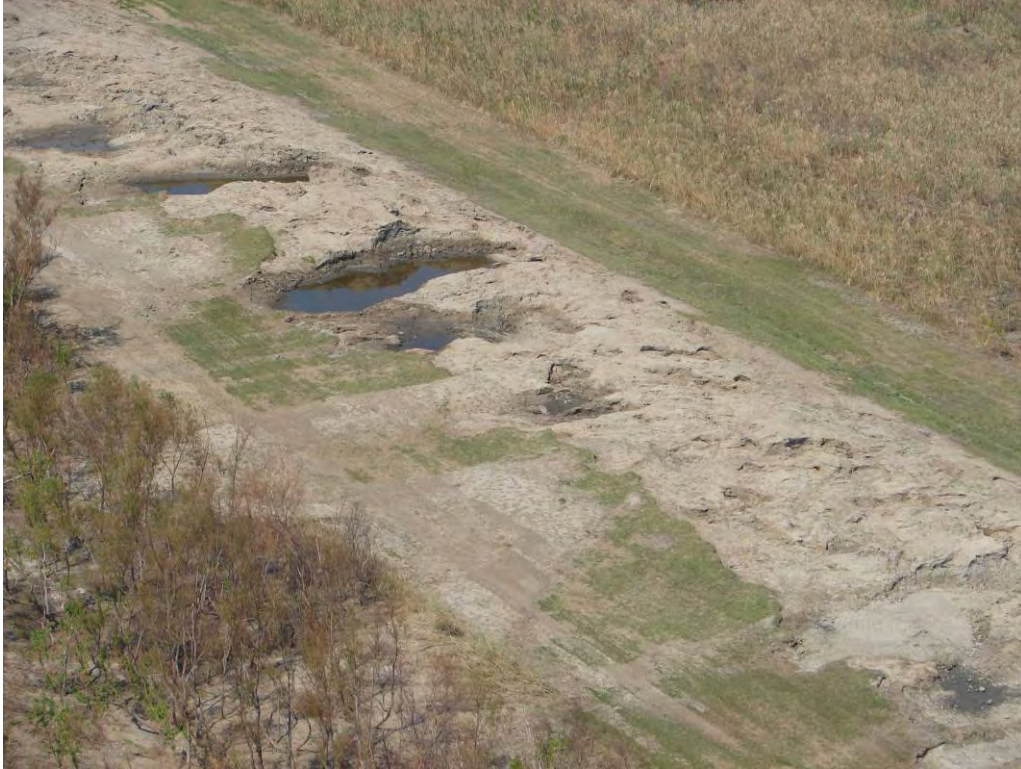
Fig. 25: Overtopping obliterated earth levee along southwestern bank of MRGO, within two miles southeast of Bayou Dupree. Note deep scour at the levee foundation level. (L. Harder, October 14, 2005).
