Preliminary Report on the Performance of the New Orleans Levee Systems in Hurricane Katrina on August 29, 2005

Report No. UCB/CITRIS – 05/01
November 2, 2005

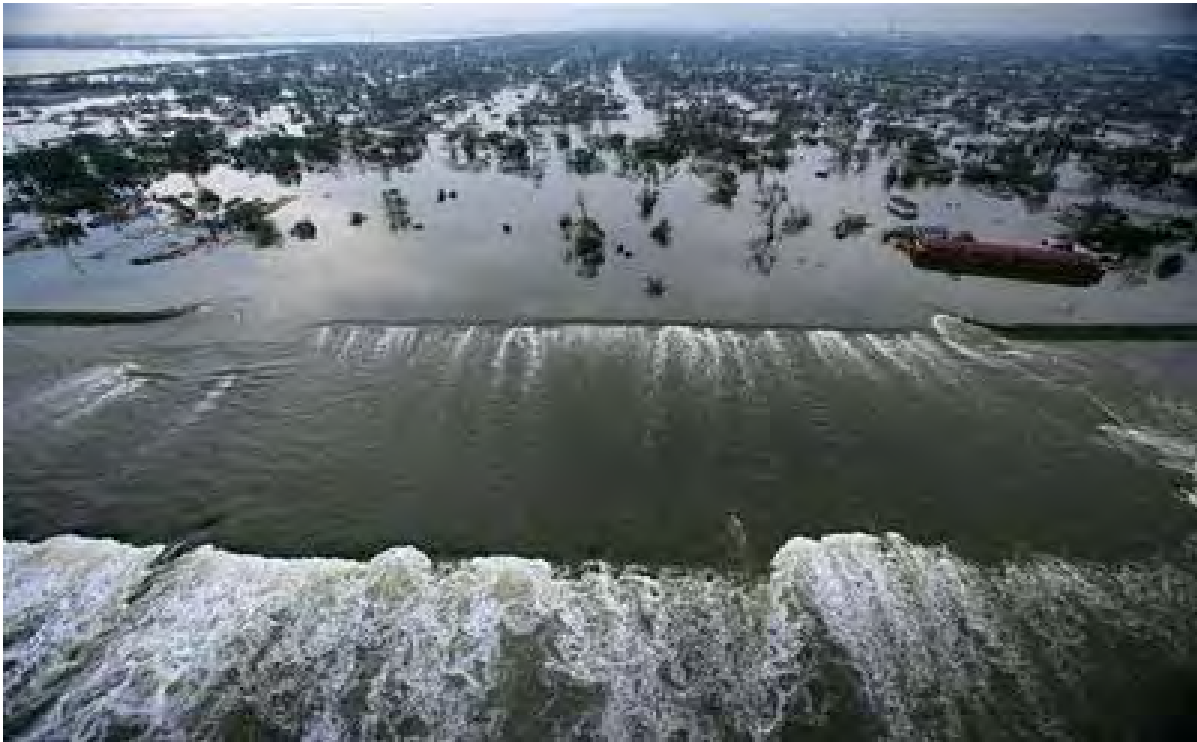
The consequences of the flooding of major portions of all four levee-protected polders were catastrophic. Figure 1.7 shows inundation of the Ninth Ward adjacent to one of the major breaches in the levee along the IHNC. Numerous areas of greater New Orleans were similarly flooded, as shown in Figures 1.4 and 1.5. Large developed areas within all of the main polders were flooded, and they remained inundated for considerable periods of time before levee breaches could be repaired and the waters pumped out.

Figure 1.7: Flooding at the west end of the Ninth Ward, and outflow through levee breach as initial storm surge subsides.

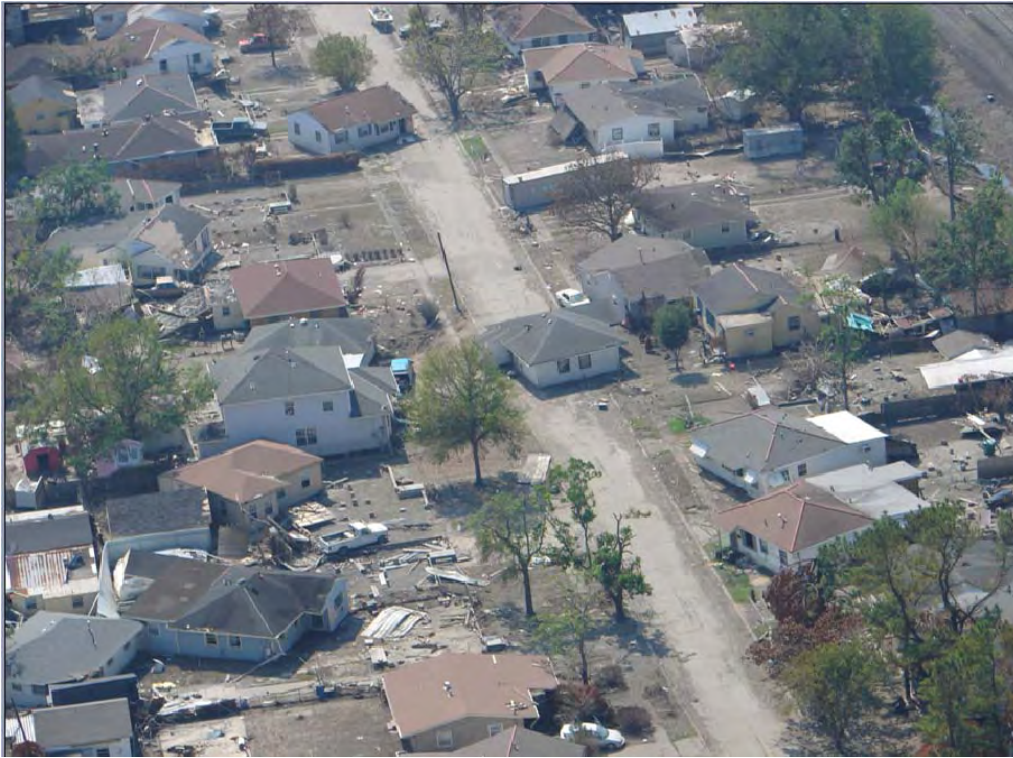
Figure 1.10 shows another aspect of the flooding. This photograph shows a region within St. Bernard Parish in which numerous homes were floated and transported from their original locations by the floodwaters, and then deposited in new locations. Figure 1.11 shows a number of homes in the Plaquemines Parish polder that were carried across the narrow polder (from left to right in this photograph) as the west side (left side of photo) “hurricane levee” or back levee was breached, and were then nearly floated over the crest of the Mississippi River levee. The water side slope face of the Mississippi River levee is clearly shown in this photograph, as evinced by the concrete slope face protection on the outboard side of the riverfront levee in the right foreground of the figure.

Figure 1.10: Flooded neighborhood in St. Bernard Parish, showing homes floated off their foundations and transported by floodwaters.

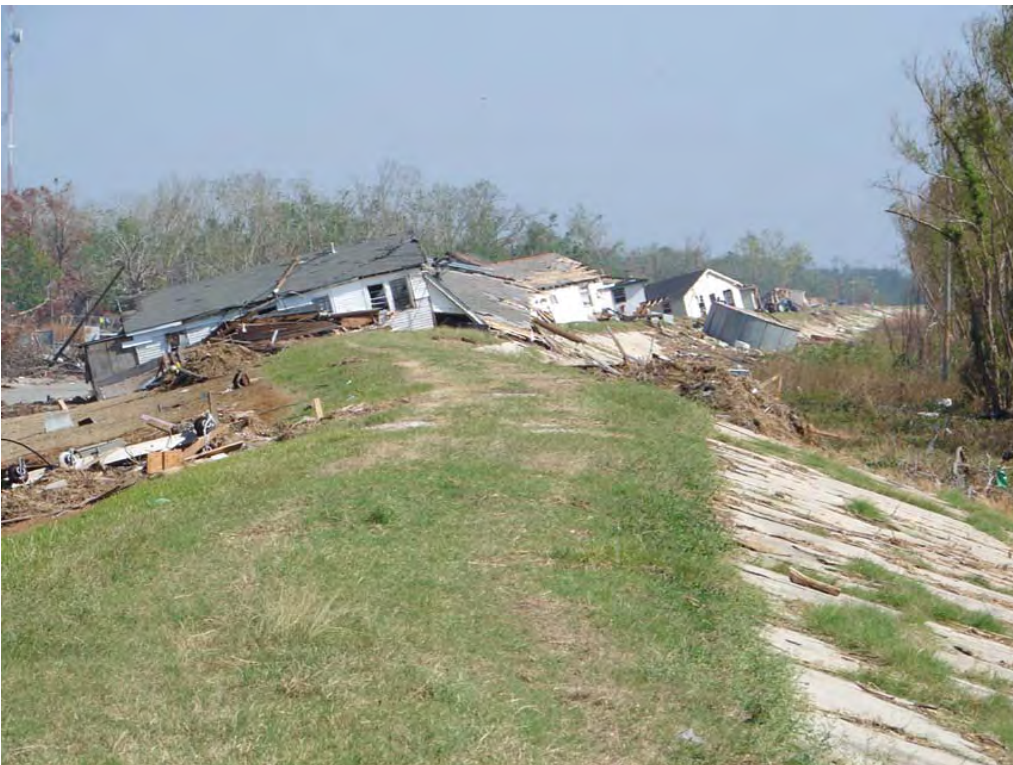
Figure 1.11: Homes in Plaquemines Parish carried from left to right in photo and strewn across the crown of the Mississippi Riverfront levee.

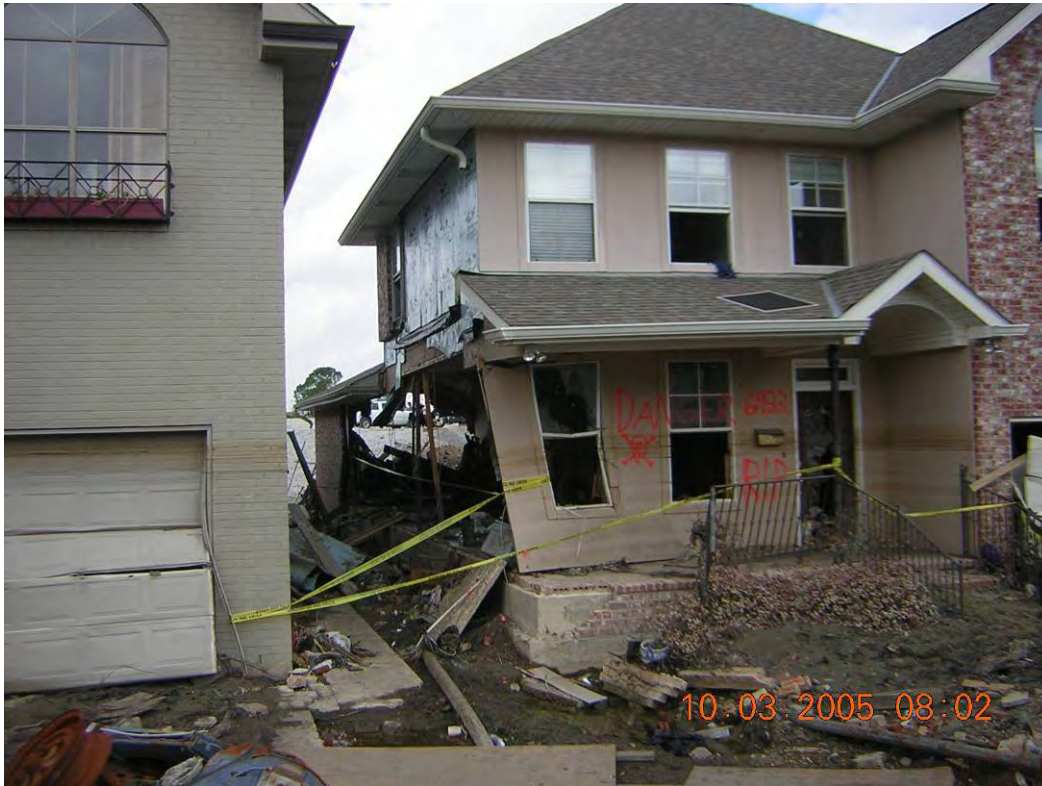
Figure 1.12: Damage to a residential neighborhood in the 17th Street Canal area due to flooding.

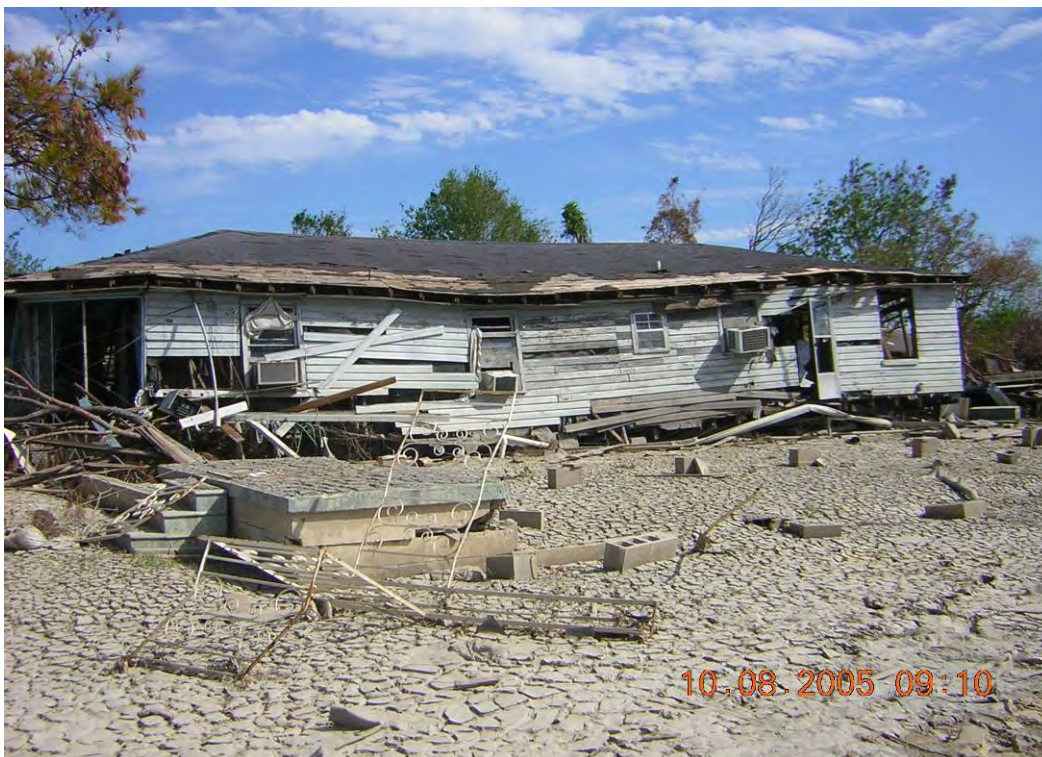
Figure 1.13: Another view of flooding damage, this time in the lower Ninth Ward.

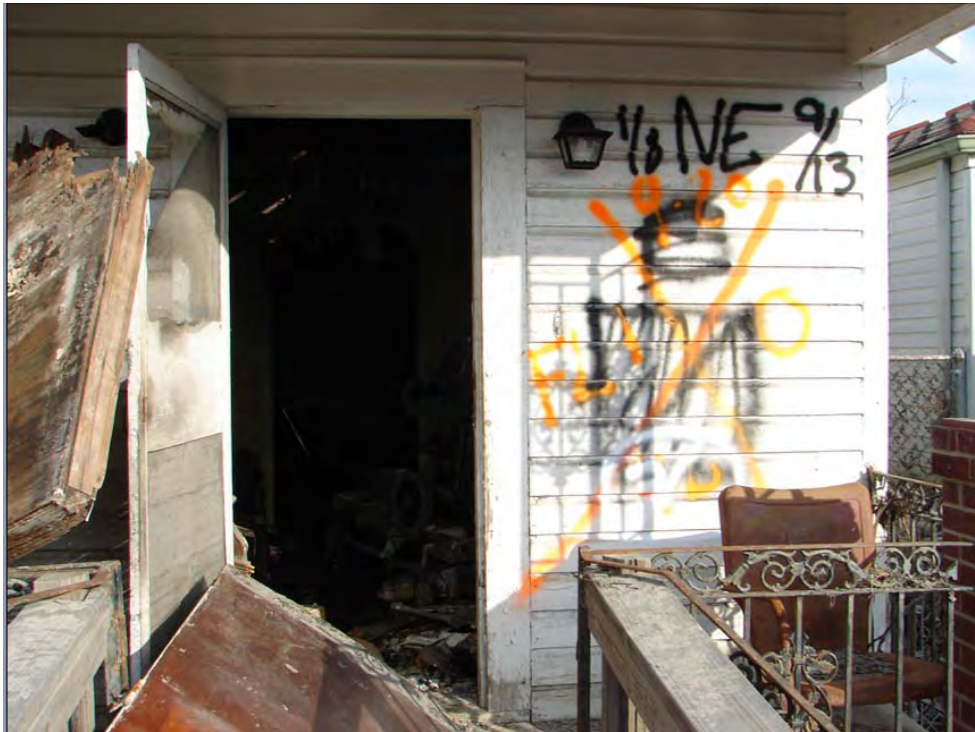
Figure 1.14: Search and rescue team markings on a building in the Ninth Ward where three inhabitants died.

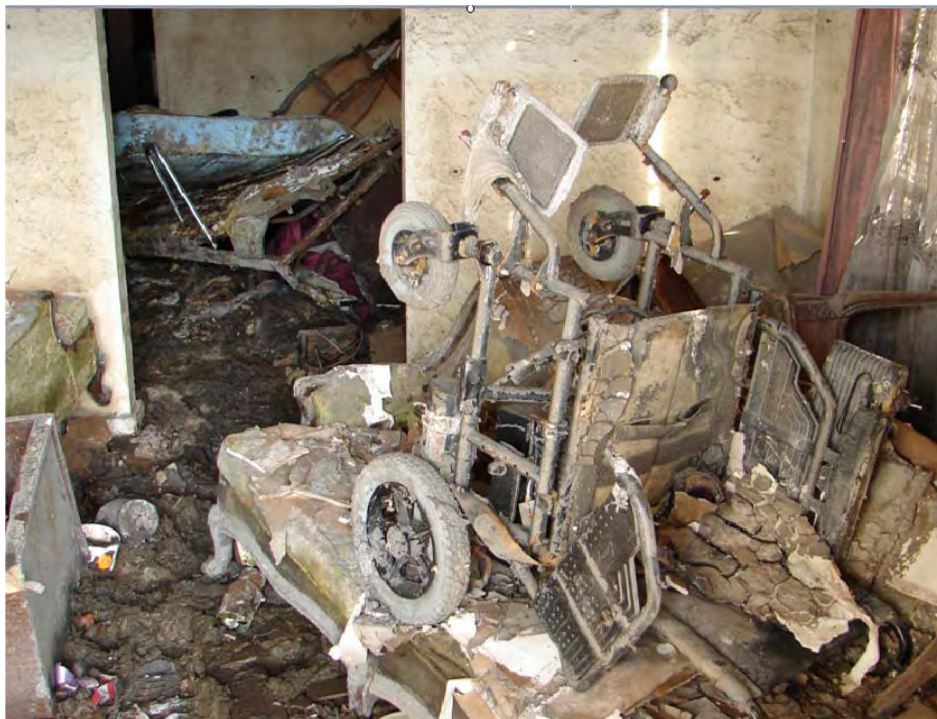
Figure 1.15: View inside structure shown previously in Figure 1.14.

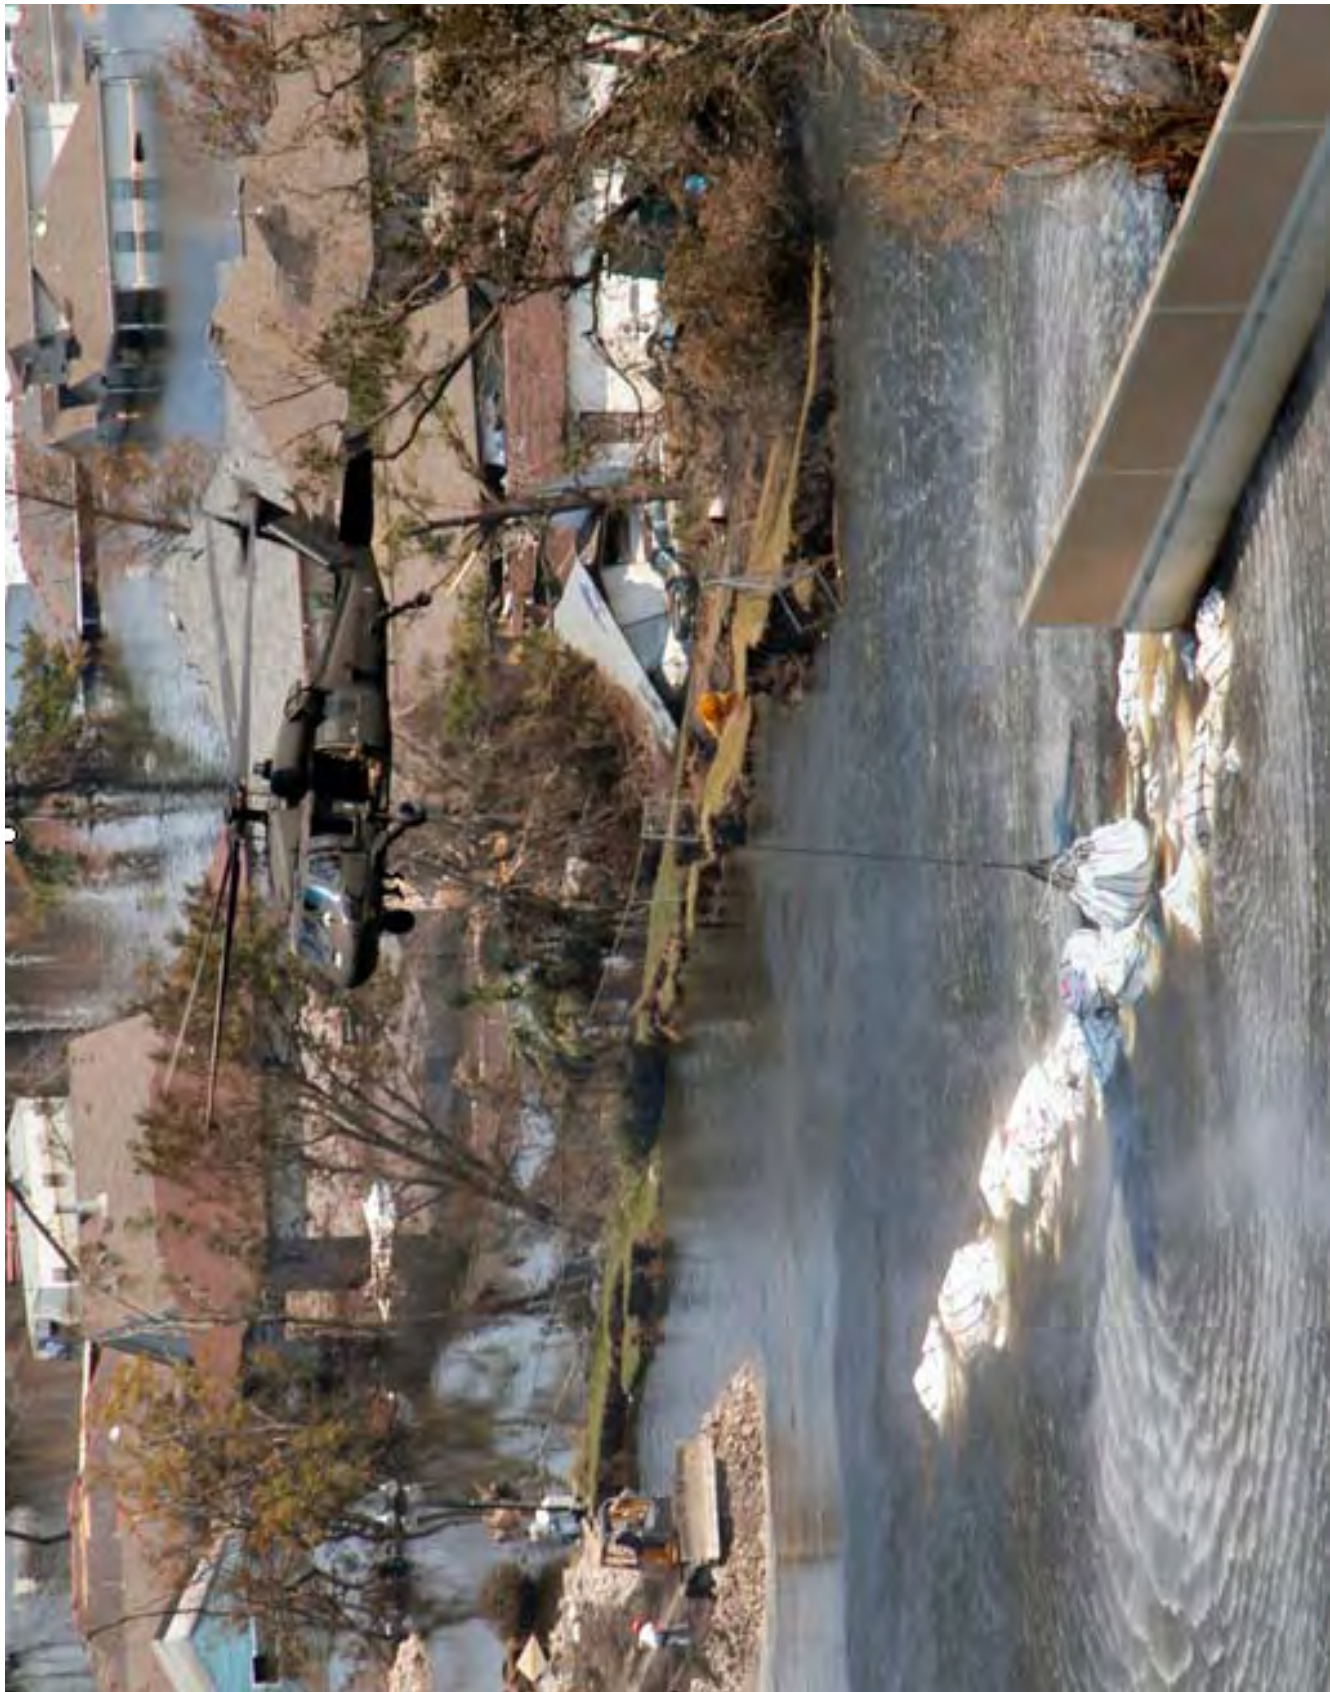
Figure 2.3(a): The 17th Street Canal breach during initial breach closure.

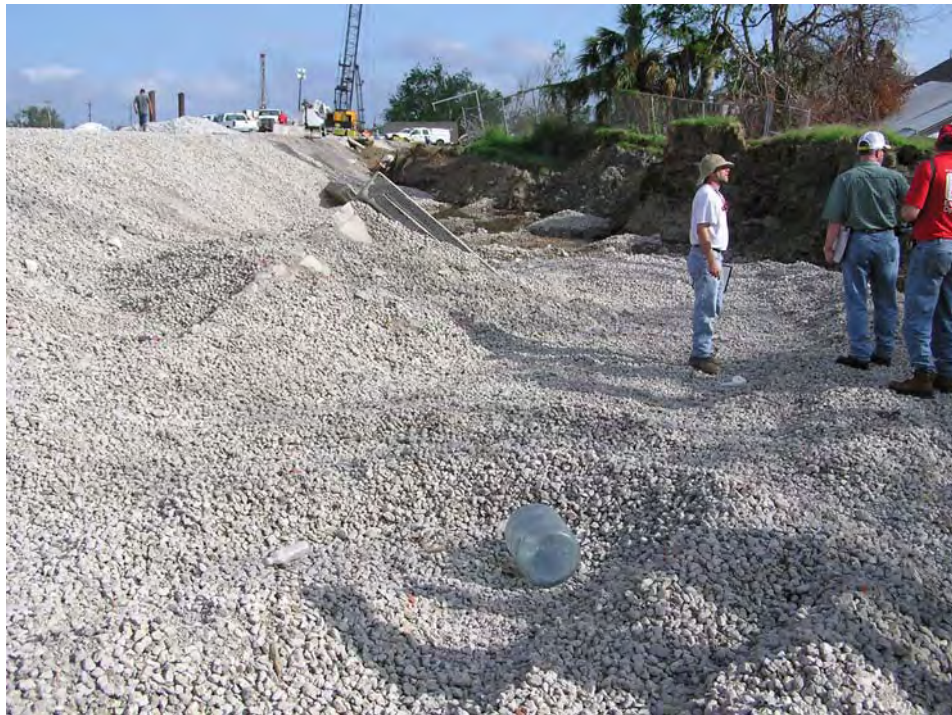
Figure 2.4: View of the 17th Street breach section from the south.

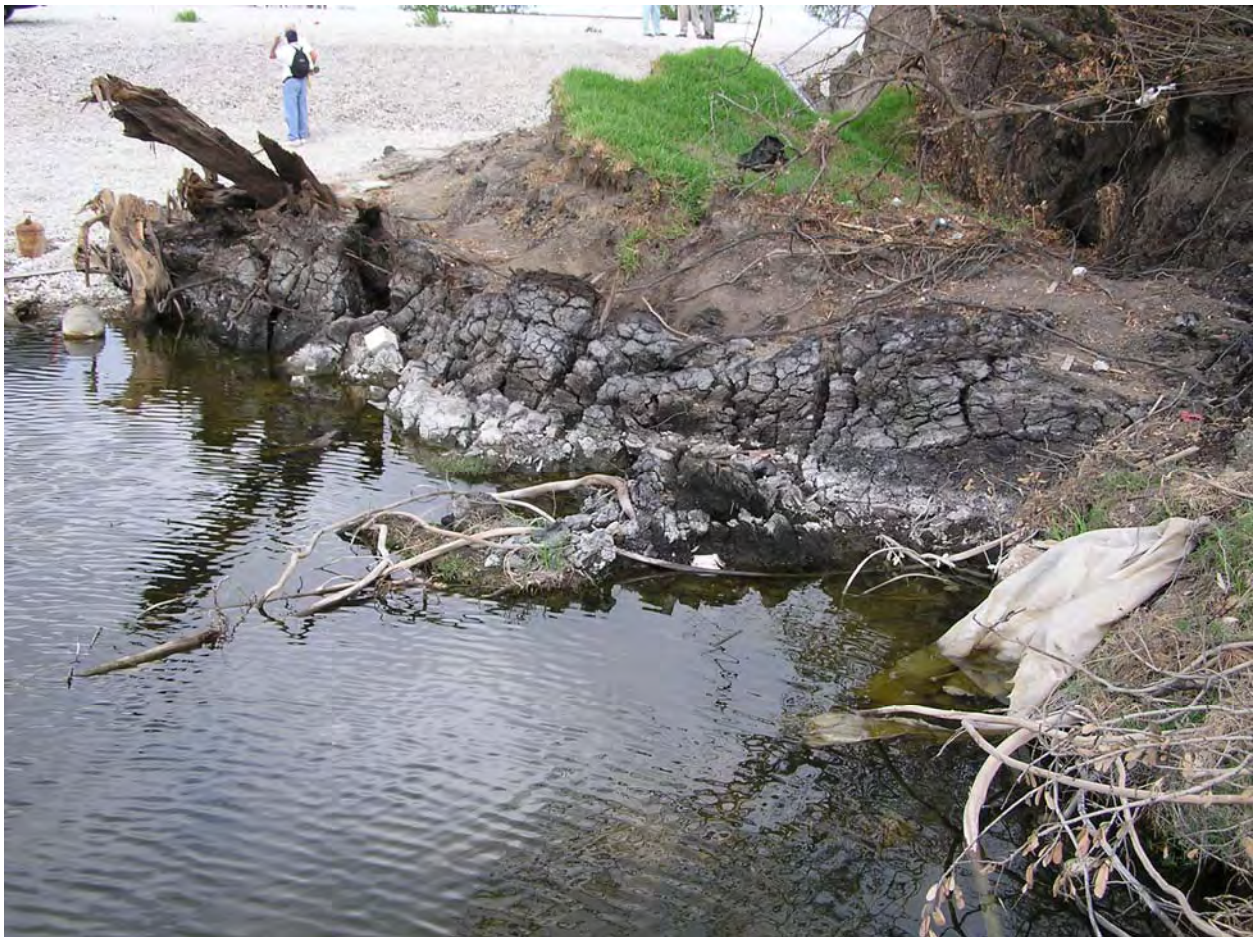
Figure 2.8: Location at which clay seam interbedded within the peat at the toe of the translated levee embankment was sampled.

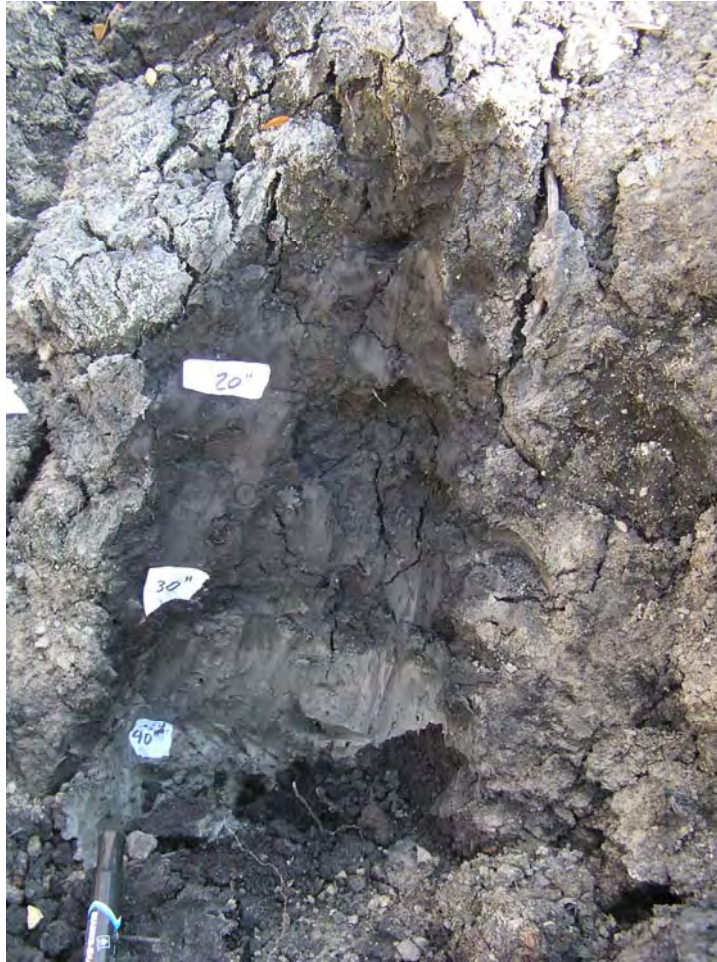
Figure 2.9: Clay seam (light gray layer) underlain by darker lean clay, and overlain by fibrous peat.

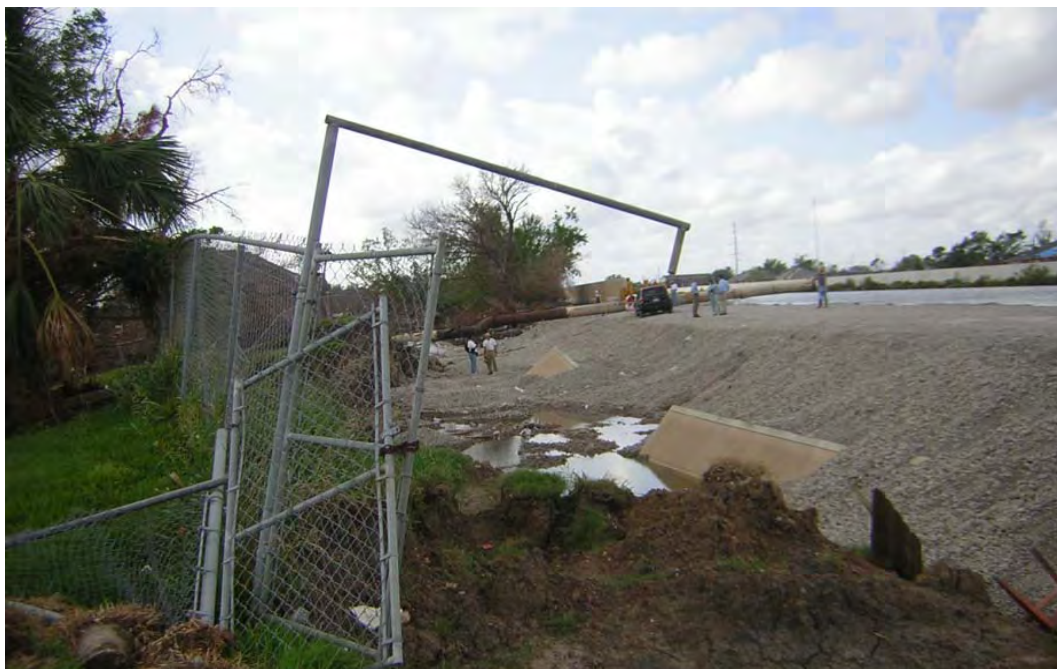
Figure 2.12: Temporary closure section embankment on October 3rd, 2005.

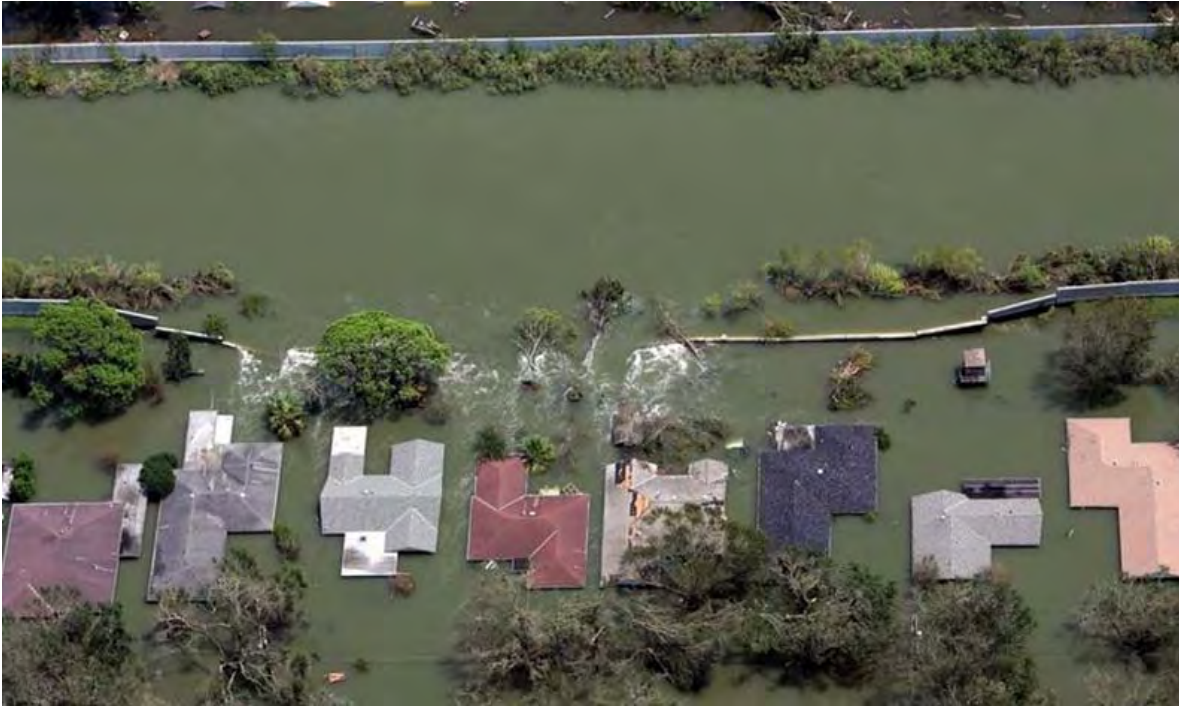
Figure 2.15: The breach section at the west side of the London Avenue Canal (North).

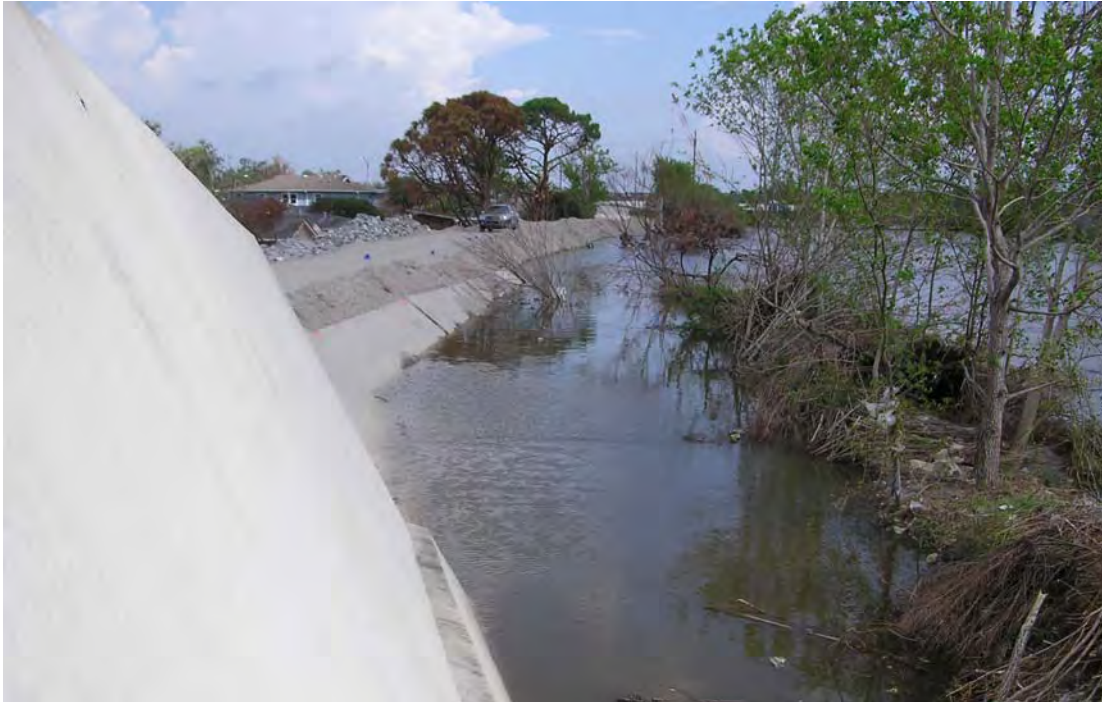
Figure 2.17: The toppled floodwall/sheetpile walls at the London Avenue Canal (North) breach site.

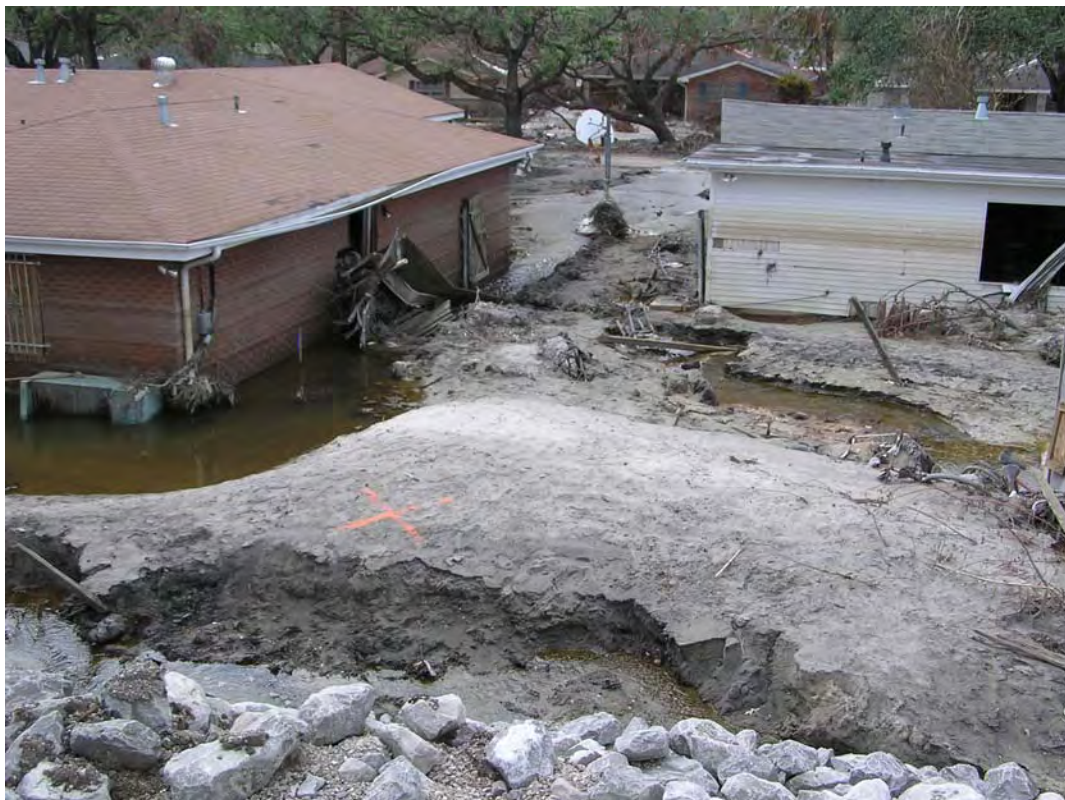
Figure 2.18: Sediment from the London Avenue Canal was deposited inboard of the levee break. High water marks (from long-term ponding) are visible on the exteriors of the residential homes.

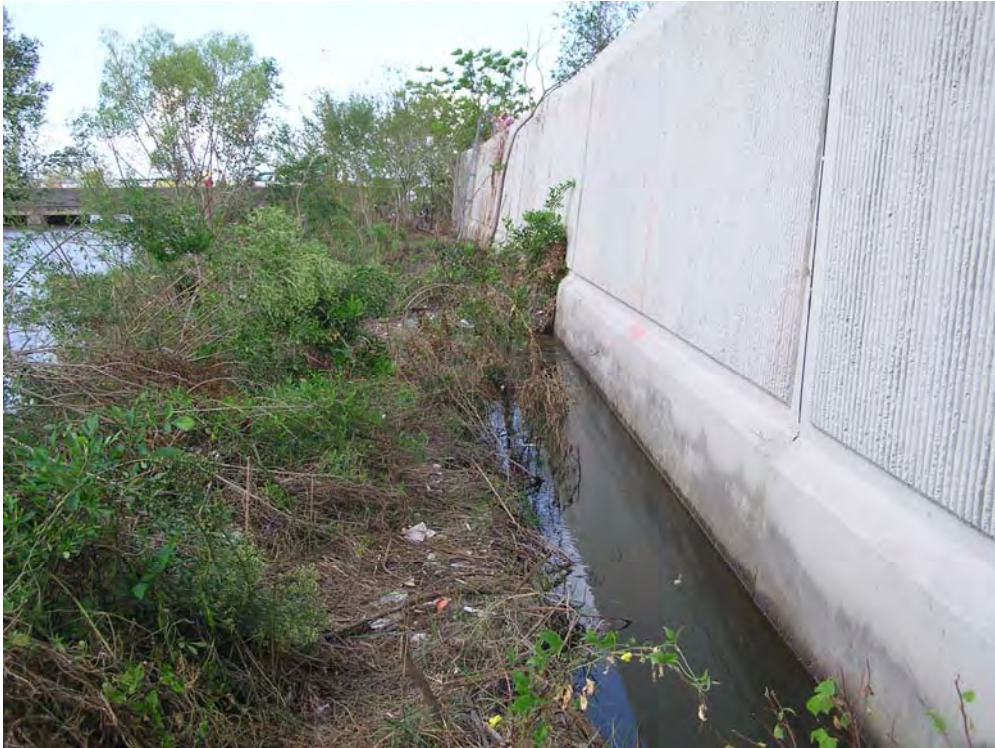
Figure 2.19: Gap at the base of the floodwall on the East Bank “distressed” section.

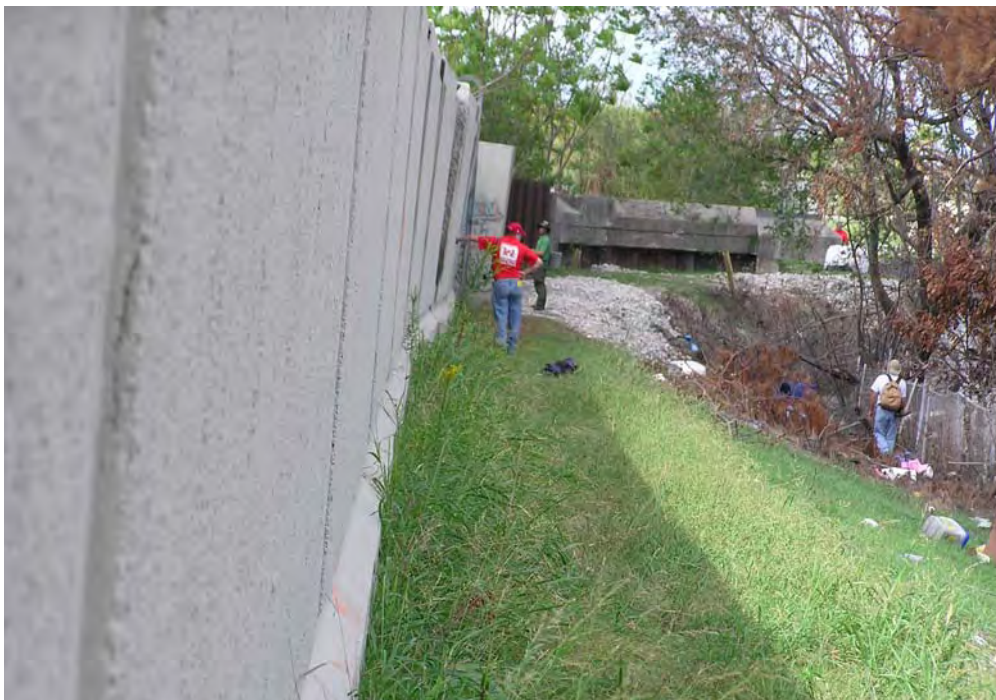
Figure 2.20: View of the inboard side of the floodwall and earthen levee embankment.

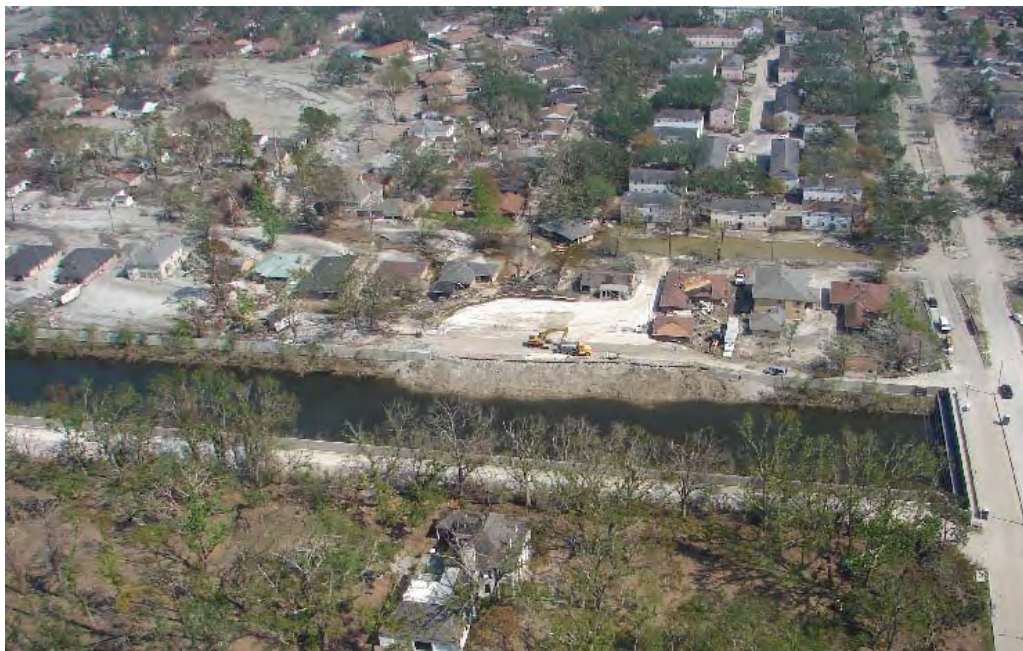
Figure 2.24: Aerial view of the breach section at London Avenue Canal (South).

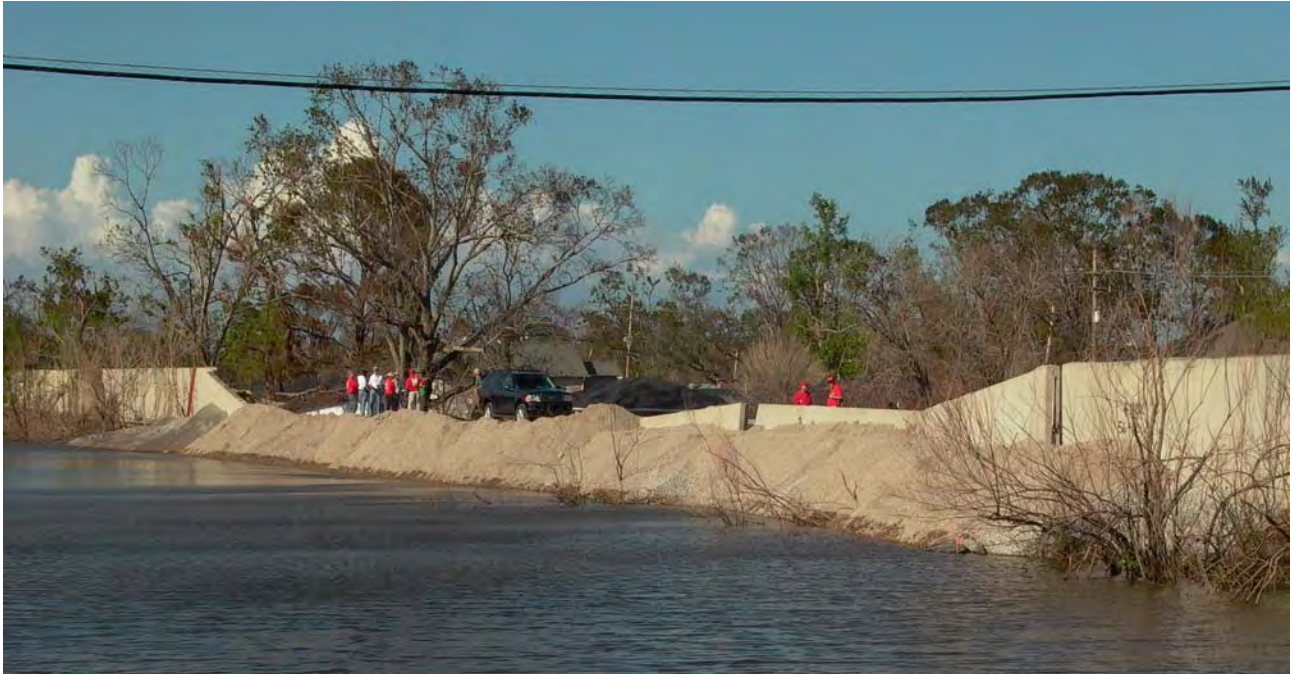
Figure 2.25: View of the crest of the temporary embankment closure section at the London Avenue Canal (South) breach.

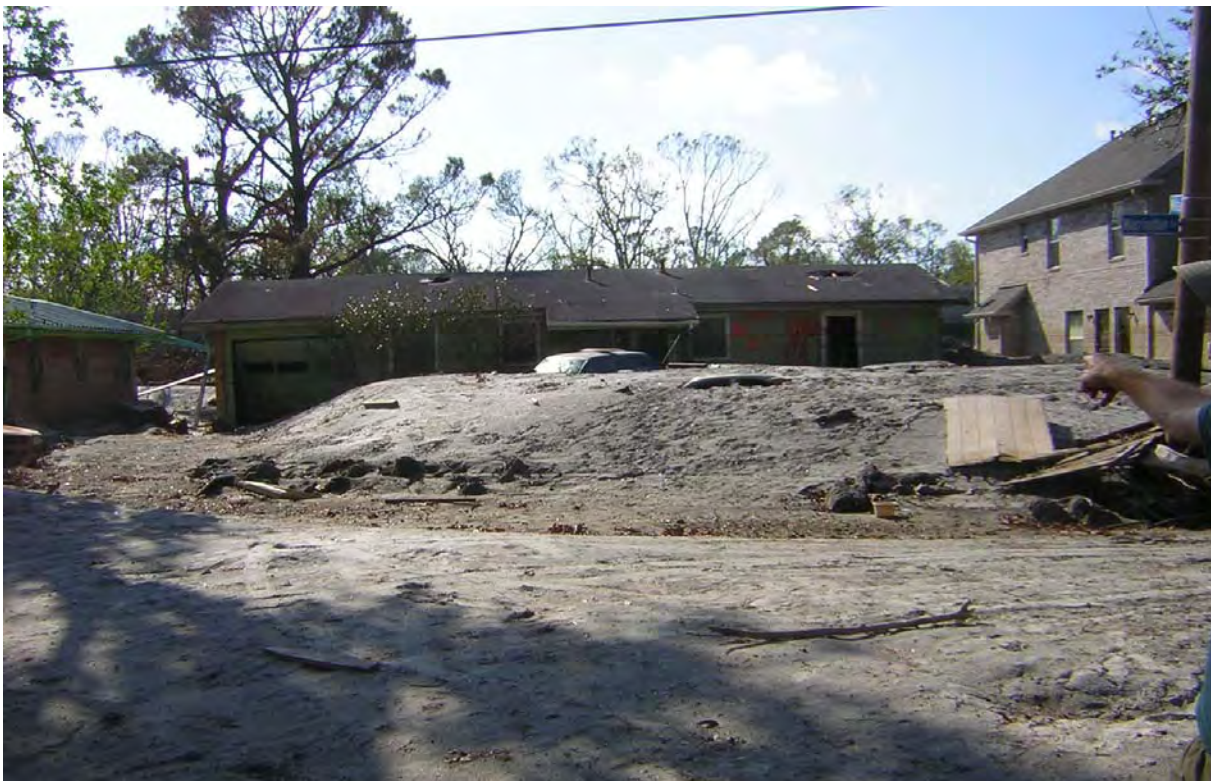
Figure 2.26: Significant quantities of sediment were deposited in the residential neighborhoods on the east side of the London Avenue Canal. More than five feet of sediment was deposited around this home.

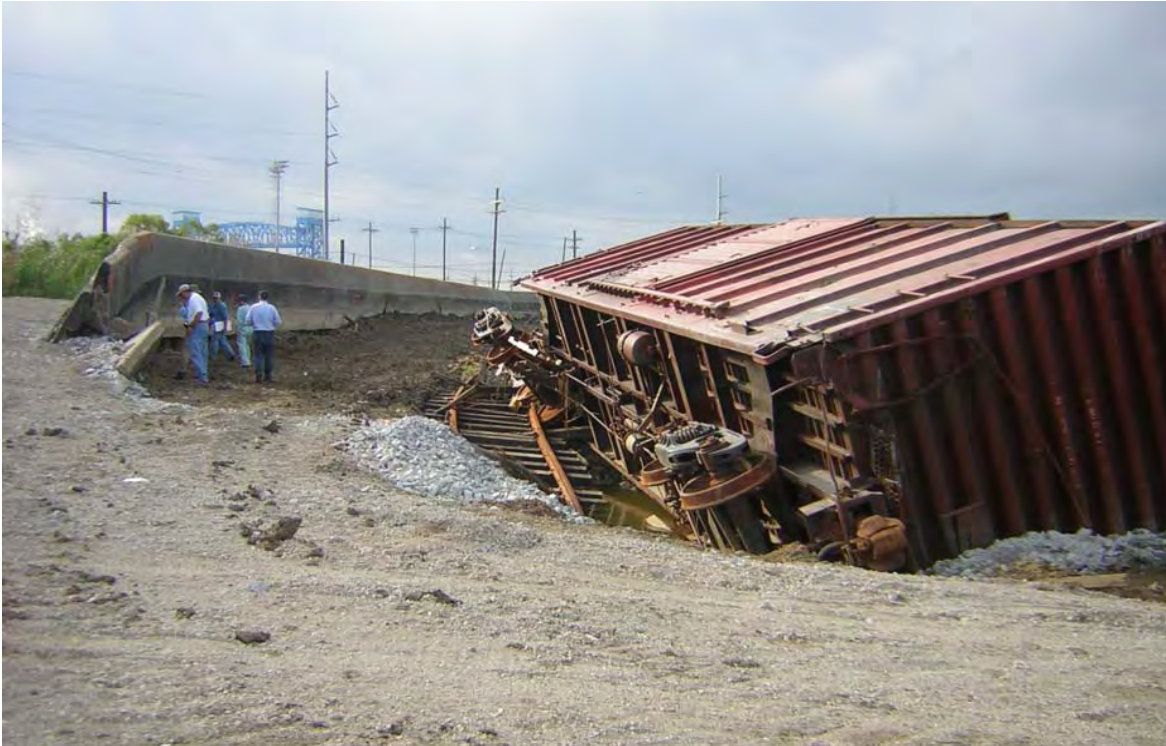
overtopping, and resultant erosion. Some were simply erosional failures of earthen embankments, or of preferential erosion at “transitions” between earthen embankment sections and adjacent structural wall sections. The significant breach at Location “A” appears to have been due to overtopping of the concrete floodwall (the sheetpile/I-wall section), and resultant erosion of soils at the inboard toe of the floodwall which reduced the ability of the sheetpile/floodwall to withstand the lateral water pressures exerted by the elevated water levels on the outboard side.

Figure 2.27: Breached levee floodwall section at Location “A” along the west side of the INHC.

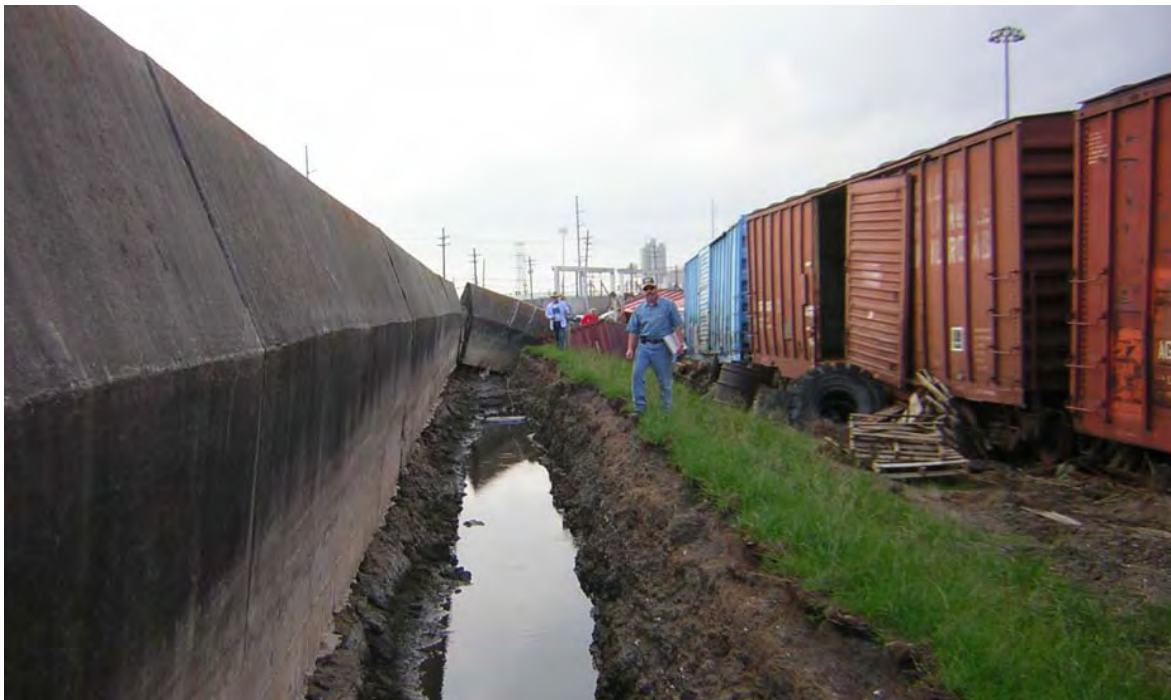
Figure 2.28: Erosion at the inboard toe of concrete floodwalls at Location “A” along the west side of the INHC, adjacent to the breached section shown previously in Figure 2.27.

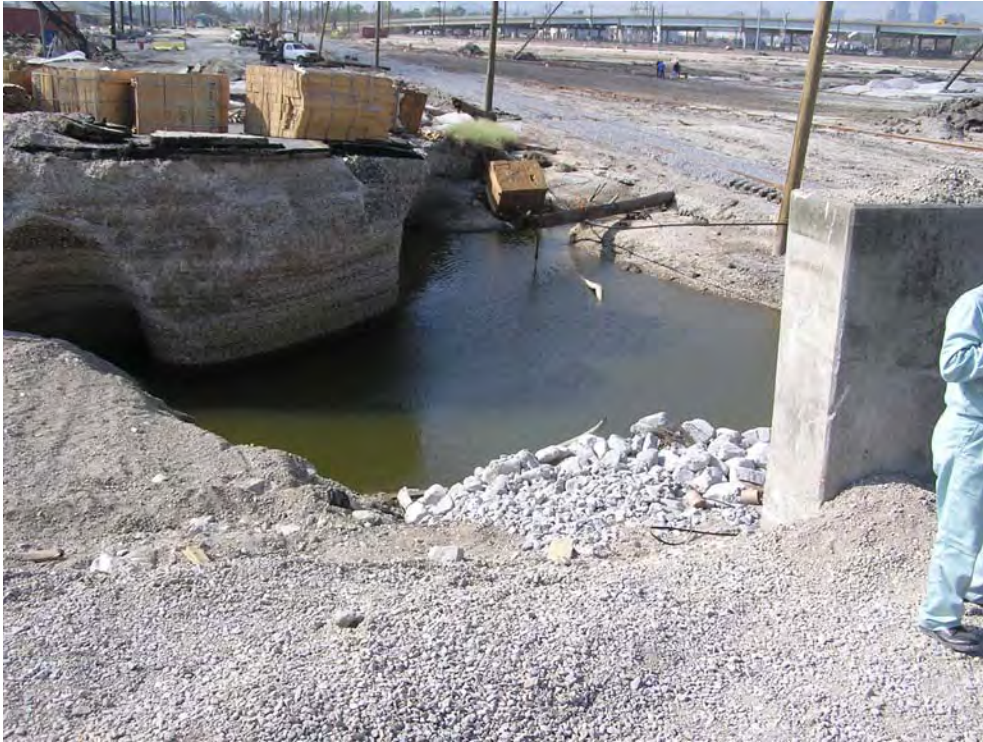
Figure 2.29: Erosion at a “transition” between a concrete floodgate wall and the adjacent earthen embankment section.

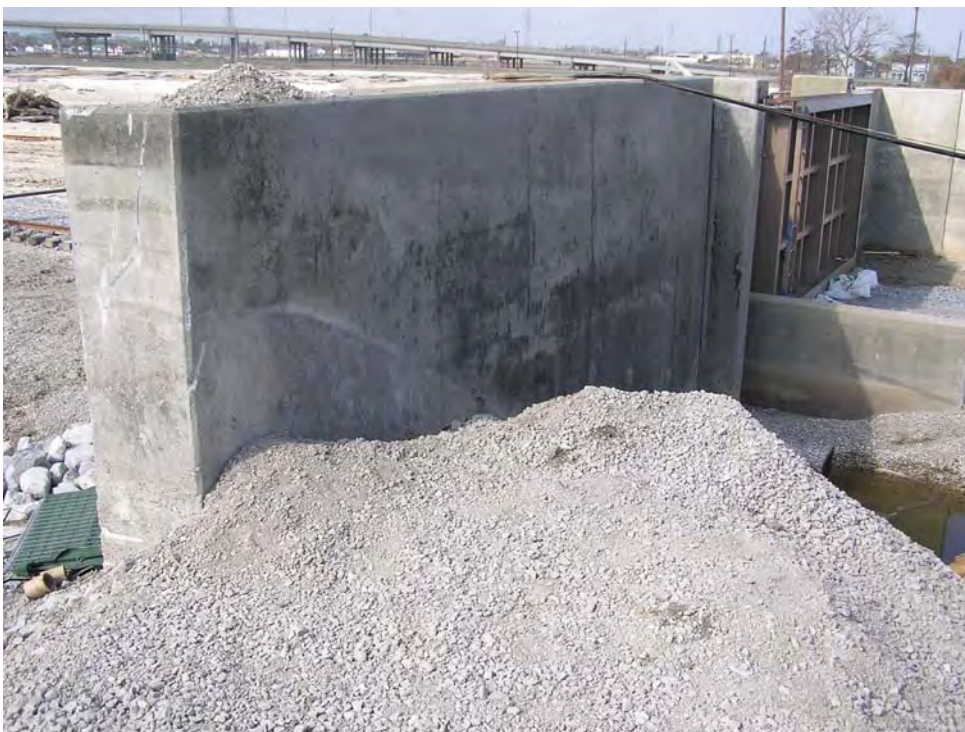
Figure 2.30: View of the structural wall and floodgate structure from Figure 2.29.

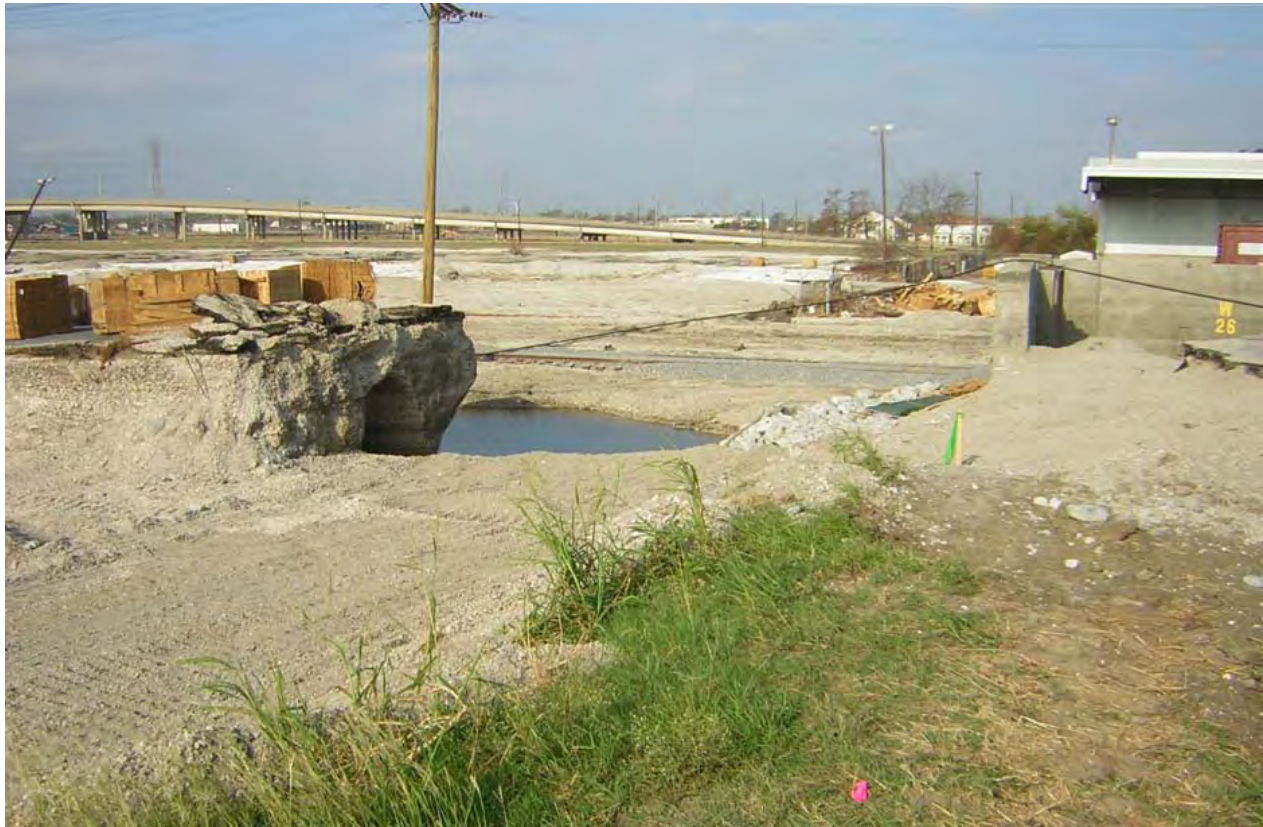
Figure 2.31: Erosion and breach in “shell fill” at a transition section at Location “C”, inboard of the Port of New Orleans.
