Preliminary Report on the Performance of the New Orleans Levee Systems in Hurricane Katrina on August 29, 2005

Report No. UCB/CITRIS – 05/01
November 2, 2005

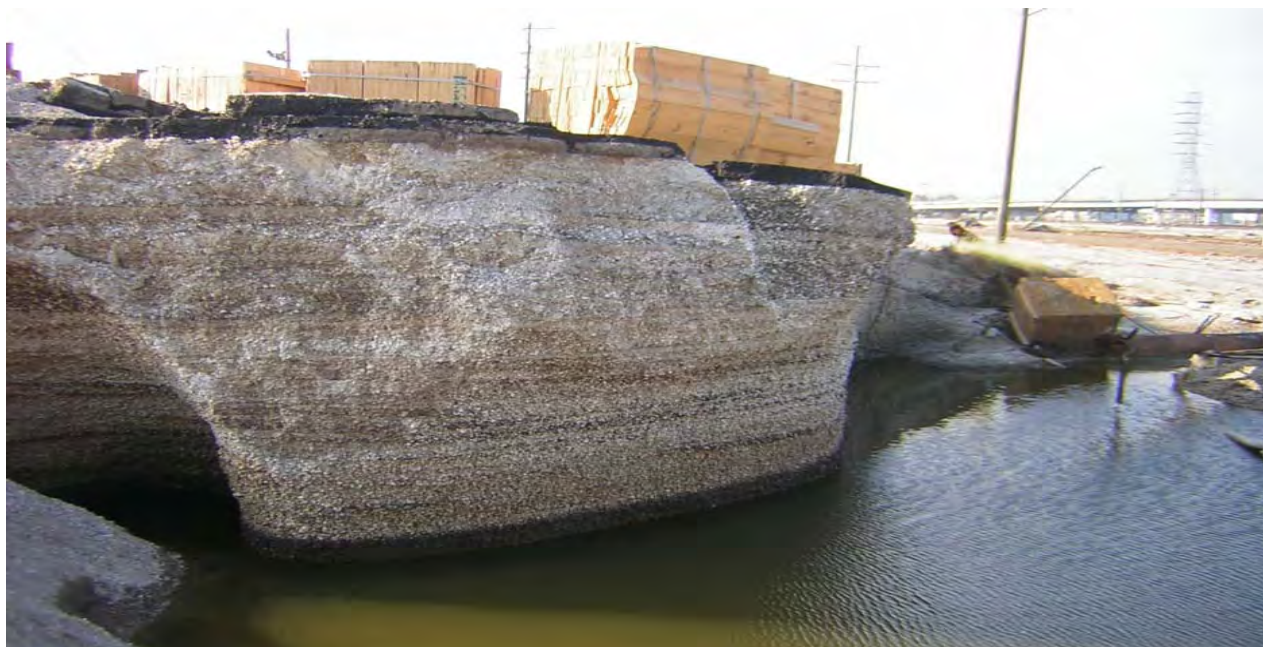
Figure 2.32: Closeup view of sandy “shell” fill at the scoured edge of the breach shown previously in Figure 2.31.

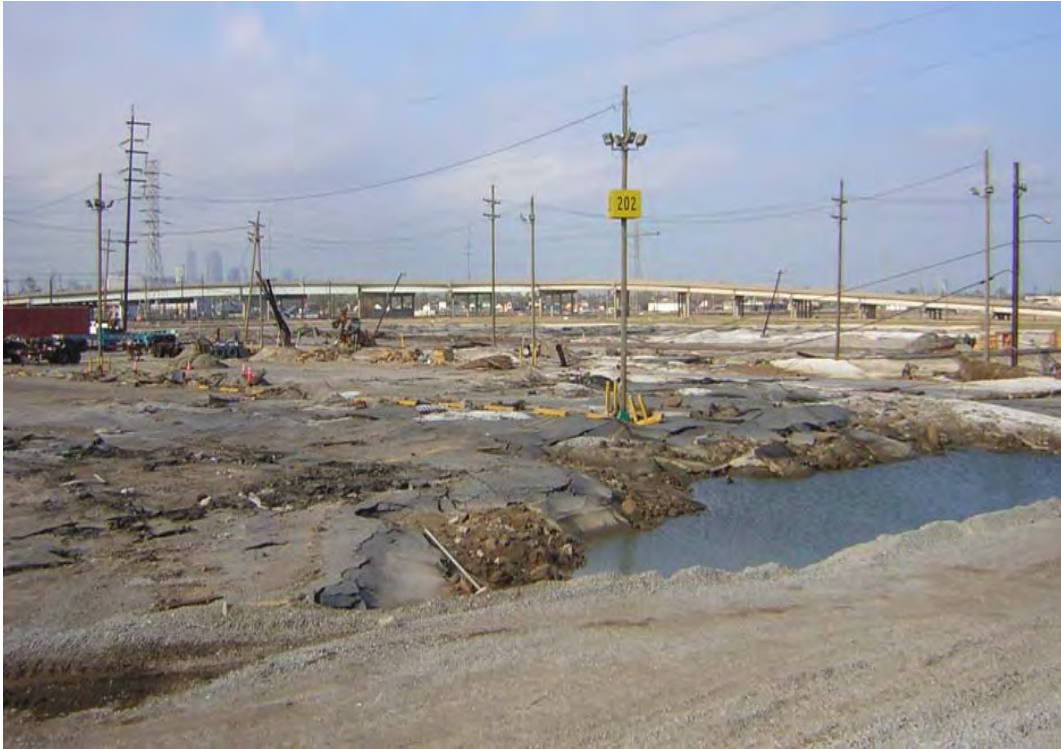
Figure 2.33: Flooding, and deposits of sediment and shells, inboard of the breach shown previously in Figure 2.32.

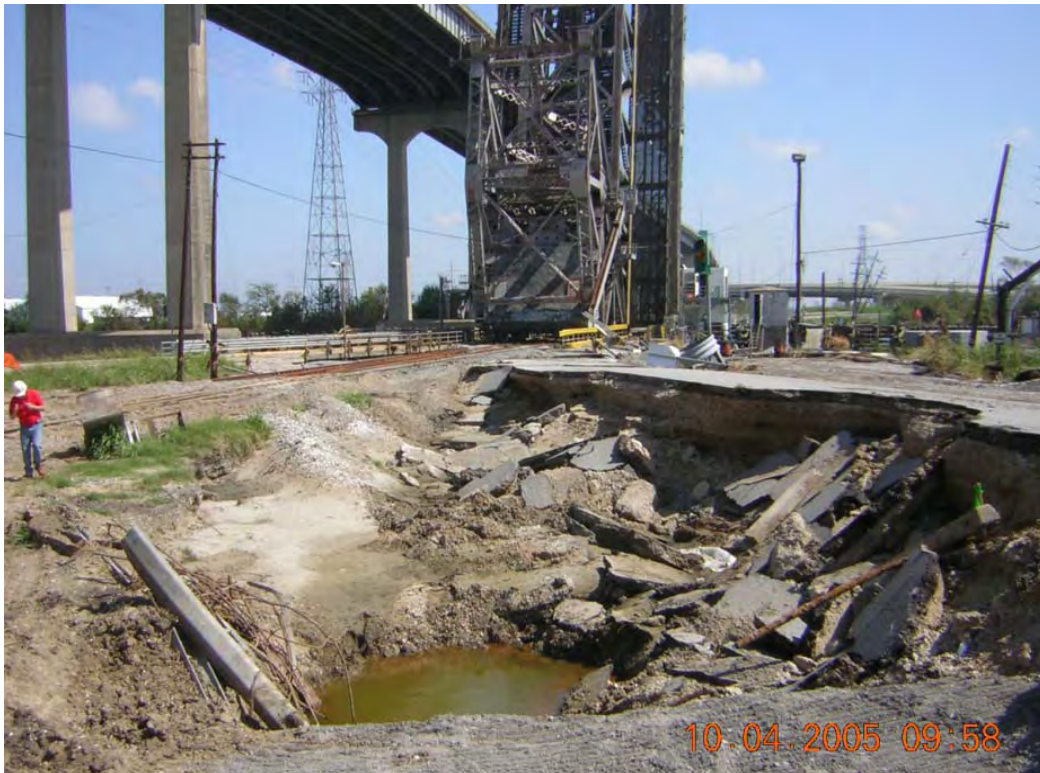
Figure 2.34: A complex “transition” involving several overlapping operations and penetrations through the flood protection levees immediately south of the I-10 bridge across the IHNC.

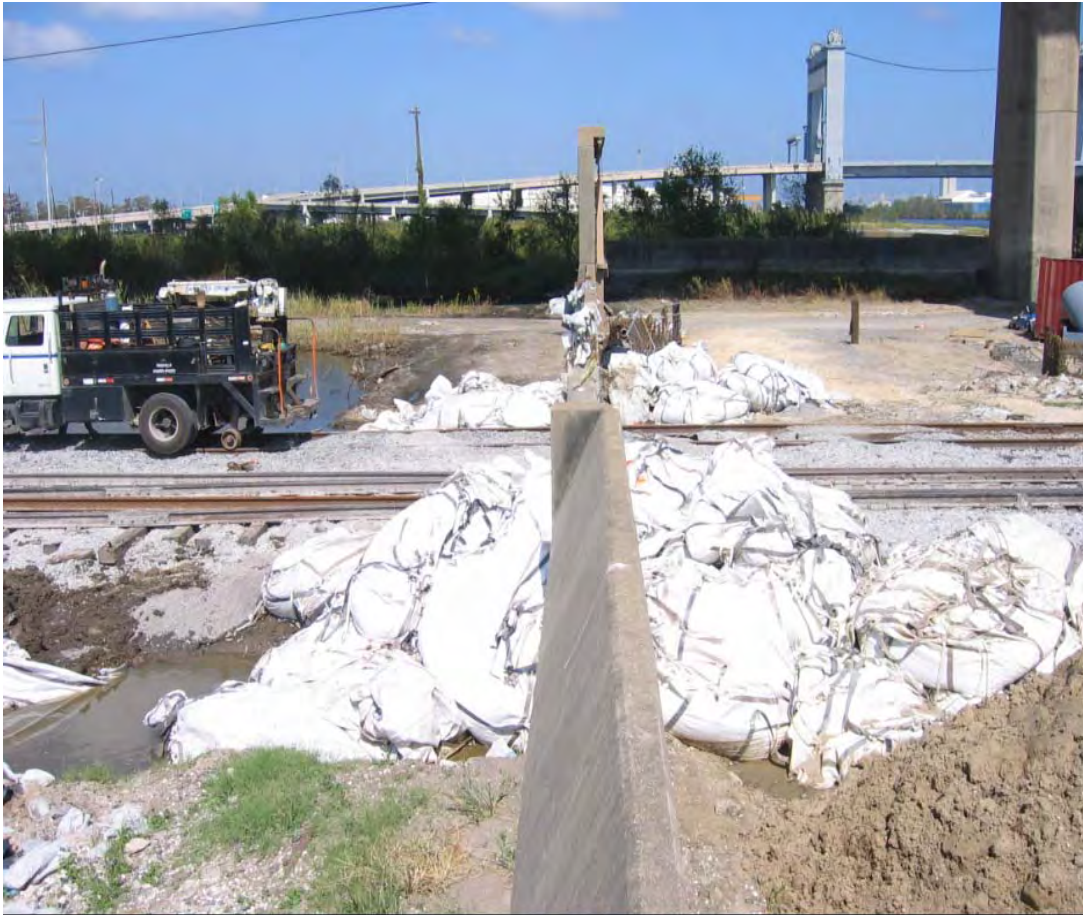
Figure 2.35: Rail line crossing through floodgate structure at the west side of the INHC at the complex transition shown in Figure 2.34.

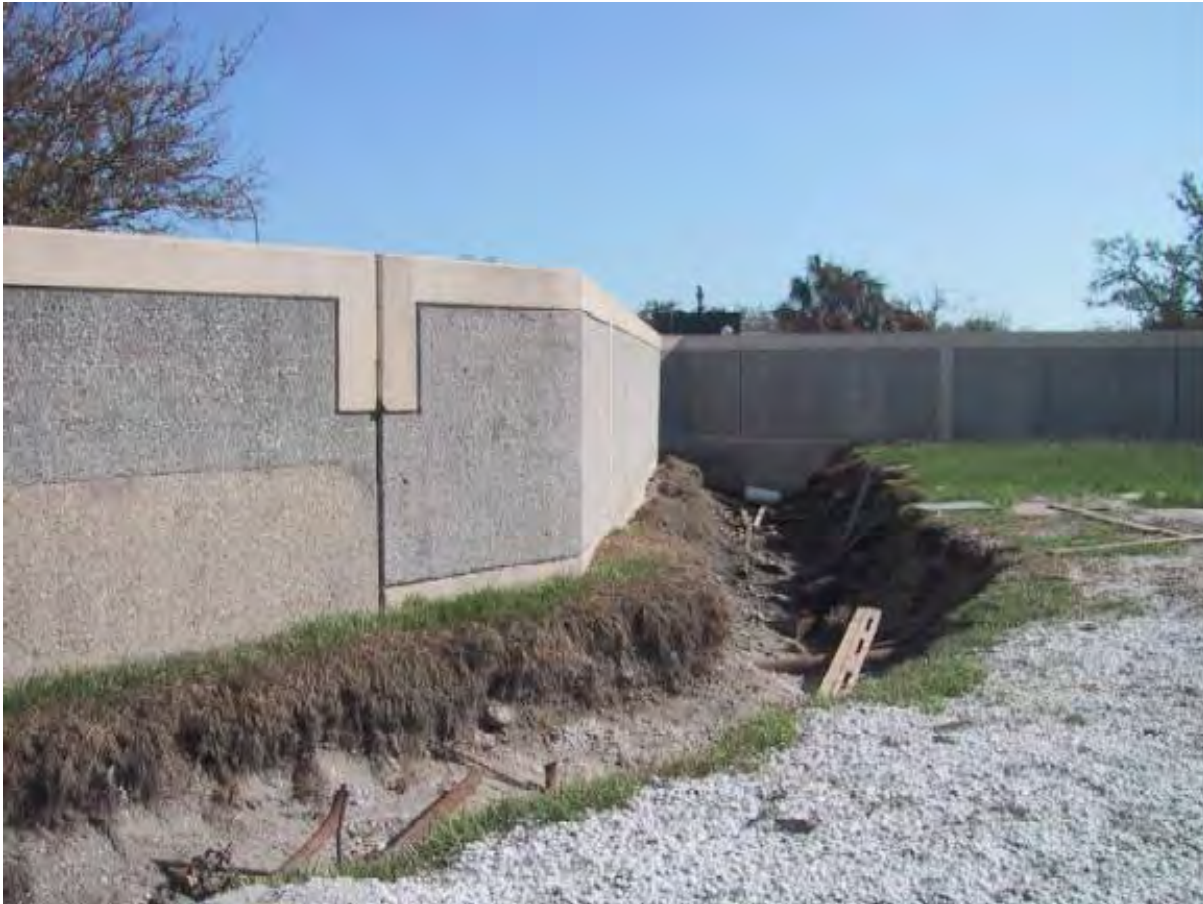
Figure 3.3: I-wall adjacent to the Lakefront Airport showing deep back-scour but no evidence of distress to the wall.

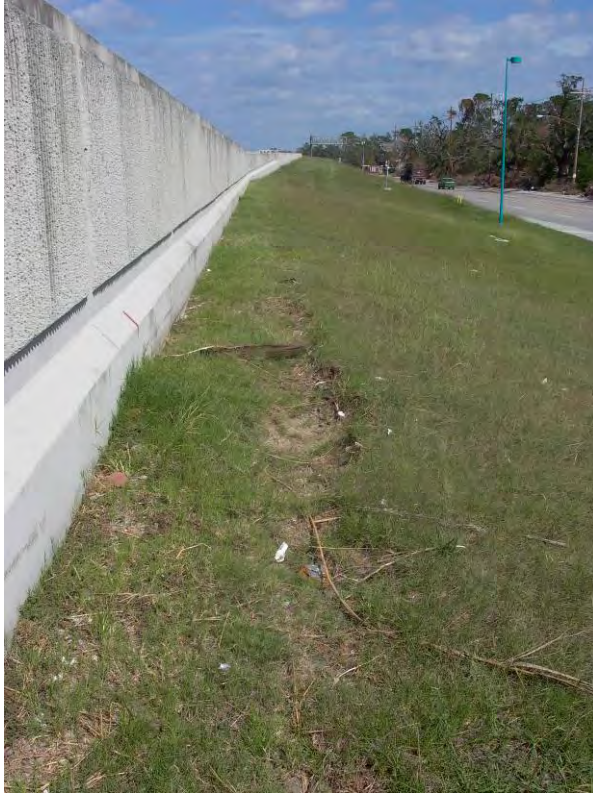
Figure 3.4: Beginning of overtopping scour along lakefront flood wall suggests moderate overtopping at this location.

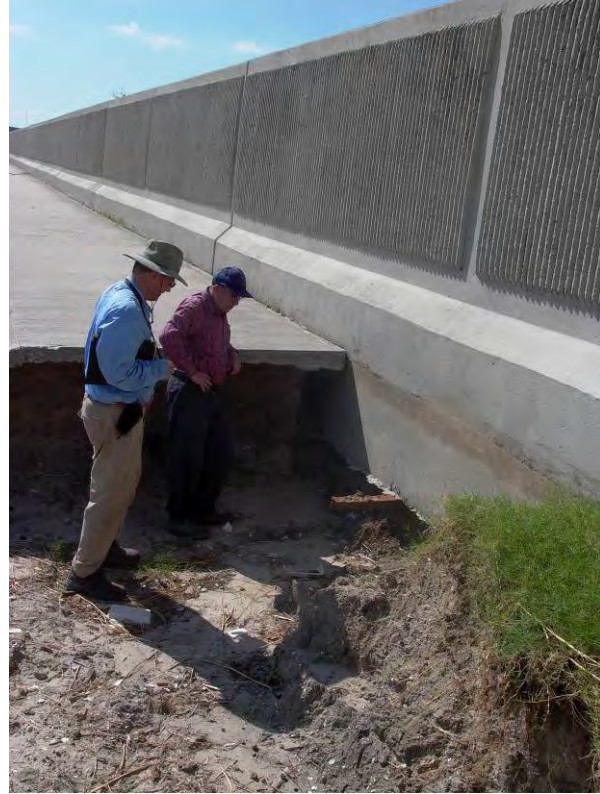
Figure 3.5: Concentrated scour due to presence of concrete apron. Area in the background is a good example of the benefits of armoring the base of the flood walls.

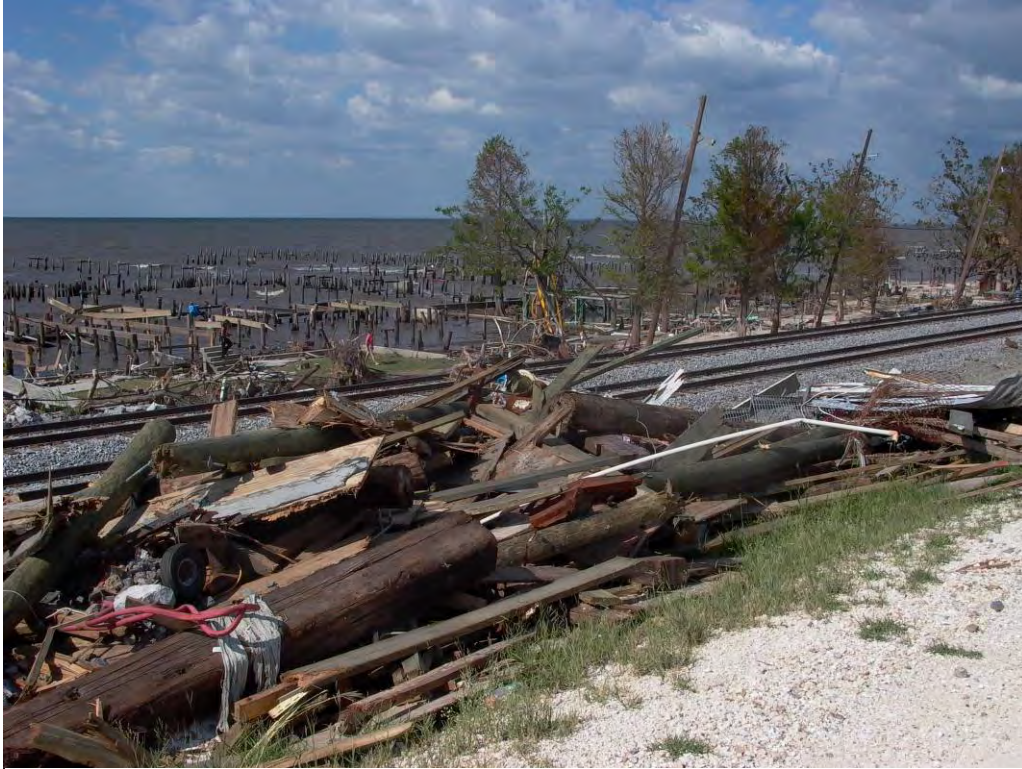
Further to the east, beyond Paris Road, the lakefront community of Little Woods was almost completely demolished by the wind and water. Figure 3.8 shows that only the pilings and some concrete stairs remain. Figure 3.9 shows debris from the demolished structures left very near the crest of the levee, indicating a high water level consistent with other water lines we observed in the lakefront area. Debris from the houses was also strewn on the landside of the levee in a pattern that suggested wind transport. Figure 3.10 shows the only surviving structure at Little Woods, which was noticeably elevated on piles. It appears intact except for the absence of stairs to reach the elevated balcony, suggesting that the building industry can deliver structures that resist storm forces like the ones experienced during Hurricane Katrina at Little Woods.

Figure 3.8: The lakefront community of Little Woods destroyed by wind and water (Photo by F. Silva – N 30° 04' 70.5", W 89° 56' 44.0")

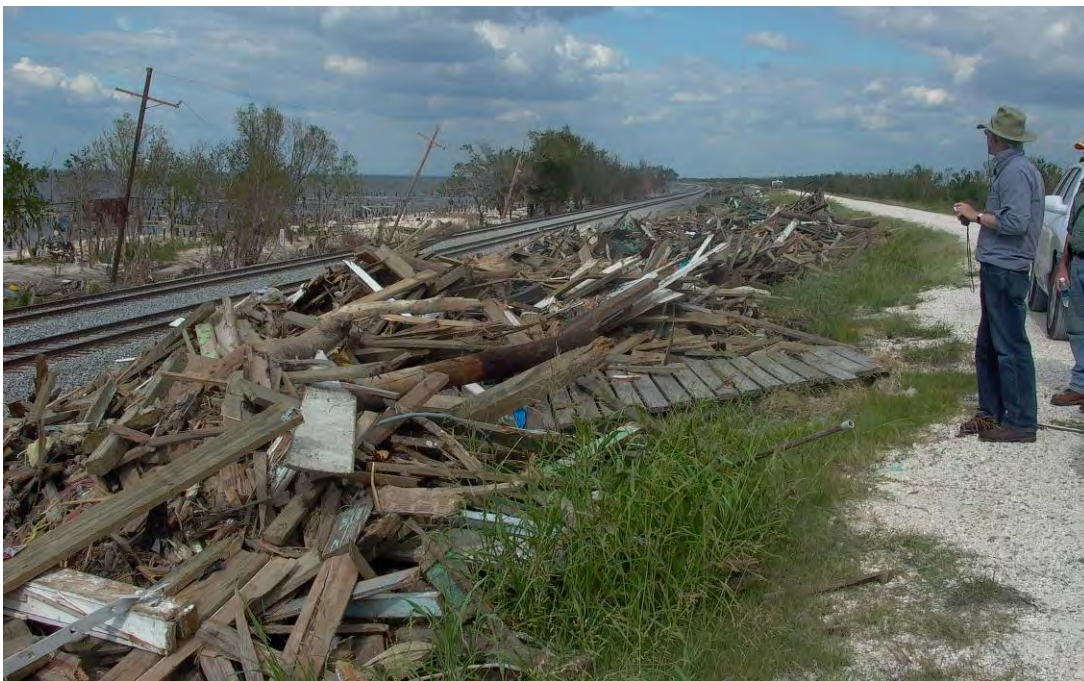
Figure 3.9: Debris from the Little Woods houses accumulated near the crest of the earth levee indicates the level of the lake waters during the storm. (Photo by F. Silva – N 30° 04' 70.5", W 89° 56' 44.0")

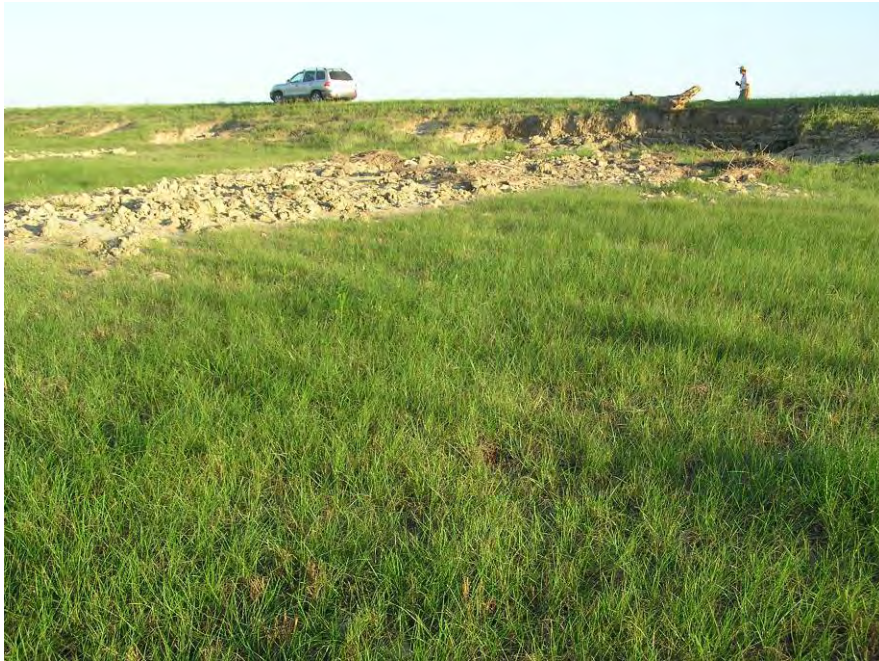
Figure 3.15: Embankment along the IW that survived although somewhat scoured.

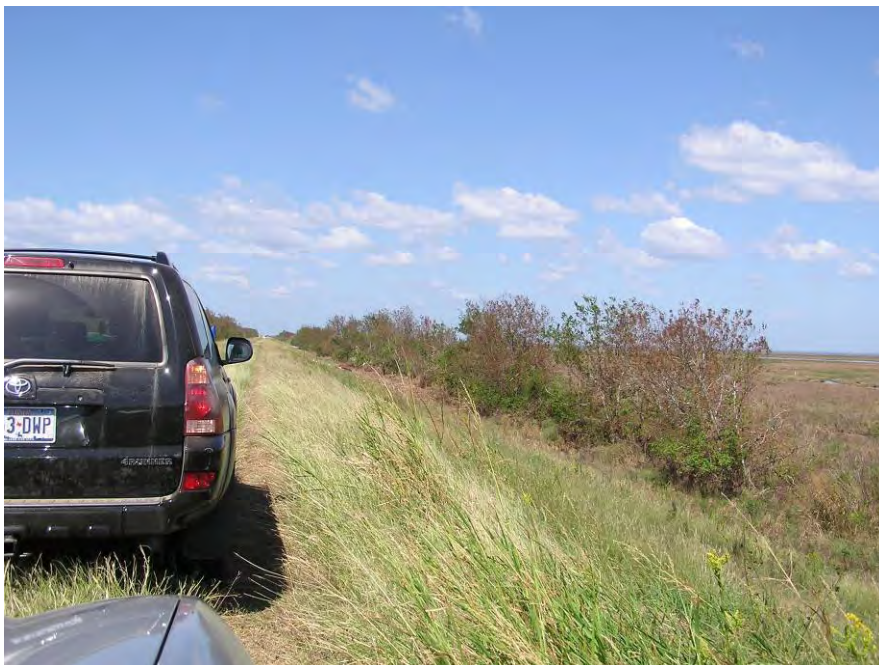
Figure 3.16: Virtually unscathed earth embankment levee on the eastern edge of the protected area of New Orleans East

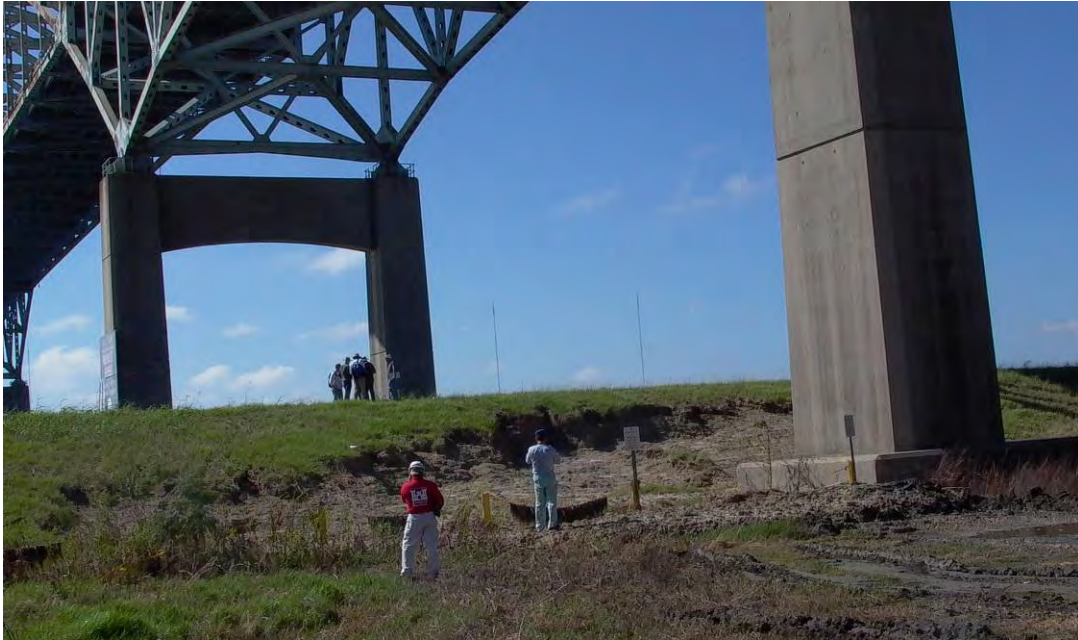
The earth levee along the north bank of the Intracoastal Waterway under the Route 47 Bridge, stands as an example of satisfactory performance despite hydraulic conditions that far exceeded the design criteria. Figure 3.17 shows the erosion damage on the landside slope of the levee due to the overtopping. Figure 3.18, taken from the Entergy Michoud Generating Plant, shows the area in Figure 3.17 under storm conditions. Given the ferocity of the storm as evidenced in Figure 3.18, the relatively modest erosion damage to the earth levee represents satisfactory performance.

Figure 3.17: Earth levee beneath the north abutment of the Route 47 bridge over the Intracoastal Waterway, next to the Entergy Michoud Generating Plant, looking south. Despite considerable erosion, the levee performed satisfactorily during and after overtopping.

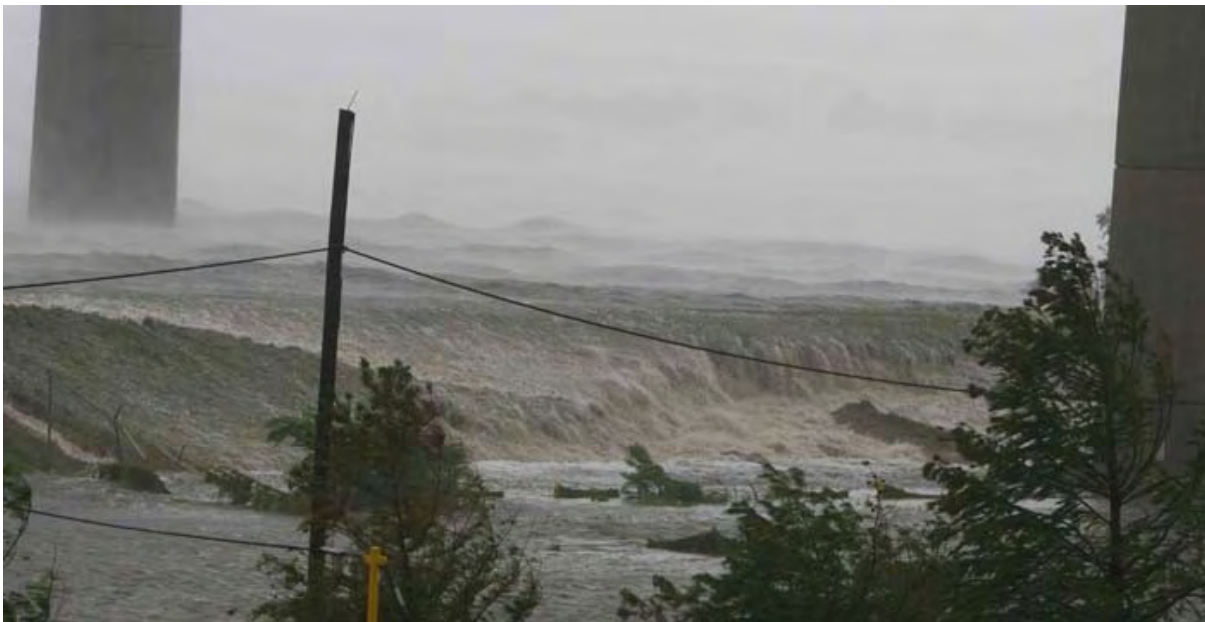
Figure 3.18: Same view of the overtopped earth embankment as seen in Figure 3.16 taken during the storm surge.

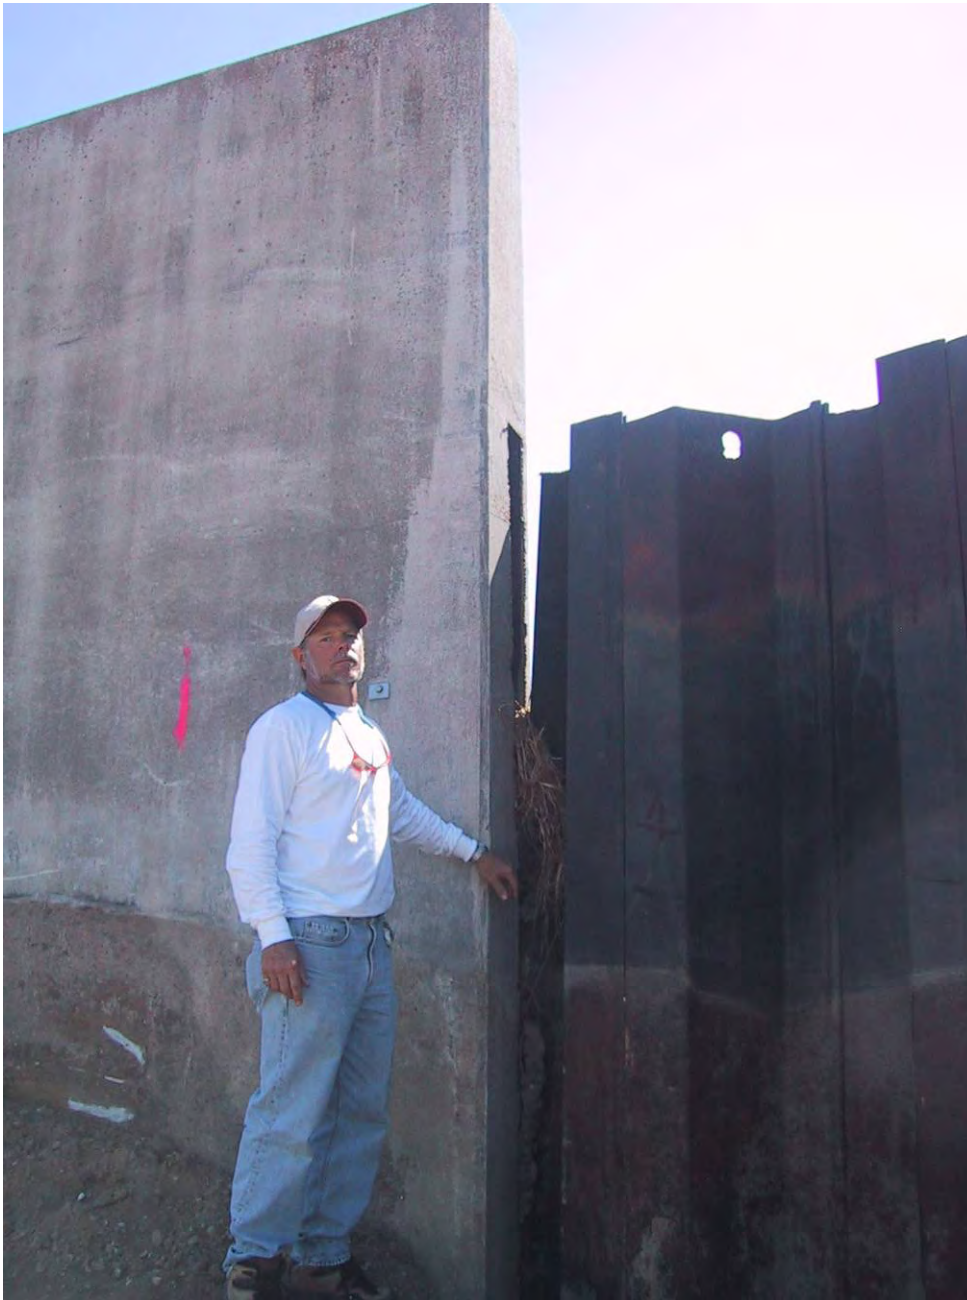
Figure 3.19: Transition between concrete and sheetpile walls at uneven wall height elevations

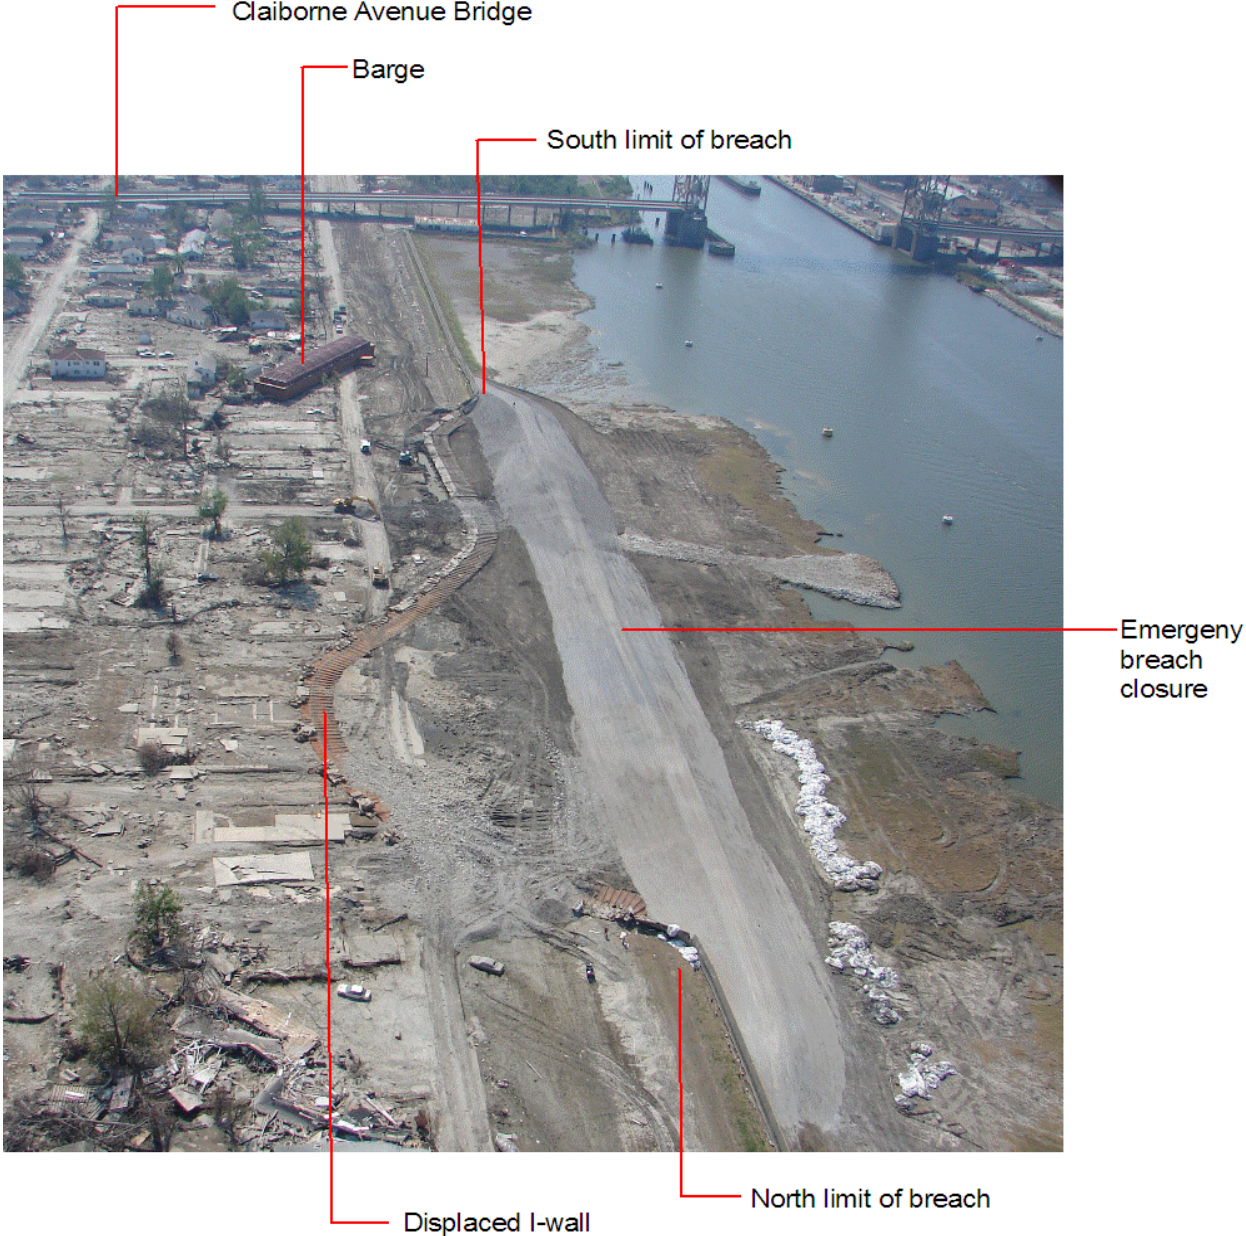
Figures 4.2 and 4.3 show aerial views of an approximately 900 ft. long levee breach located approximately 850 ft. north of the Claiborne Avenue Bridge. The breach initially resulted from the Hurricane Katrina storm surge in the IHNC. An emergency repair was made shortly after the breach occurred. This repaired portion of the breach was later overtopped on September 24 by a storm surge caused by Hurricane Rita, which flooded the Lower Ninth Ward for a second time (floodwaters reached a depth of about 3 feet). This second flooding incident was reportedly much less severe than that caused by Hurricane Katrina, and as such, it is likely that it caused relatively little, if any, additional damage to the levee system along the east side of the IHNC. The earthen portion of the levee was almost completely destroyed and the I-wall was overturned (toward the land side) and dragged inland a maximum of 187 feet. As shown in Figure 4.2, the displaced I-wall assumed a sinuous shape that reached its maximum distance along the northern extent of the breach. It is worth noting that the sheet pile remained interlocked, hence the displacement resulted from stretching of the I-wall structure. The unbreached portions of the I-wall system located immediately north and south of the failure were tilted landward, reaching their maximum inclination of approximately 3 degrees near the breach and gradually tapering to close to vertical at further distances. Scour trenches at the toe of the floodwall (protected side) were found along the entire length of the intact I-wall section. The scour trenches were typically about 5 ft. wide at the top and extended to depths of approximately 4 ft. The scour trenches were generally wide and U-shaped near the breached area and gradually became narrower, V-shaped and incised with distance from the breach (Figure 4.4).

Fig. 4.2: Aerial view of the South Breach of the Lower Ninth Ward (L. Harder, October 14, 2005).

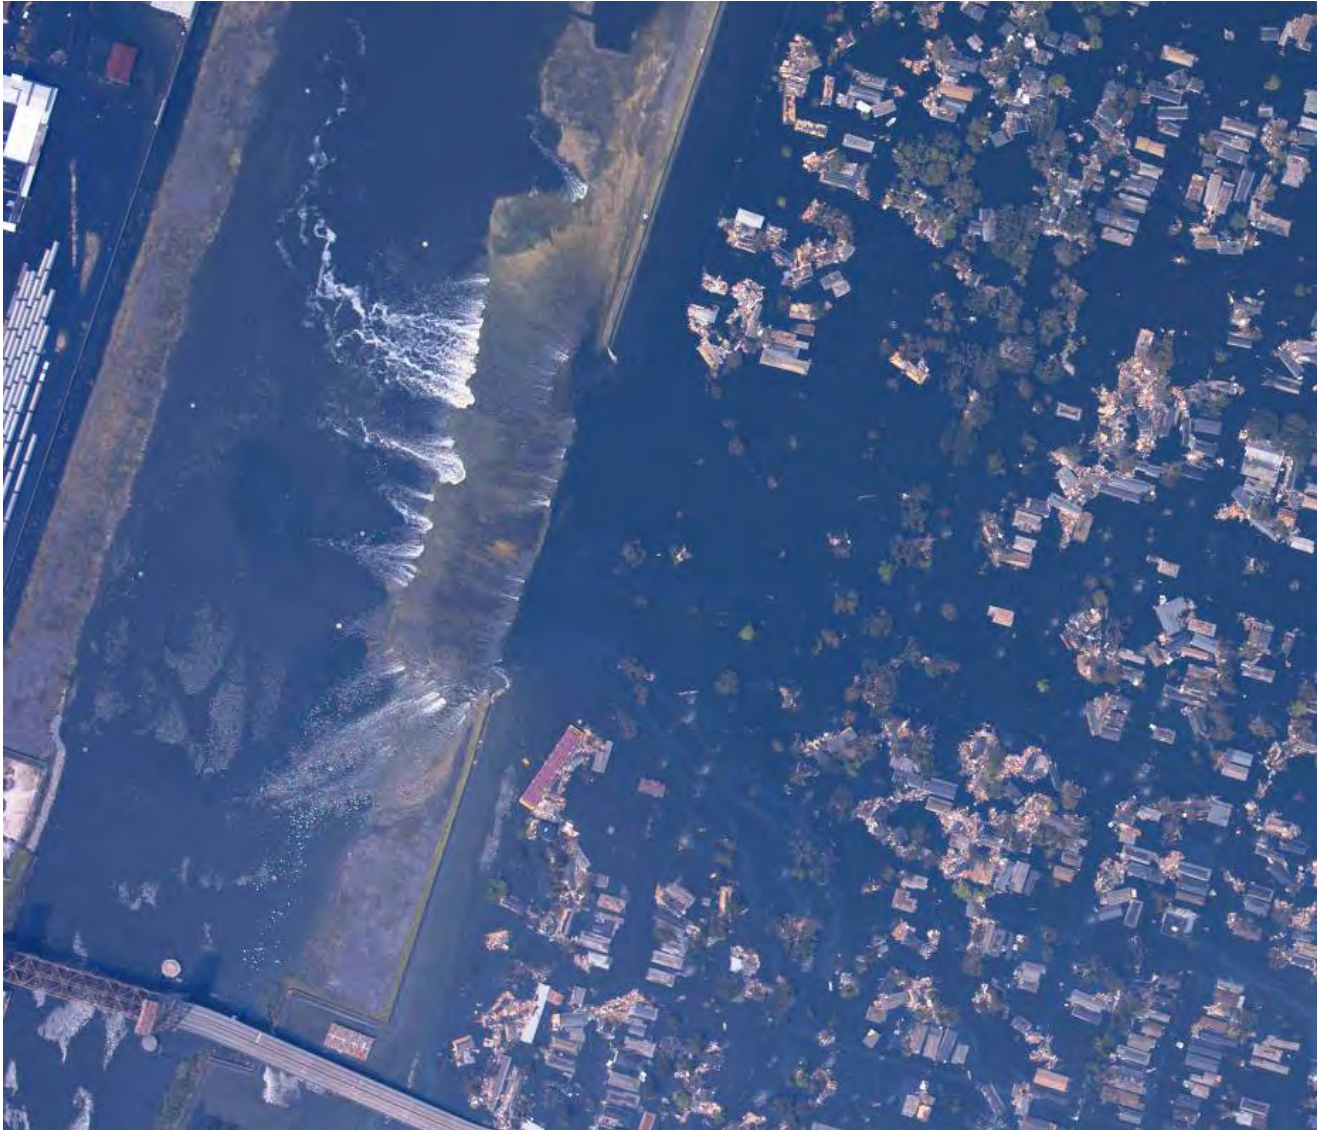
Fig. 4.3: Airborne digital imagery of the south breach at the Lower Ninth Ward. Water is shown flowing back into the IHNC. (courtesy NOAA, August 31, 2005).

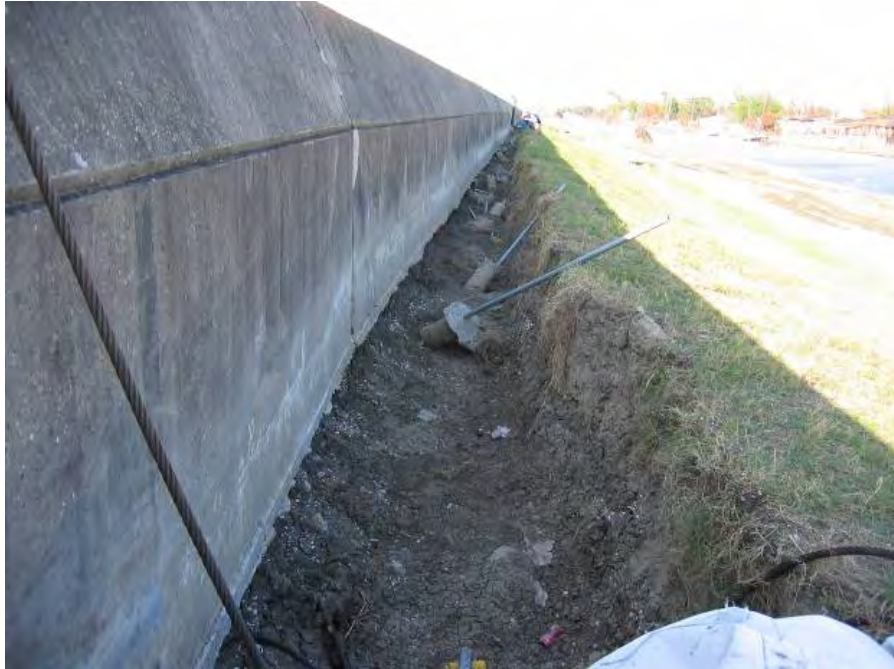
Fig. 4.4: North view from the end of the south breach of Lower Ninth Ward. Note how the scour trench becomes progressively wider as it approaches the breach. (J. Wartman, October 4, 2005).

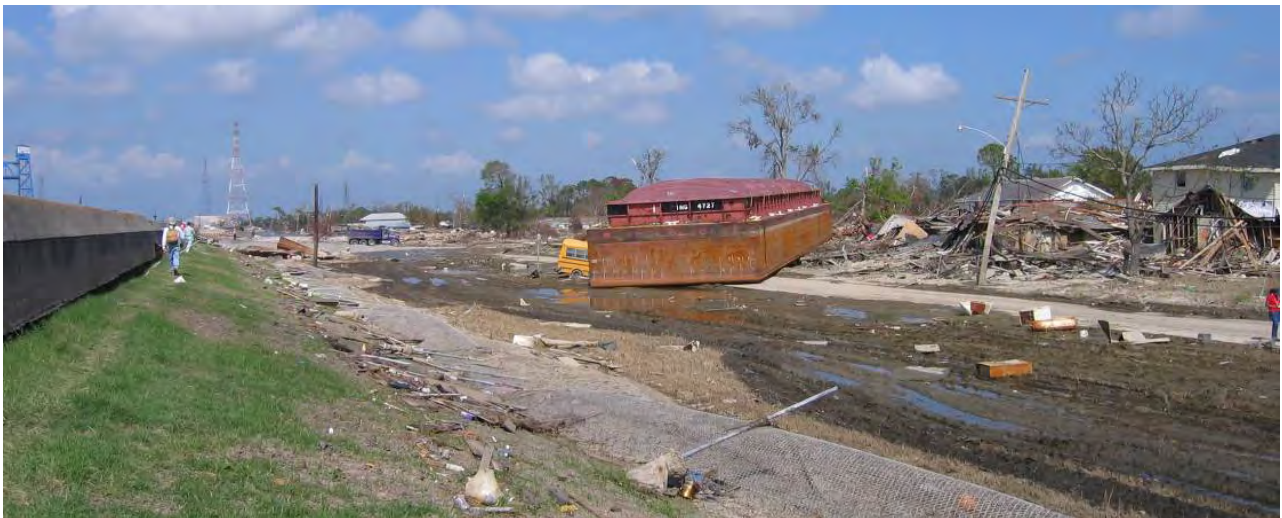
Figure 4.5 shows a unique feature of the failure site: a large barge that was drawn through the breach and came to rest on the land side of the levee as floodwaters receded. The barge was reportedly docked in the IHNC and became unmoored during Hurricane Katrina. Note the crushed school bus under the right side of the barge. Review of press photographs suggest that the barge initially came to rest further inland as floodwaters from Hurricane Katrina receded. The barge was later refloated as the Ninth Ward flooded a second time during Hurricane Rita. The barge drifted back toward the breach and eventually came to rest upon the school bus as the Lower Ninth Ward was later unwatered.

Fig. 4.5 - A barge was drawn through the south breach of the Lower Ninth Ward (J. Wartman, October 4, 2005).

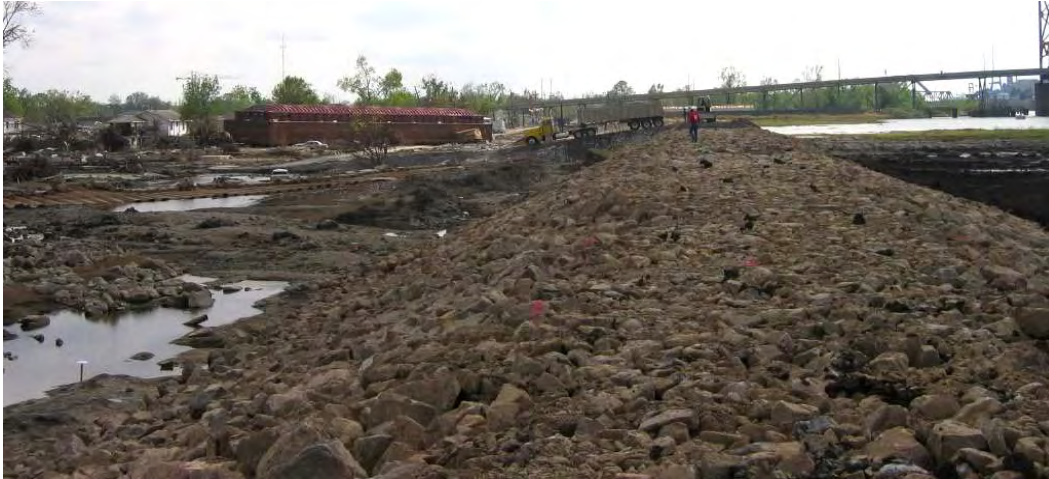
Fig. 4.6 - South view of the south breach repair at the Lower Ninth Ward (J. Wartman, October 4, 2005).

Figure 4.6 shows the emergency repair, which consists of a core of large sandbags overlain by embankment fill. Additional gravelly fill had been placed along the top of the embankment to serve as a working mat. The sandbags were airlifted into place, while the stone was placed from land. There was no significant seepage noted at the time of a site visits on October 4 and during the week of October 9.

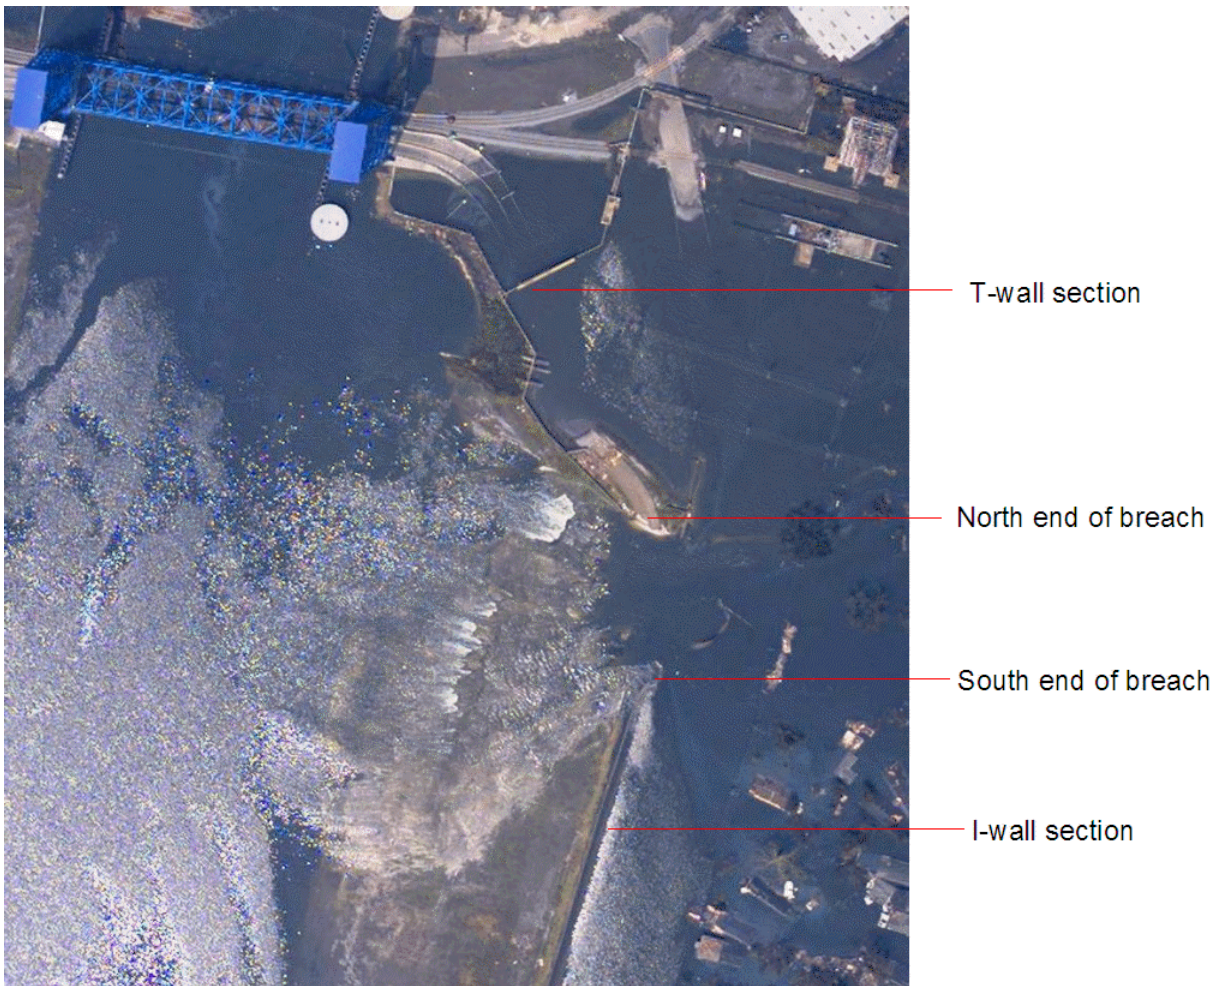
The flood protection system in the vicinity of Florida and Surekote Avenues near the northwest corner of the Lower Ninth Ward consists of I-walls/earthen levees that transition to T-wall sections near an adjacent flood gate (Fig. 4.7). The I-walls at this location are the same as those found at the South Breach location. Figure 4.8 shows a T-wall levee system at the site. The T-wall levee system at this location is similar to that presented earlier in Section 2.4. Subsurface conditions at the site are much like those found at the south breach site, with very soft clays overlying soft peats at shallow depths.

Fig. 4.7, Airborne digital imagery of the north breach at the Lower Ninth Ward. Water is shown flowing back into the IHNC. (courtesy NOAA, August 31, 2005).

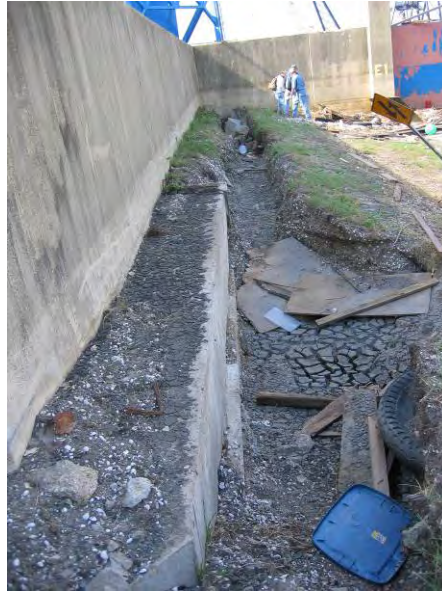
The unbreached portions of the I-wall system located immediately south of the failure were tilted inward (landward). The tilted I-walls reached their maximum inclination of approximately 3 degrees near the breach and gradually tapered to close to vertical at further distances. Scour trenches at the toe of the floodwall (protected side) were found along the entire length of the intact I-wall section. The scour trenches were typically about 5 feet wide at the top and extended to depths of approximately 3 to 4 feet. As with the south breach, the scour trenches were wide and u-shaped near the breached area and gradually became narrower, v-shaped and incised with distance from the breach. Scour was also noted along the land side of the T-wall levee sections (Fig. 4.8).

Fig. 4.8 - A scoured, but nevertheless well-performing "T-wall" levee section located near the north breach of the Lower Ninth Ward (J. Wartman, October 4, 2005).

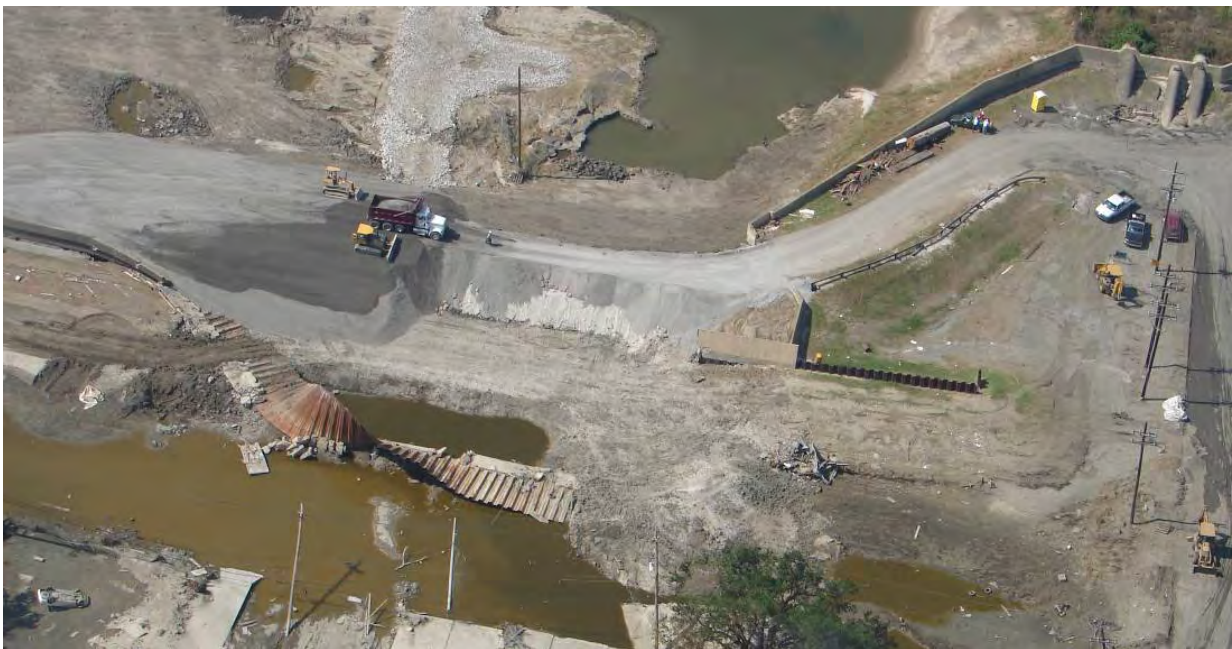
Figure 4.9 shows an aerial view of a 210 ft. long levee breach located approximately 500 south of Florida Avenue. The breach initially resulted from the Hurricane Katrina storm surge in the IHNC. An emergency repair was soon after made to breach. It is reported that unlike the south breach location, the north breach was not overtopped in Hurricane Rita. The earthen portion of the I-wall levee system was almost completely destroyed and the I-wall was overturned and dragged inland by as much as 70 feet while remaining fully interlocked. In the most extreme case, the I-wall came to rest upside down, with the concrete portion at the bottom, and the toe of the sheeting pointing upward (Figure 4.10). The sheet pile separated from the concrete wall at the north end of the site by splitting the webbed section rather than tearing the interlock.

Fig. 4.9: Aerial view of the north breach of the Lower Ninth Ward (L. Harder, October 14, 2005).

Figure 4.9 shows the emergency repair, which consists of a core of large sandbags overlain by embankment fill. The sandbags were airlifted into place, while the stone was placed from land. Owing to the presence of standing water on the land side during a visit on October 4, it was not possible to determine if seepage was occurring through the repaired section.

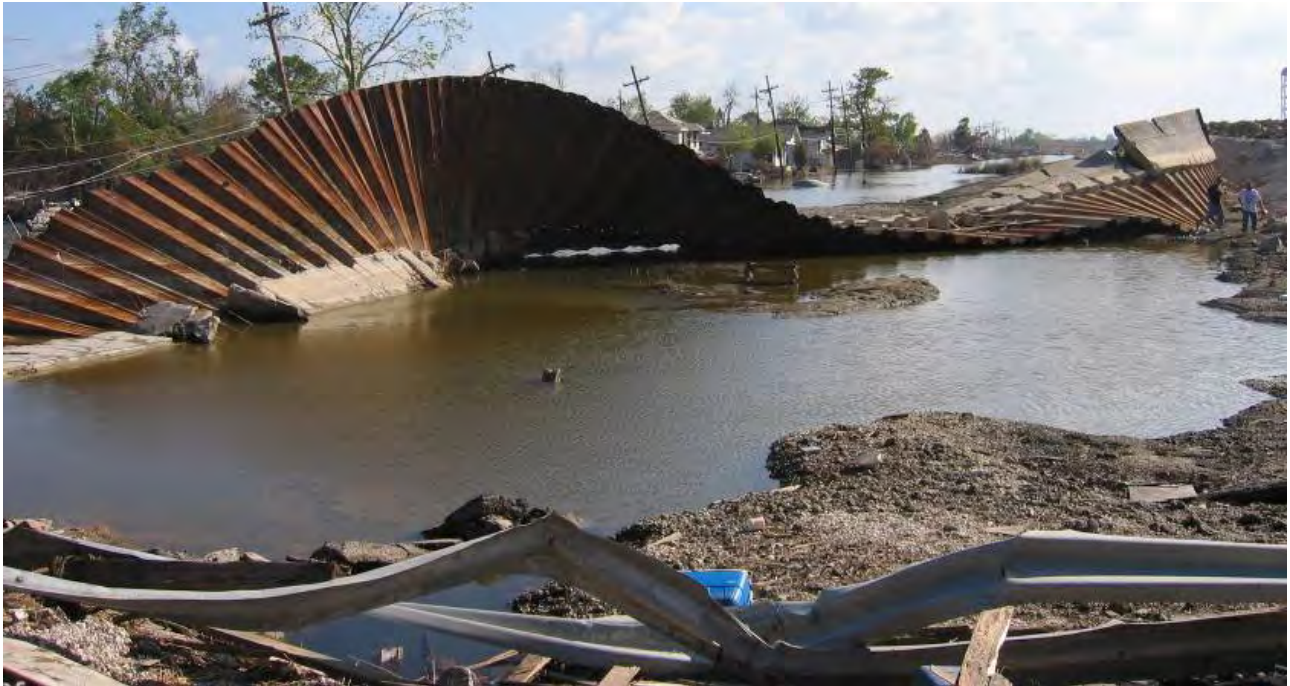
Fig. 4.10: Overturned I-wall system at north breach of Lower Ninth Ward (J. Wartman, October 4, 2005).

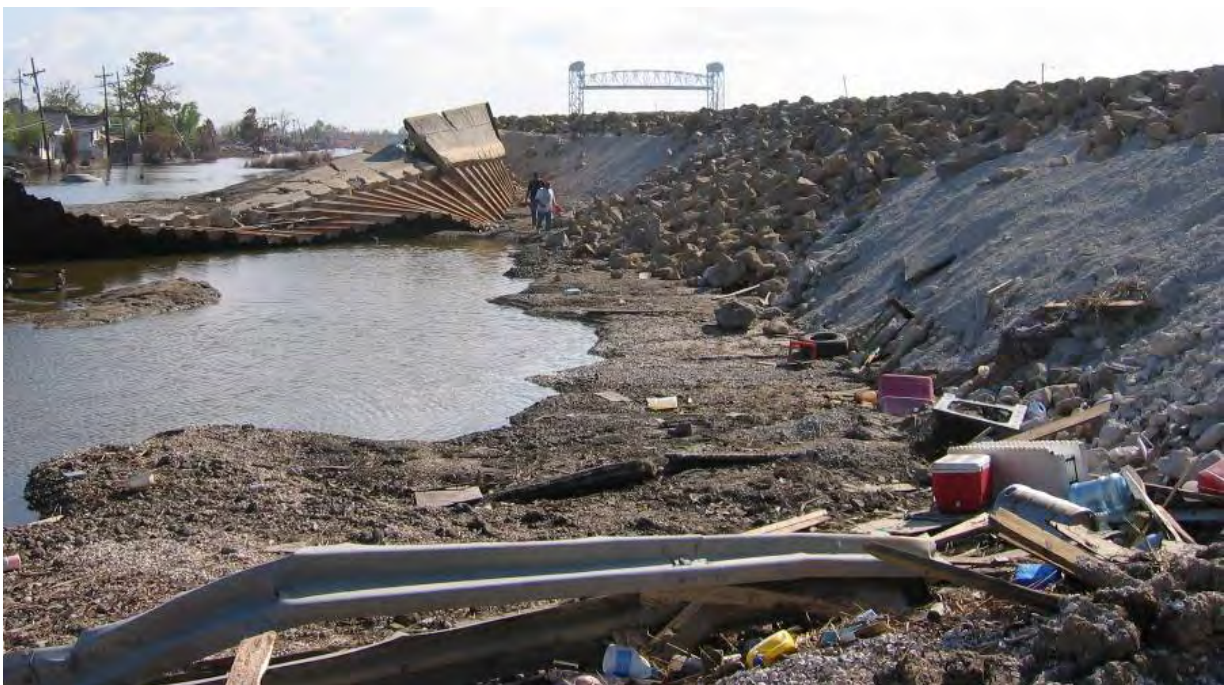
Fig. 4.11: Looking south of the north breach repair at the Lower Ninth Ward (J. Wartman, October 4, 2005).
