Preliminary Report on the Performance of the New Orleans Levee Systems in Hurricane Katrina on August 29, 2005

Report No. UCB/CITRIS – 05/01
November 2, 2005

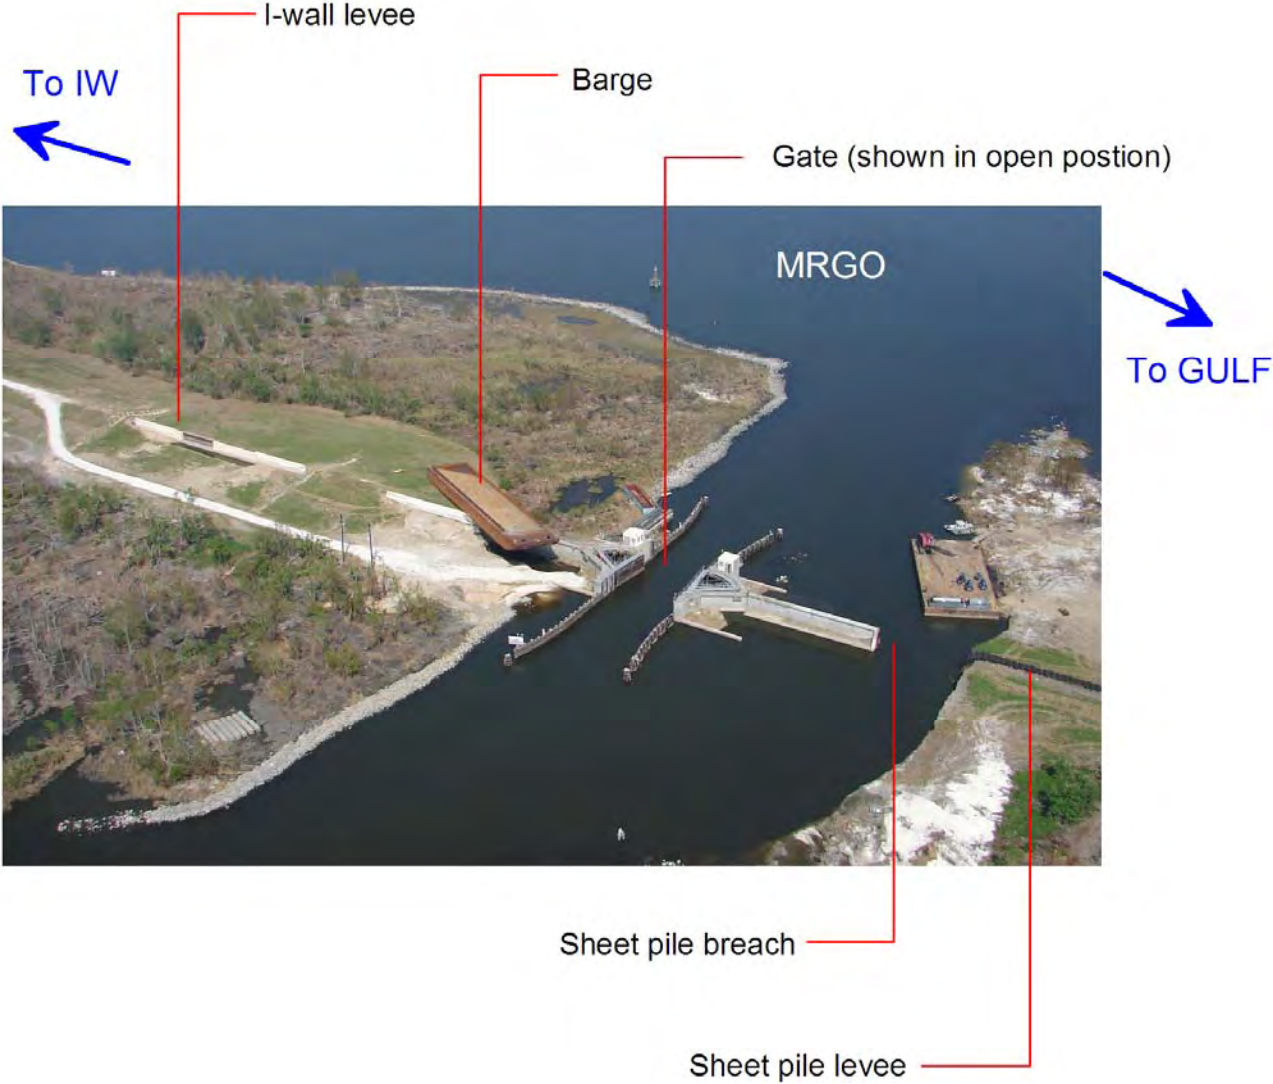
The flood protection system at the Bayou Bienvenue gate site is a complex levee-gate transition involving several different levee sections located as shown in Figure 4.12. These include (from west to east) an earthen levee, transitioning to an I-wall, transitioning to a gate structure, transition to a sheet pile section, which finally transitions again to an earthen levee along the MRGO.

Visible in Figure 4.12 is a large barge that stuck and then overran the I-wall section south of the gate. The barge eventually came to rest directly upon the I-wall, which was locally damaged by the impact of the barge. Scour was found immediately adjacent to the I-wall damage, probably as a result of concentrated water flow at this location (Figure 4.14). Despite the combined effects of the scour, impact damage, and the vertical load imposed by the barge, the I-wall at this location survived relatively intact and performed remarkably well. As shown in Figure 4.15, minor scour was also noted at the transition between the earthen levee and I-wall section located just south of the barge.

Fig. 4.12: Aerial view of the South Breach of the Lower Ninth Ward (L. Harder, October 14, 2005).

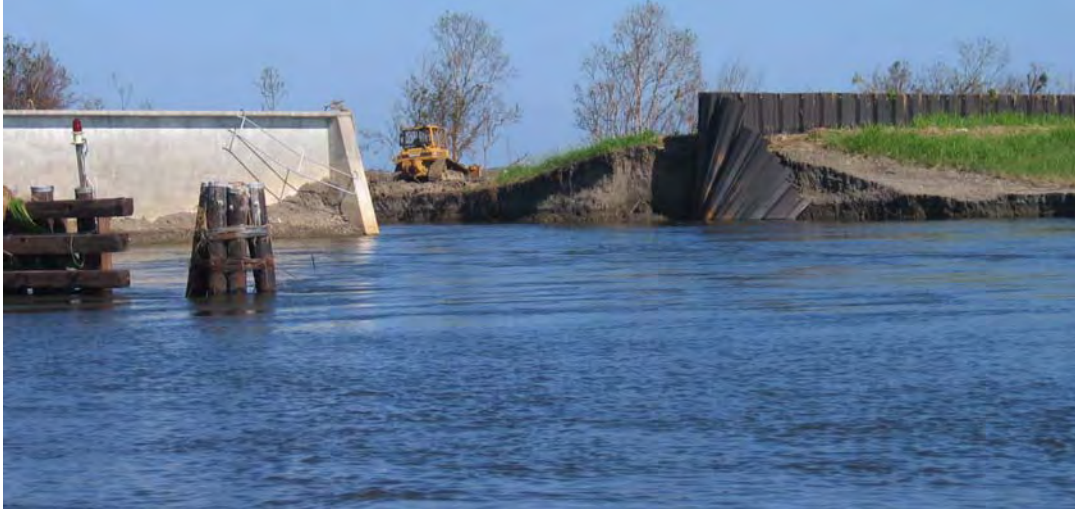
Figure 4.13 shows an approximately 80 ft. long levee breach in the sheet pile section located immediately east of the gate structure. The earthen portion of the levee was completely obliterated and the sheet pile wall appears to have been "torn" from its connection to the concrete gate structure, and overturned. Orleans Levee District staff indicated that the gates were closed during Hurricane Katrina, and later reopened (manually, due to the lack of electric power) after the storm had passed. Many of the sheet pile breach features were obscured by water at the site, and hence it was not apparent if the breach occurred due to a structural failure at the sheet pile gate connection, a result of overtopping, leading to scour and subsequent loss of passive resistance, or some combination of these factors. At the time of the last visit to the site on October 5, no repairs had been made to the breach.

Fig. 4.13: Sheet pile breach at the Bayou Bienvenue Gate (J. Wartman, October 5, 2005).

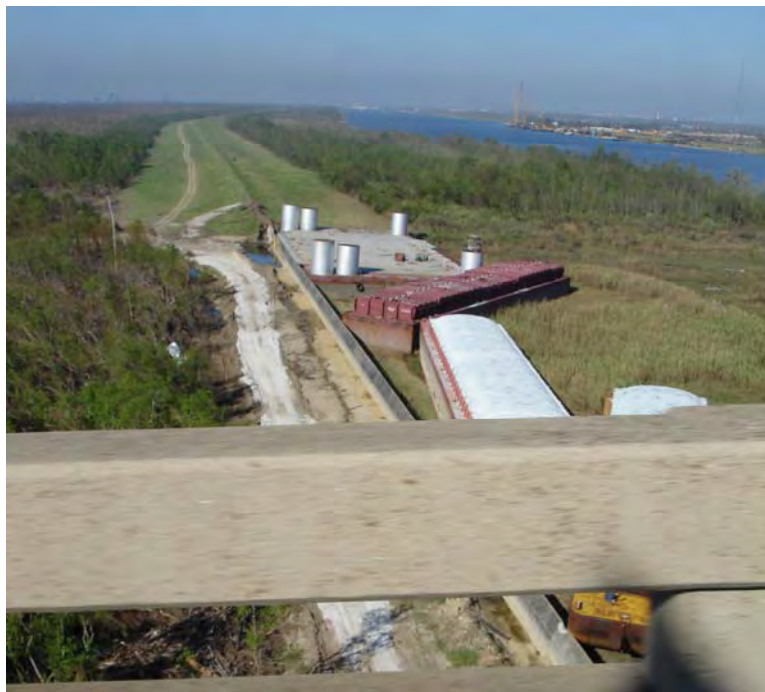
Fig. 4.16, View of levee along the south bank of the Intracoastal Waterway from the Rt. 47 Bridge. (Lee Wooten, October 6, 2005)

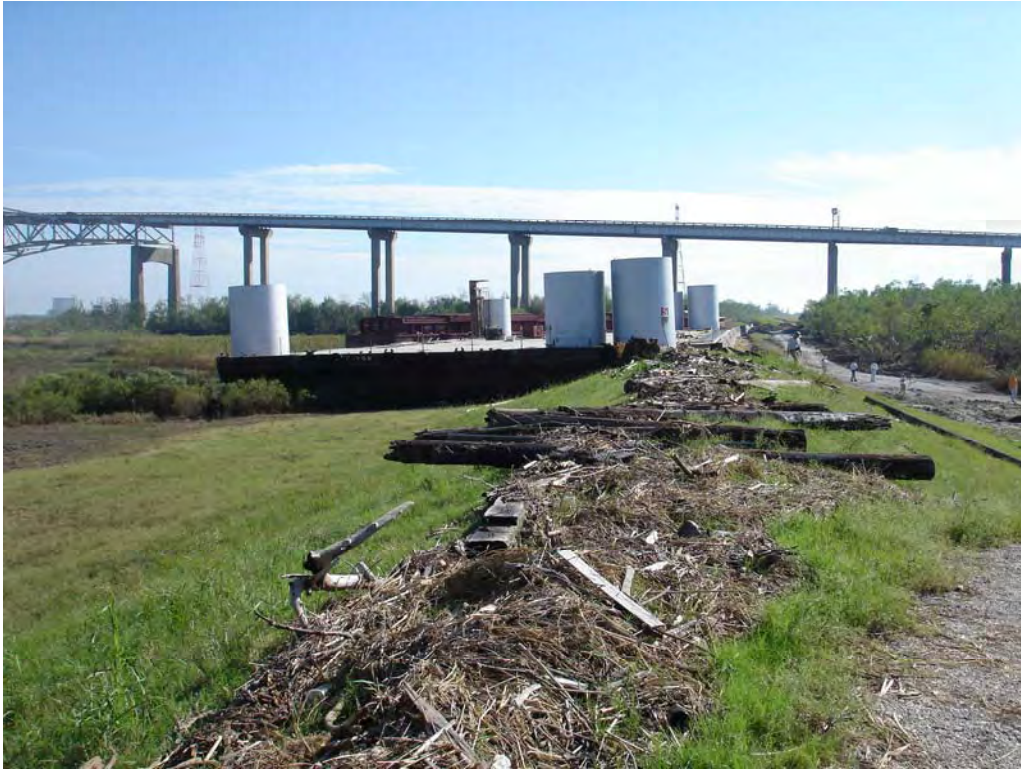
Fig. 17: Debris line near levee crest just west of the Rt. 47 Bridge south abutment. (L. Wooten, October 5, 2005).

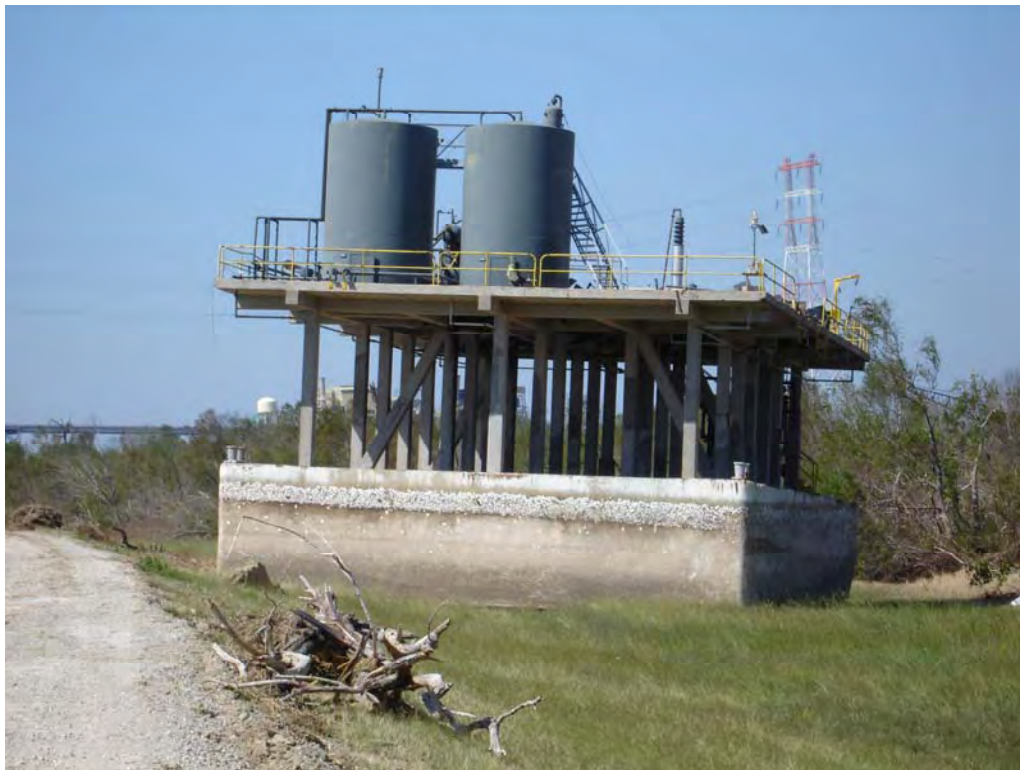
Fig. 18: Various barges and other floating structures made contact with the earth levees without causing significant damage. Photo shows a gas processing barge. (F. Silva, October 1, 2005).

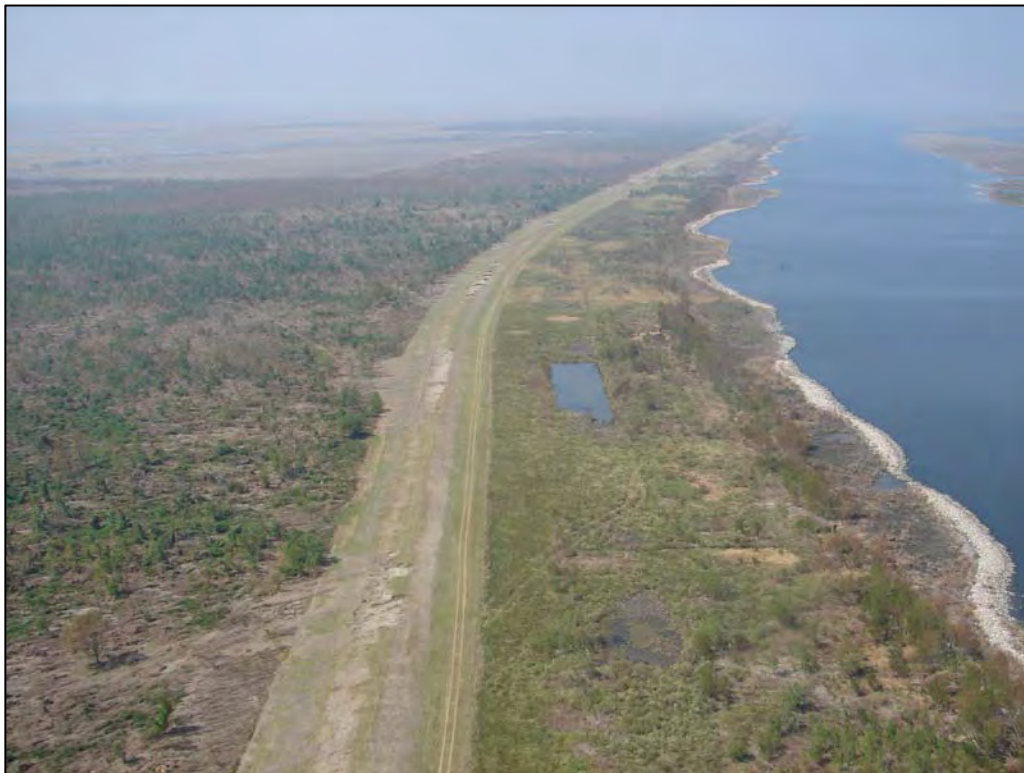
Fig. 26: Aerial view of MRGO looking towards the city of New Orleans (L. Harder, October 14, 2005).

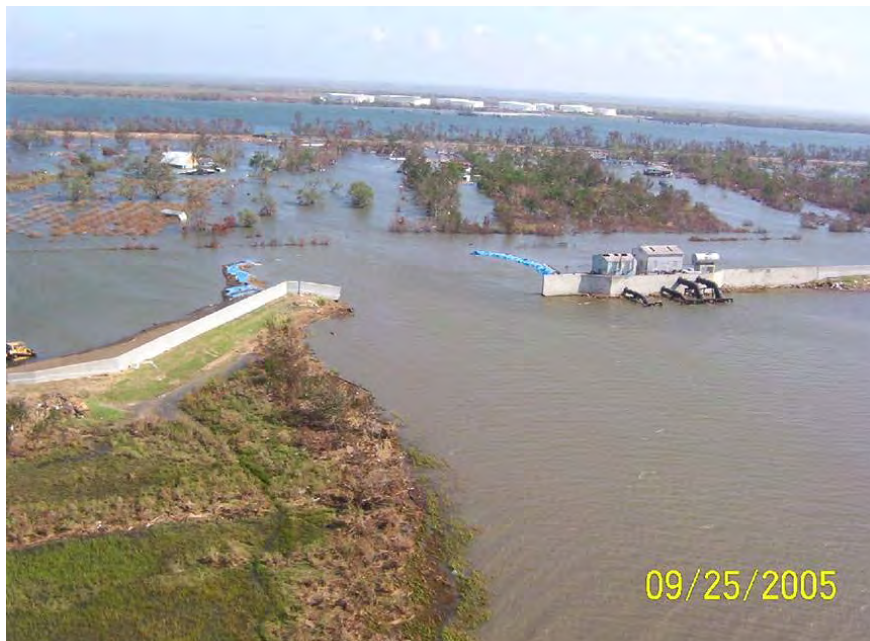
Sunrise - 29 21.62 N 89 33.67 W

Figure 5.2: Aerial photograph of levee breach of hurricane (back) levee along western side of the Mississippi River near the community of Sunrise (September 25, 2005)

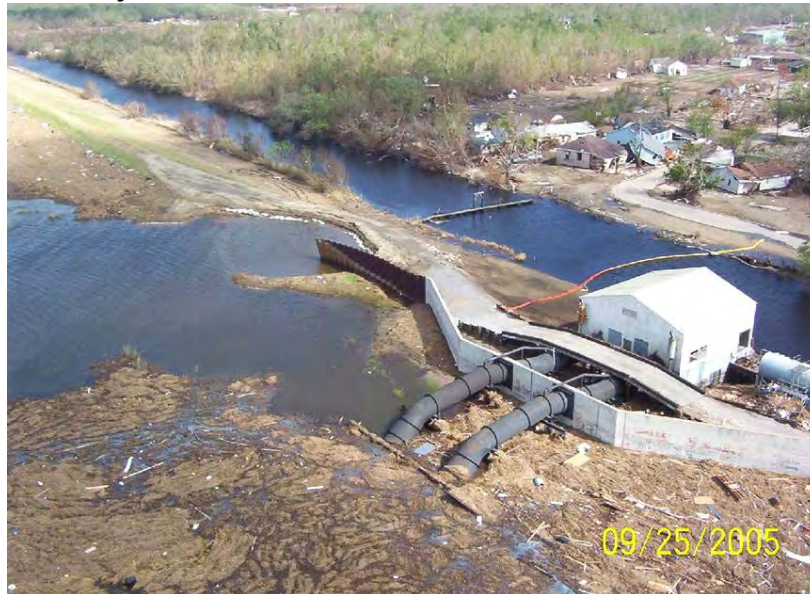
Hayes PS - 29 30.79 N 89 43.90 W

Figure 5.3: Aerial photograph of levee breach of hurricane (back) levee at levee transition near Hayes Pump Station (September 25, 2005)

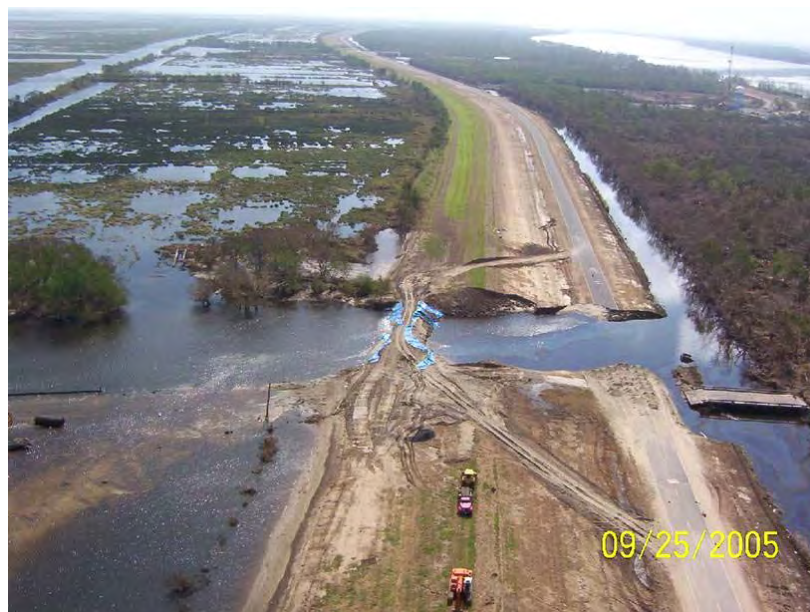
East Pointe a la Hache - 29 35.68 N 89 48.75 W

Figure 5.4: Aerial photograph of levee breach of hurricane (back) levee east of Pointe a la Hache (September 25, 2005)

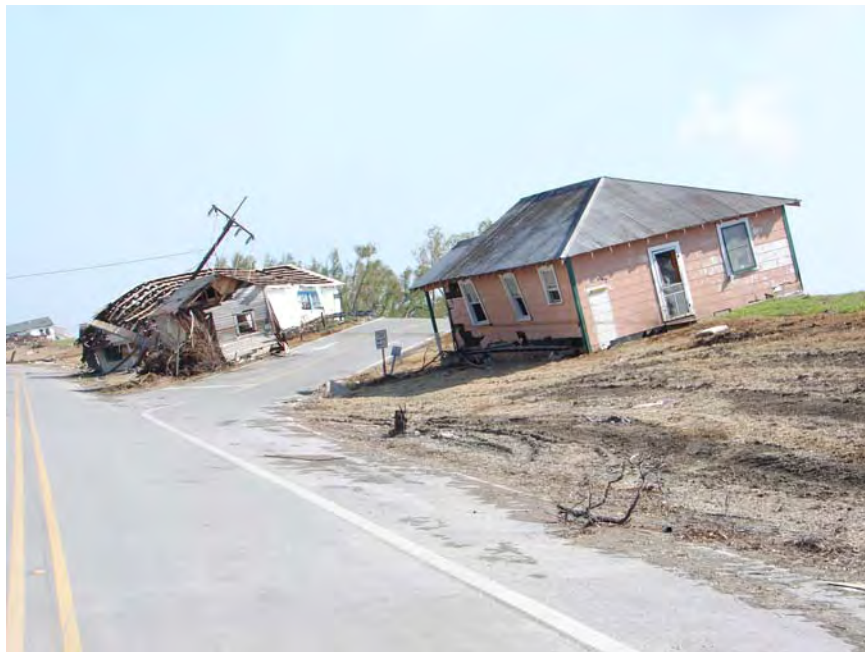
Figure 5.7: Photograph of Pointe a la Hache home deposited on Mississippi River levee crown after storm surges overtopped this levee from the east (left) towards the River – which is to the right in this photograph (October 12, 2005)

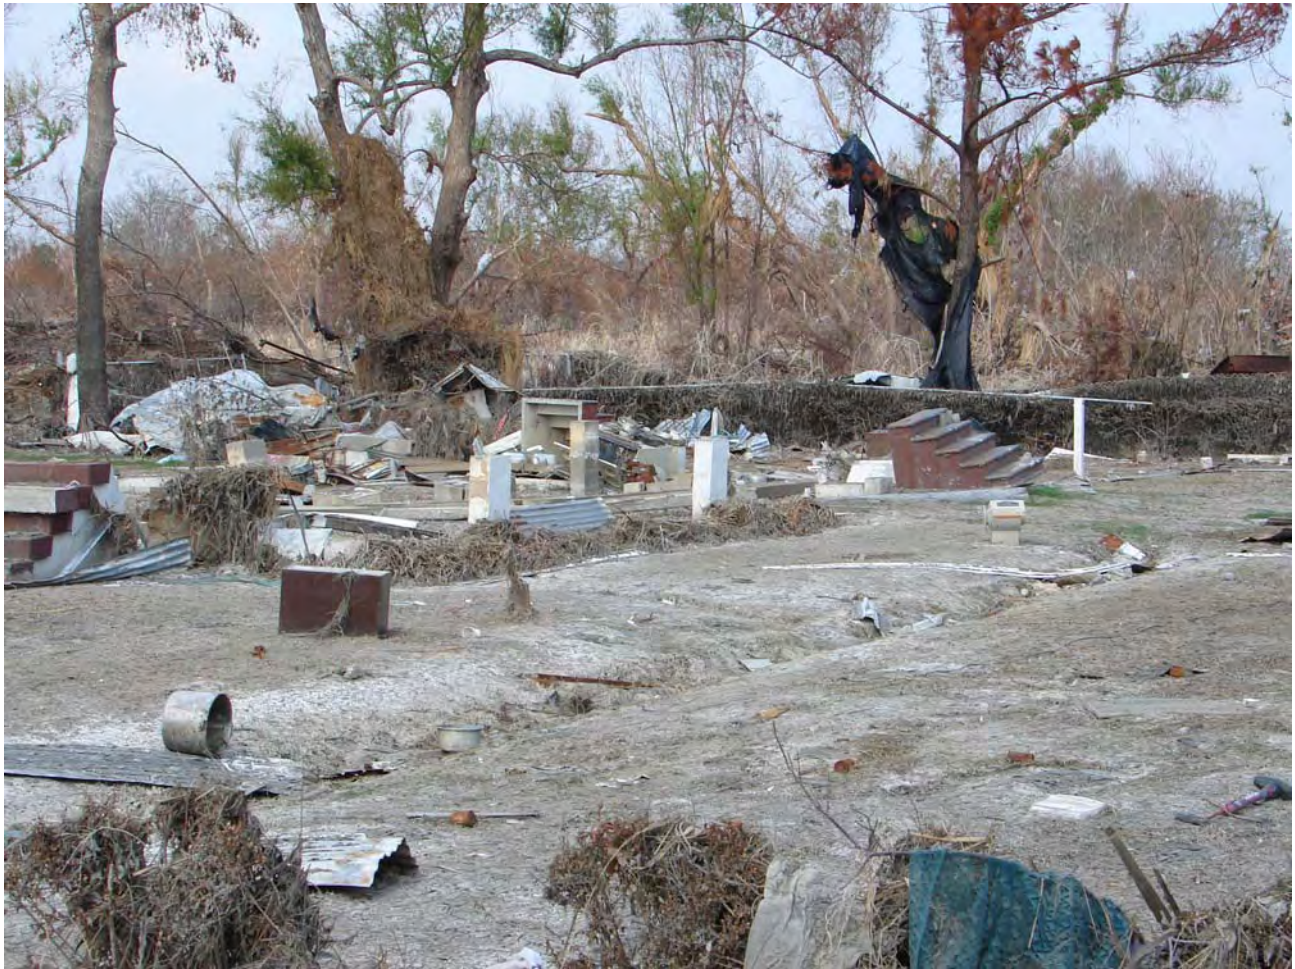
Figure 5.8: Photograph of Pointe a la Hache homes deposited on Mississippi River levee after storm surges overtopped the levee from the east (left) towards the river (right) (October 12, 2005)

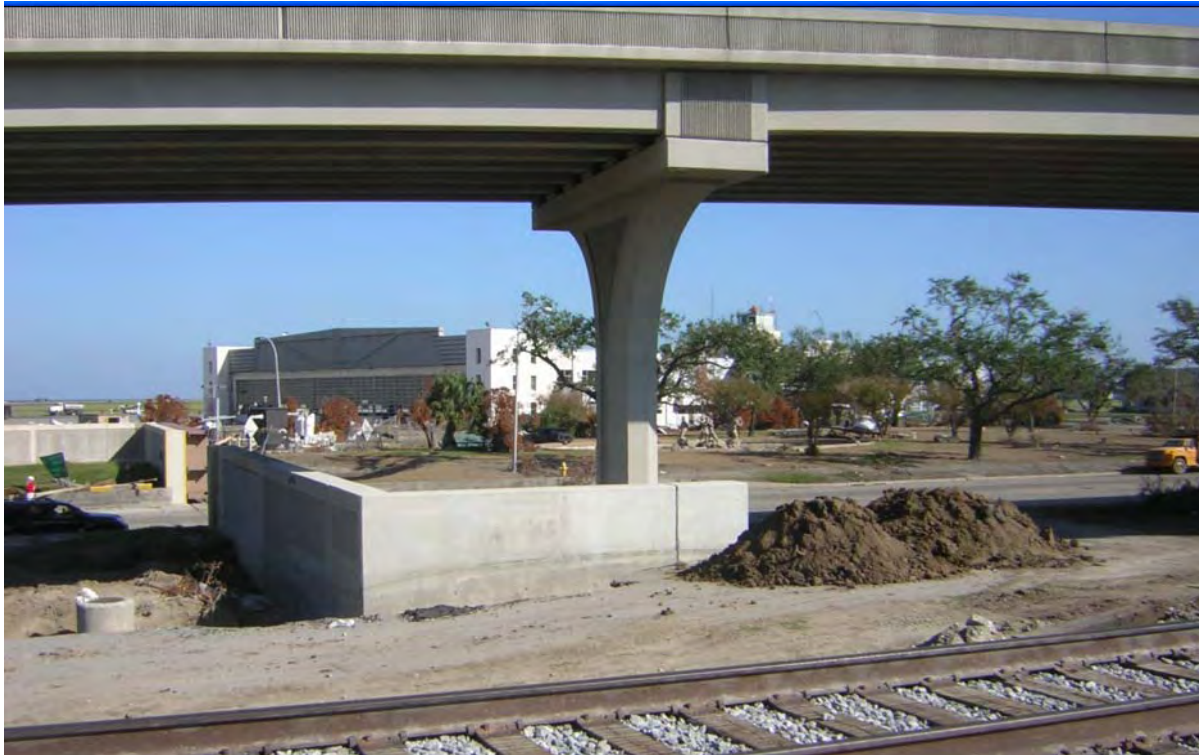
A good example was found on the west side of the IHNC at the lake front adjacent to the railroad bridge that crosses this canal near the Lakefront Airport (Figure 6.1). Inspections of this area clearly indicated that large amounts of water had entered through a railway opening in the adjacent concrete flood wall and soil levee (Figure 6.2). The inspection did not disclose the presence of a flood gate that had closed the railway opening, even though immediately adjacent to this opening was a securely closed flood gate and concrete flood control structure maintained by the USACE (this gate and the adjacent flood control structure had not been breached and showed no signs of overtopping) (Figure 6.3) The low spot in this complex interchange was the base of the railroad ballast, and it was here that the water had flowed through. Attempts had been made to place sandbags prior to the arrival of hurricane Katrina; the attempts had not been successful and water had poured through the opening flooding the areas immediately south and west of the opening.

Figure 6.1: A flood protection earthen levee, near the Lake Pontchartrain lakefront suffered scour as a result of overtopping at a location where railroad lines traversed the top of the levee and connected to a flood gate structure.

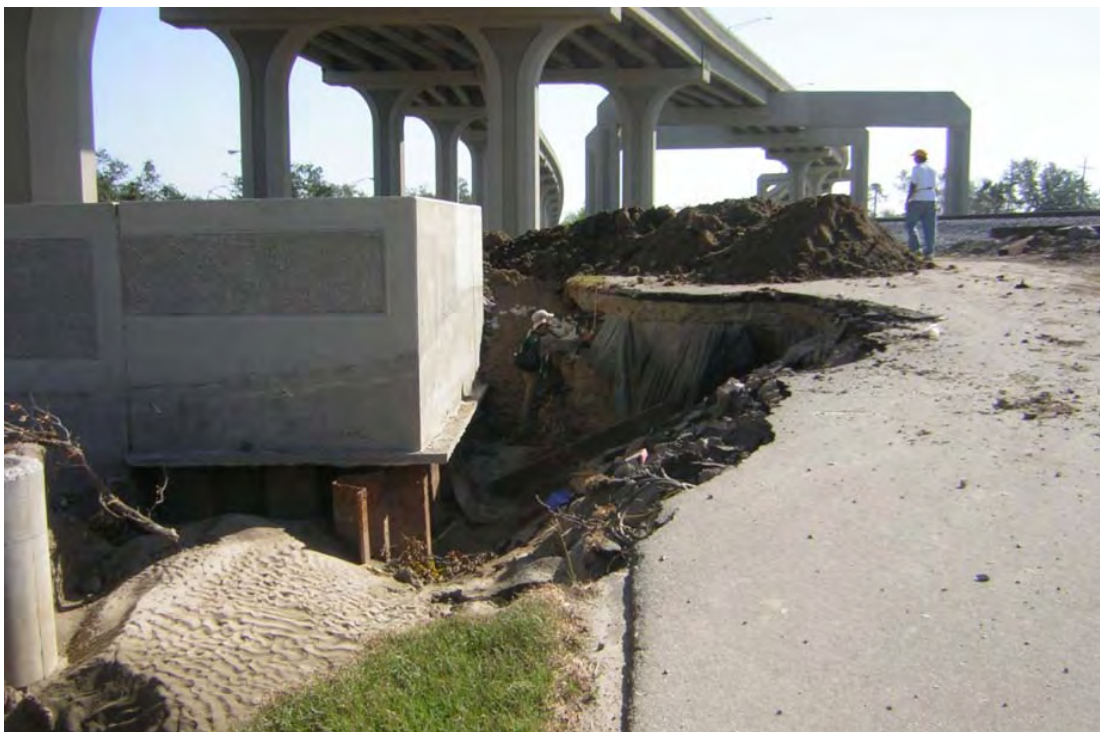
Figure 6.2: Scour through the earthen levee at the transition to the reinforced concrete flood gate structure.

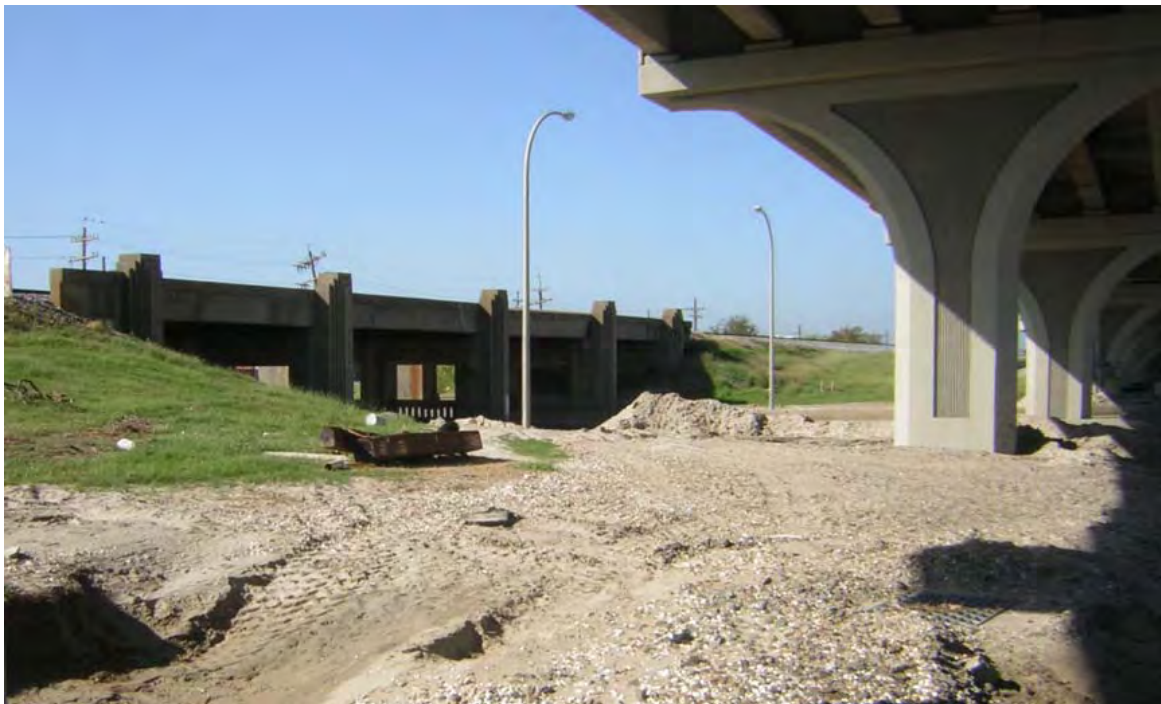
Figure 6.4: Lack of a flood gate beneath the railroad over-crossing facilitated the flooding of residential neighborhoods.

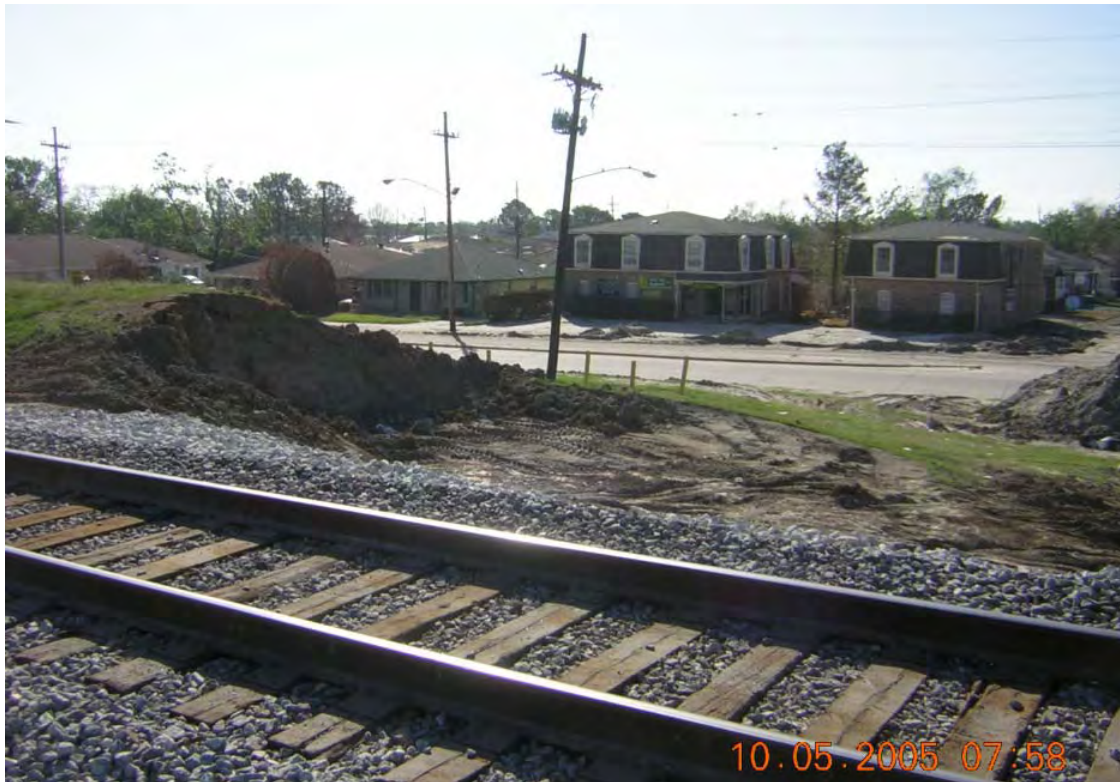
Figure 6.5: This flood protection levee was overtopped and scoured, resulting in flooding of this lakefront residential area.

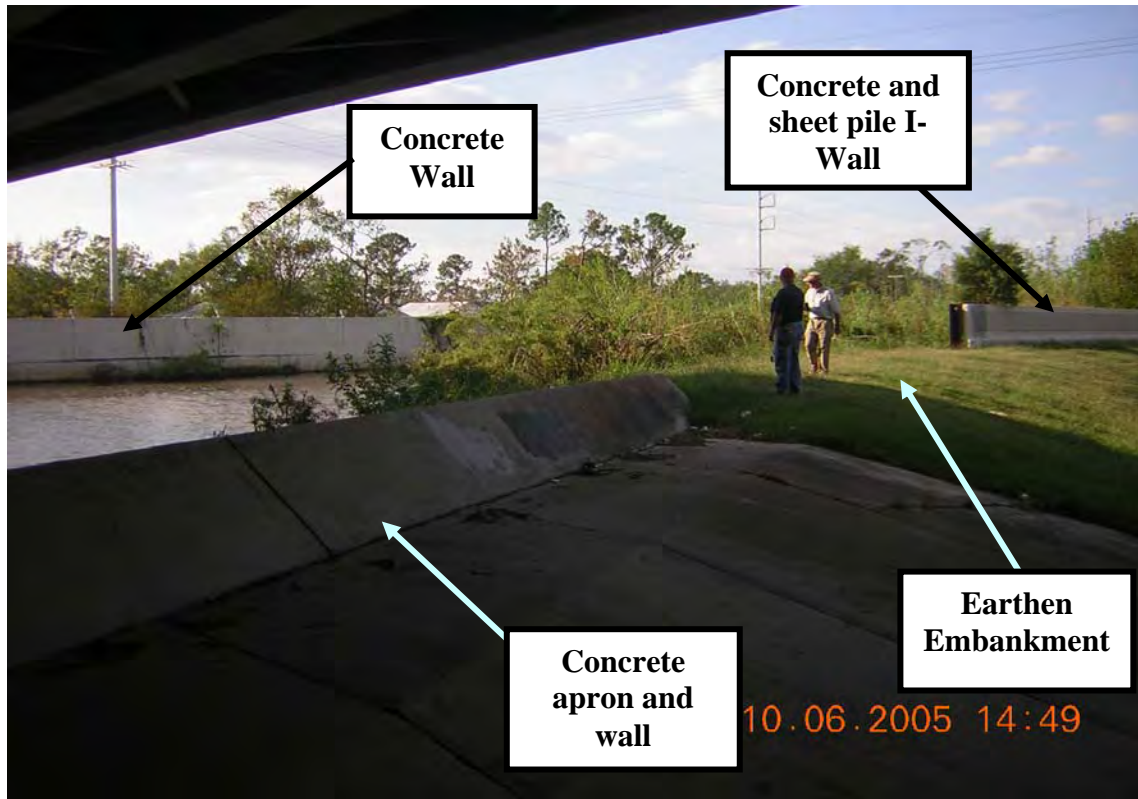
After touring the pump station, we surveyed the area immediately outside of the pump station to determine how the flood walls and other parts of the levee system had performed. We found that it had performed very well, with little signs of overtopping. However, as we toured the area we found that there were 5 different elevations of different parts of the levee system (Figure 6.9). For example, the flood walls abutted to adjacent earth levees that were substantially lower than the tops of the flood walls. Other variations in the elevations of the flood defense elements were correlated with the agencies that had responsibilities for various parts of this part of the system, (e.g.: highway department determining the heights under the road overpass immediately adjacent and upstream of the pump station, Figure 6.10)).

Figure 6.10: At the Orleans Canal pump station, the flood protection system consisted of different components, each with a different “top of wall” elevation.

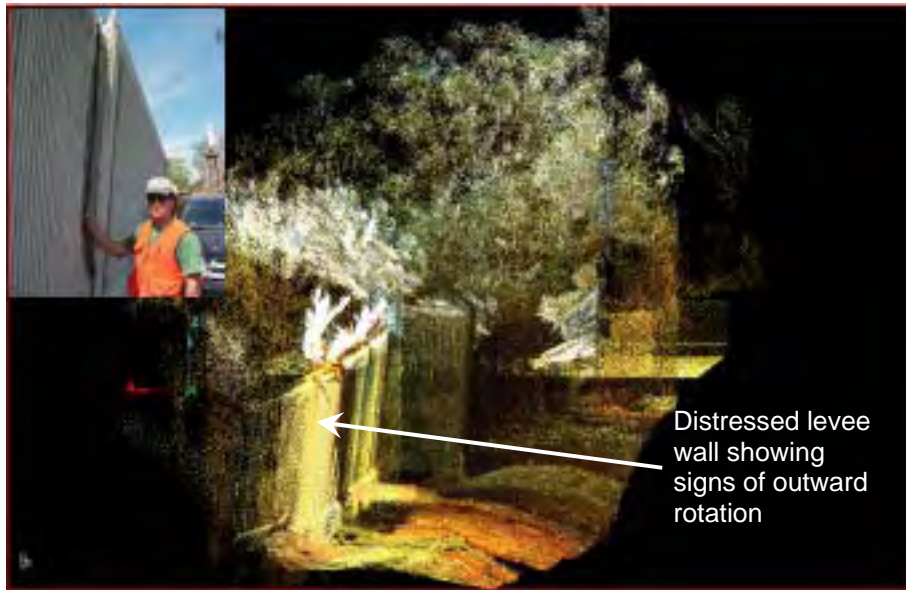
Laser mapping allows for highly accurate computation of rotation, length, area, and volume. Rotational displacement was common at areas of levee T-wall distress. For example, the east side of the London Canal immediately south of Robert E. Lee Boulevard suffered distress and lateral deformation associated with incipient failure of the levee. This movement is along a section of wall diagonally northeast of the west side breach across the canal. In Figure 7.13, an oblique image of the distressed wall can be seen from the southwest. The wall, preserved in incipient failure, leans toward the levee maintenance road and downstream portion of the levee. In the background is the abutment of the Robert E. Lee Bridge (to the right).

Figure 7.13: Leaning T-wall of a distressed portion of the London Canal. The wall leans toward the levee maintenance road and landslide portion of the levee. In the right-most background is the abutment of the Robert E. Lee Bridge along with vegetation on the canal side of the levee.

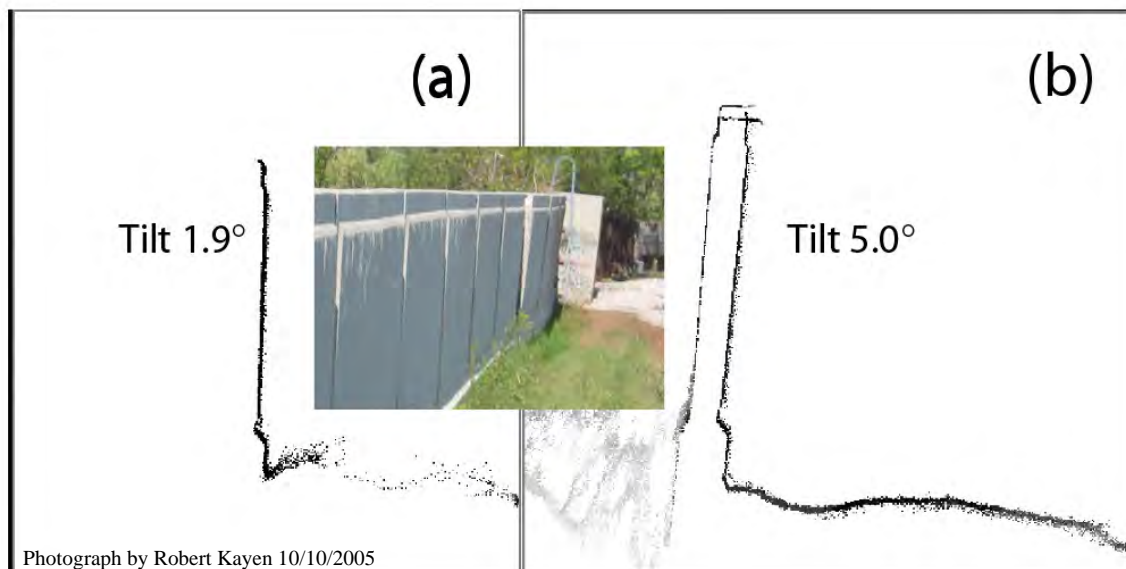
Considerable vegetation grows along the banks of the canal side of the levee that are less maintained for growth than the landside neighborhood-side of the levee wall. Thin slices of the point-cloud data orthogonal to the alignment of the levee wall (Figure 7.14) display highly accurate cross sections of the distressed T-wall at London Canal. Segment (a) is toward the south (left) of Figure 7.13 and has a modest 1.9 degree rotational deformation. Near a position of maximum distress, the T-wall has 5.0 degrees of rotational deformation toward the landside of the levee.

Figure 7.14: Cross sections through two segments of distressed T-wall at London Canal. Segment (a) is toward the south (left) of Figure 7.13 and has a modest 1.9 degree rotational deformation toward the downstream side of the levee. Near a position of maximum distress, the T-wall has 5.0 degrees of rotational deformation.

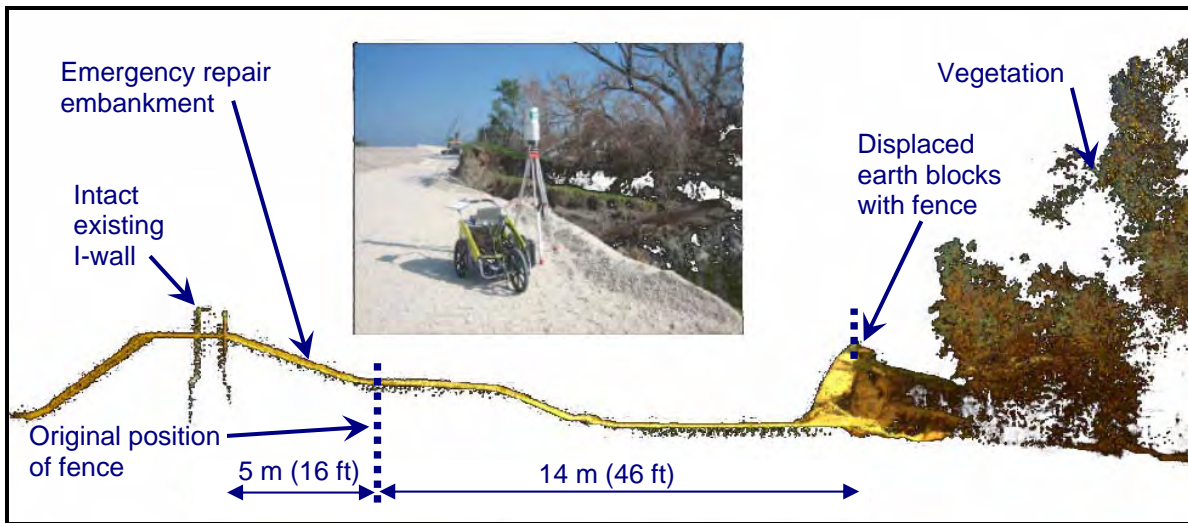
From the perspective shown in Figure 7.17, it can also be seen that the canal width of the 17th St. Canal has been shortened about 6 meters (20 ft) by the placement of the earthen embankment.

Figure 7.17: Measurement of the lateral translation of the downstream soil levee from its original position is approximately 14 meters (46 ft). The I-wall in this image is offset (out of the page) from the slide block.

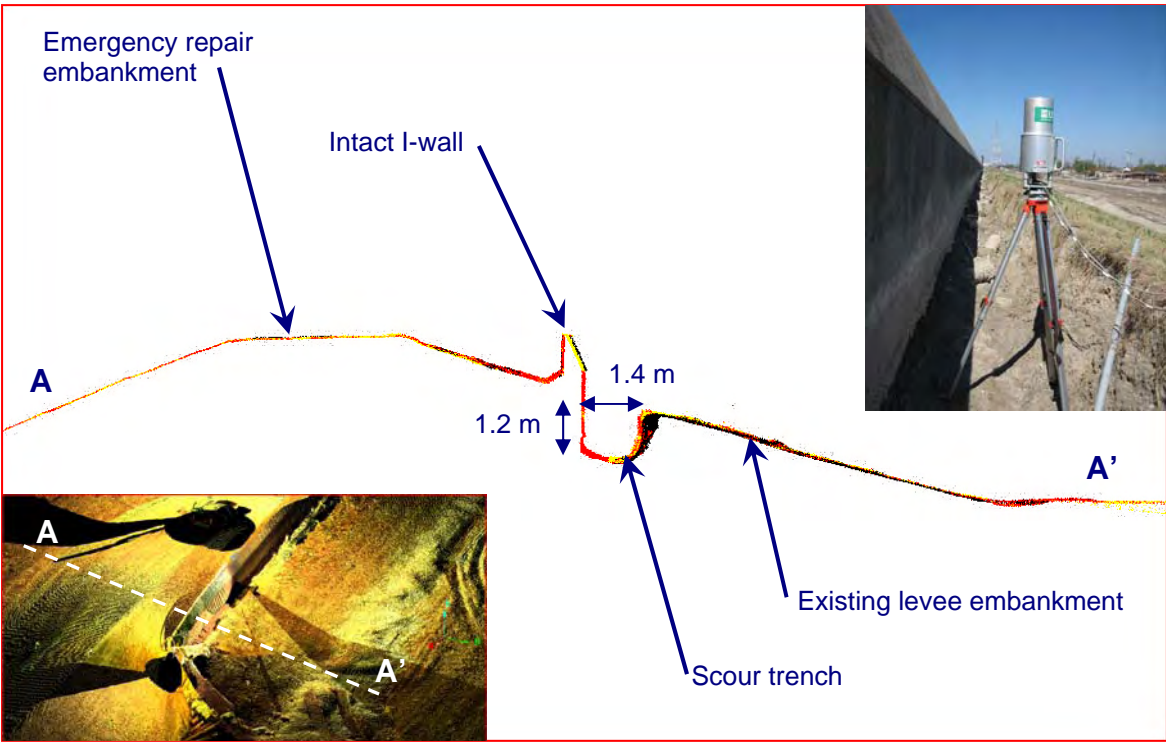
A final example of the use of the LIDAR data is shown in Figure 7.18. Here, the dimensions of the scour trench in the vicinity of the east side IHNC – south breach are outlined. This view shows the depth of the scour below the I-wall and into the embankment supported sheet pile so that a direct comparison of the scour depth to sheet pile embedment can be calculated.

Figure 7.18: Measurement of scour trench dimensions at the IHNC – South site.
